An Architectural Self - Criticism: The Accessibility Analysis of Berlika Park Swimming Pool

Özlem Demirkan*

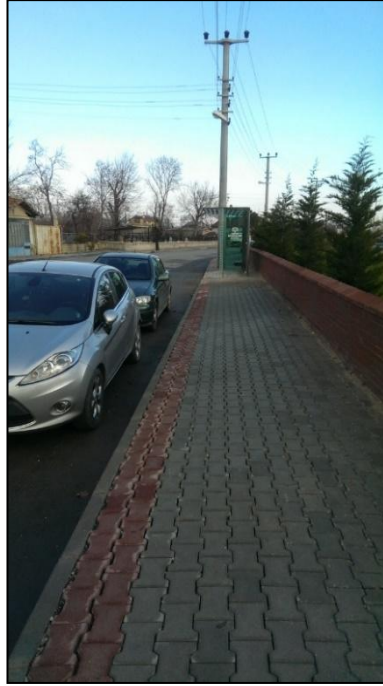
Photograph 1. Approach to the Building (Demirkan, 2015)

1. There is no handrail (TS 12576 Article 5.8).
2. There is no backrest above 45 cm of the seat (TS 12576 Article 5.5.1).
3. The width of the pavement is less than 300 cm in bus stops (TS 12576 Article 5.5.1).

4. It is not banned for other vehicles to stop or park within the bus stops by horizontal and vertical signs (TS 12576 Article 5.8). The information in the information board is missing.

5. No information about the route plan of each bus, the closest cabstand and important phone numbers on the information board (TS 12576 Article 5.8)
6. No tactile surface on the pavements (TS 12576 Article 5.1.5.1)

7. Power pole is in the middle of the pavement without any warning sign.
8. The curbstone isn't made with different material and color from the pavement overlay (TS 12576 Article 5.1.7.2).

9. The sidewalk of the bus stop isn't high enough, so there is a level difference between the pavement and the landing area (TS 12576 Article 5.8).

10. No space for a wheelchair adjacent to the seats in the bus stop (TS 12576 Article 5.5.1.)
11. There is no shiny, colored and reflective strip with 15 cm thickness and at a level of 100 and 140 cm (TS 12576 Article 5.8).

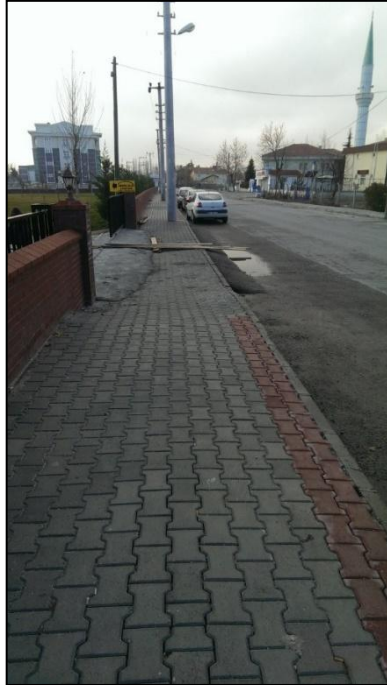
Photograph 2. Approach to the Building (Demirkan, 2015)

1. The guideboards aren't made of flat material and there isn't enough lighting (TS 1257 Article 5.6) (TS 9111 Article 4.8.6)
2. The screws used for the setup of power poles and traffic signs to the ground aren't arranged so that they aren't dangerous for the pedestrians (TS 12576 Article 5.1.7.1)

3. When the sidewalk behind the ramp isn't between 90 and 122 cm, a ramp of 1:12 (8%) should have been built in order to decrease the height of the pavement (TS 9111 Article 4.4.3.1) (TS 12576 Article 5.2)

4. No roadblocks are placed on the curbstone to prevent the car parking.
5. The ramps (above 5% slope) aren't covered with firm, non-skid and slightly rough material (TS 12576 Article 5.2.3).

6. There is no yellow-black warning sign is present during maintenance and repairs (TS 12576 Article 5.6).
7. No signing for the visually impaired individuals at the start and end of the ramps (TS 9111, Article 4.4.3.4)

8. The curbstone isn't made with different material and color from the pavement overlay (TS 12576 Article
9. No drainage gutter and grate on it to remove the surface water (TS 12576 Article 5.1.7.3)

10. In the event of maintenance and repair on the pavement, there is no audial and light warning, and the maintenance area

isn't surrounded with an obstacle at least 10 cm height (TS 12576 Article 5.1.6)

11. On two sides of the 150-cm pavement, there is no emergency lanes, 50 cm on the curbstone side and 25 on the property side (TS 12576 Article 5.1.1)

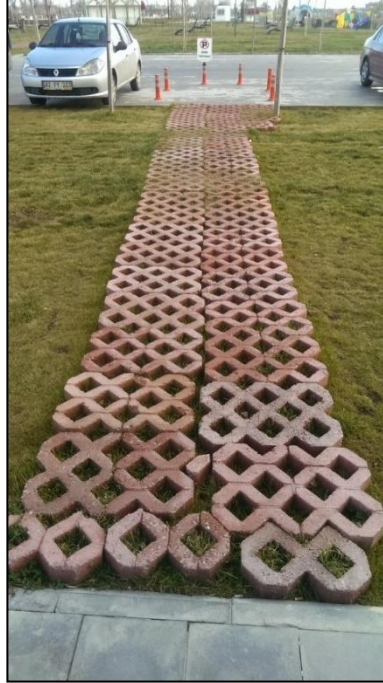
Photograph 3. Approach to the Building (Demirkan, 2015)

1. The signs and symbols aren't perceivable and there is no information with braille alphabet. Similarly, they aren't visually understandable for hearing impaired individuals. (TS 12576 Article 5.6)(TS 9111 Article 4.8.15)
2. There is no sign, which shows the accessible routes, on walkways, important cross-roads and parks (TS 12576 Article 5.6)
3. The use of inappropriate material for the access from parking lot to the building
4. There is no at least one accessible route from bus stop, accessible parking lot, accessible kiss and ride zone, streets and pavement to the accessible entrance of the building (TS 9111 Article 4.3.1)

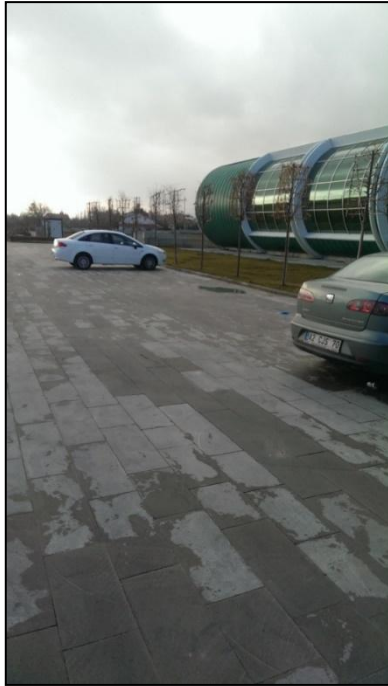
Photograph 4. Approach to the Building (Demirkan, 2015)

1. The parking lot for disabled individuals isn't protected against weather conditions such as snow and ice (TS 9111, Article 4.4.1)
2. The ratio of handicapped parking space is less than 5% (TS 9111, Article 4.4.1) (TS 12576 Article 5.7)
3. There is no secure kiss and ride zone that has an access to the building (TS 9111, Article 4.4.1)
4. The size, quality and the signs of handicapped parking lot cannot be questioned (TS 9111, Article 4.4.1)

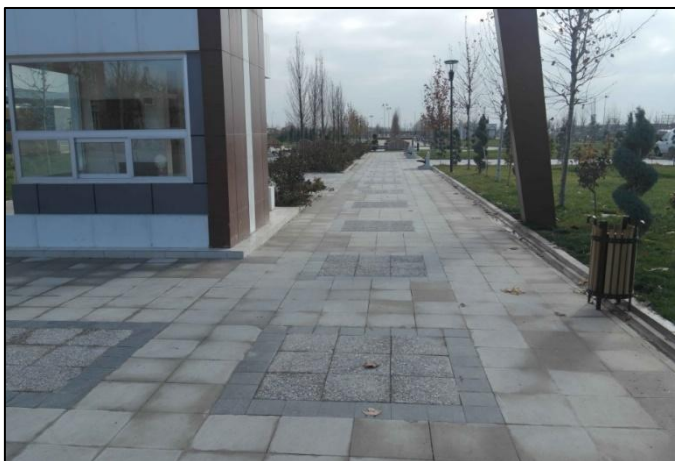
Photograph 5. Approach to the Building (Demirkan, 2015)

1. There is no additional lights or opposite colors and information board with perceivable surface at important decision-making points, which would help find the way or provide orientation (TS 9111, Article 4.4.2.2)
2. The walkways to the buildings around and between the buildings have straight, firm and non-skid (wet/dry) surface and free of drainage grate (TS 9111, Article 4.4.2.2)

3. There is no visual, audial and perceivable information boards in the site with the aim of orientation and finding way (TS 9111, Article 4.4.2.2)

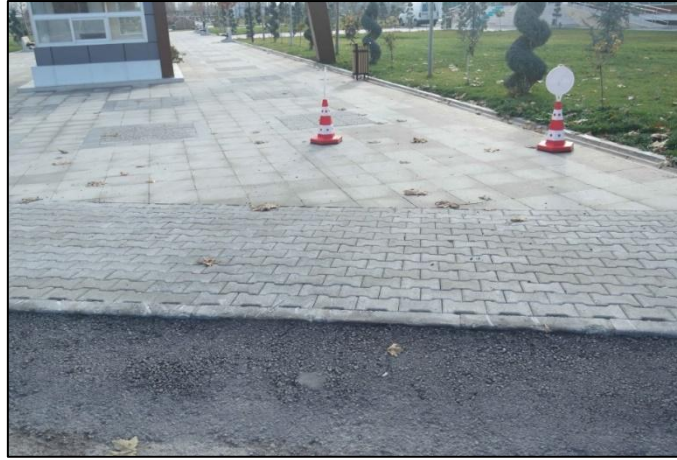
Photograph 6. Approach to the Building (Demirkan, 2015)

1. In front of the ramp, there is no floor covering of 60 cm wide on three sides of the pavement which shows the ramp (TS 9111 Article 4.4.3)
2. The perceivable surfaces don't have opposite colors with their surroundings

3. There is no at least one accessible route from bus stop, accessible parking lot, accessible kiss and ride zone, streets and pavement to the main entrance of the building (TS 9111 Article 4.3.1)

4. There is no perceivable surface on the pavement (TS 12576 Article 5.1.5.1)
5. The ramps (above 5% slope) aren't covered with firm, non-skid and slightly rough material with different colors (TS 12576 Article 5.2.3)

6. The height of curbstone isn't between 3 and 15 cm
7. There is no perceivable warning surface on the ramp which decreases the height of the pavement (TS 9111 Article 4.11.1.3)

8. There is no roadblocks are placed on the curbstone to prevent the car parking.
9. When the sidewalk behind the ramp isn't between 90 and 122 cm, a ramp of 1:12 (8%) should have been built in order to decrease the height of the pavement (TS 9111 Article 4.4.3.1) (TS 12576 Article 5.2)

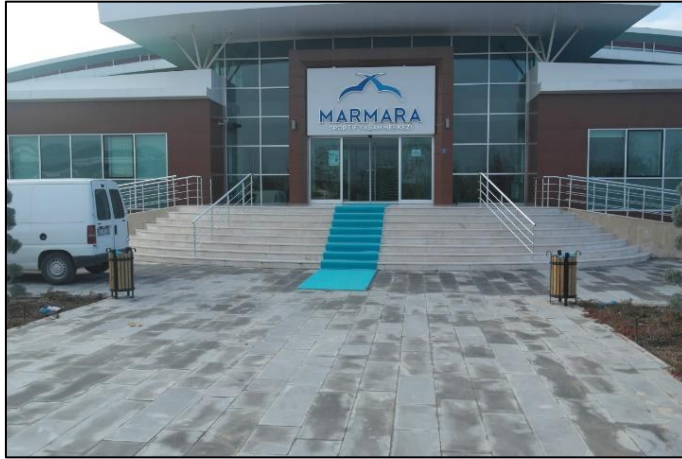
Photograph 7. Approach to the Building (Demirkan, 2015)

1. There are safety rails on both sides of the exterior stairway (TS 12576, Article 5.3)
2. There is no warning surface at the beginning and the end of the stairway (TS 12576 Article 5.3.2)
3. The front of the steps should be nosing and round (TS 12576 Article 5.3.3)
4. When the width of the stairs is more than 300 cm, there should have been a safety rail in the center of the stairs
5. The points of the rails aren't open, and they aren't in U shape (TS 12576 Article 5.3.3) (TS 9111, Article 4.7.1.3.3)

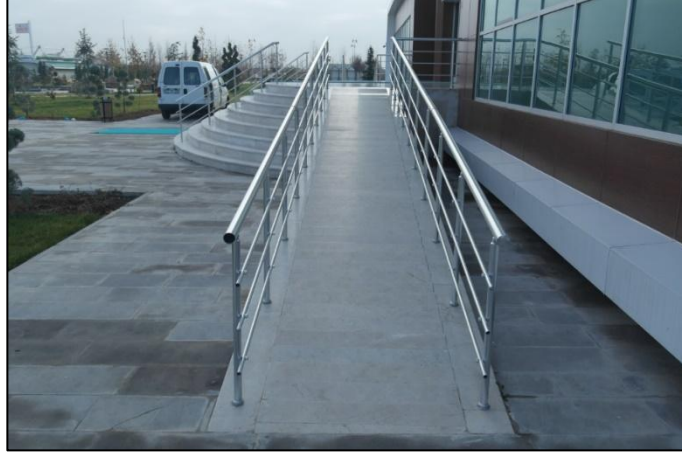
Photograph 8. Ramp
(Demirkan, 2015)

1. When the level difference is more than 100 cm, the slope of the ramp should have been 1:16
2. When the level difference is more than 100 cm after the ramp ends, the slope of the ramp should have been 1:16 and it should have been 30 cm longer (TS 9111)
3. The width of the ramp is 130 cm (TS 9111 Article 4.4.3.2)
4. The rail doesn't go 30 cm more than the ramp in the beginning of the ramp (TS9111, Article 4.4.3.4)
5. There is no first level rail of 70 cm height on the both sides of the ramp (TS 9111, Article 4.4.3.4)
6. There are second level rails of 90 cm height on both sides of the ramp (TS 9111, Article 4.4.3.4)
7. The ramp sign isn't consistent with the international signs (TS12576 Article 5.6)

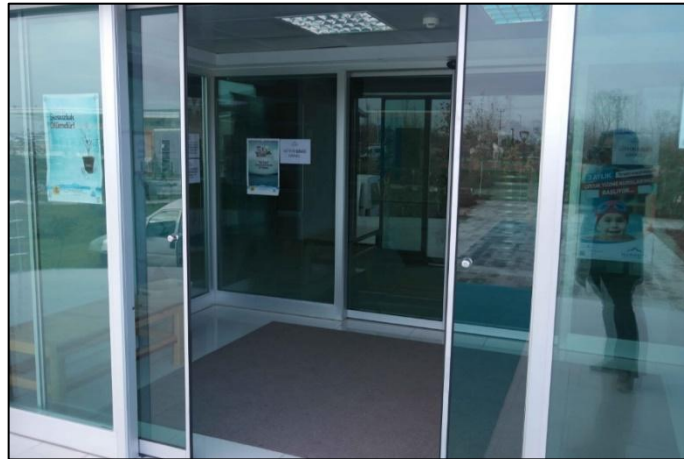
Photograph 9. Ramp
(Demirkan, 2015)

1. The floor coverings are made of slippery materials (TS 9111, Article 4.6.1)
2. The carpet is thinner than 1.3 cm

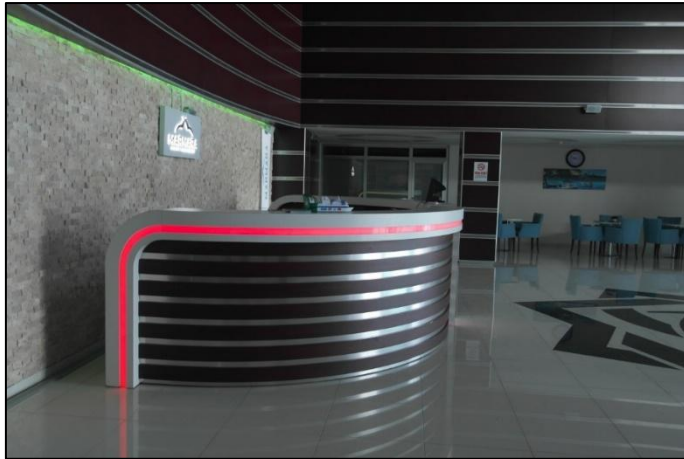
Photograph 10. Information desk (Demirkan, 2015)

1. There is no at least one disabled information desk which is 90 cm width and 86 cm height (TS 9111, Article 4.10.3.2)
2. The floor coverings are made of slippery materials (TS 9111, Article 4.6.1)
3. There isn't a foldable shelf system on the desk, on which the disabled people can write (TS 9111, Article 4.10.3.2)
4. The necessary equipment isn't labeled by signs for hearing impaired individuals (TS 9111 Article 4.8.15)
5. There is no guidance plan or floor plan near the main entrance

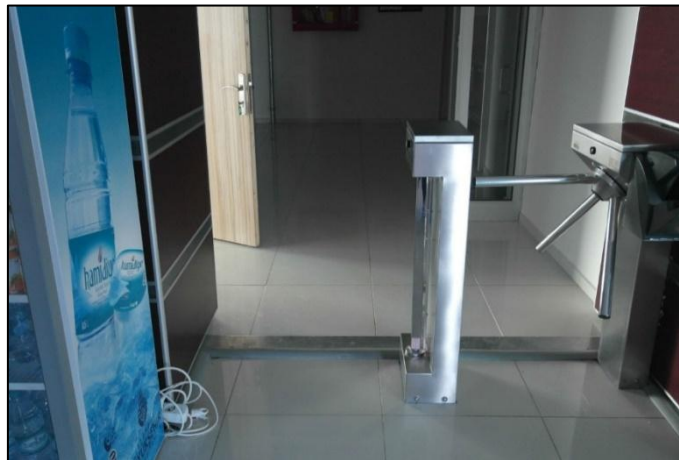
Photograph 11. Entrance to the pool (Demirkan, 2015)

1. There isn't a space of 90 cm width and 220 cm height without obstacles inside the corridors.

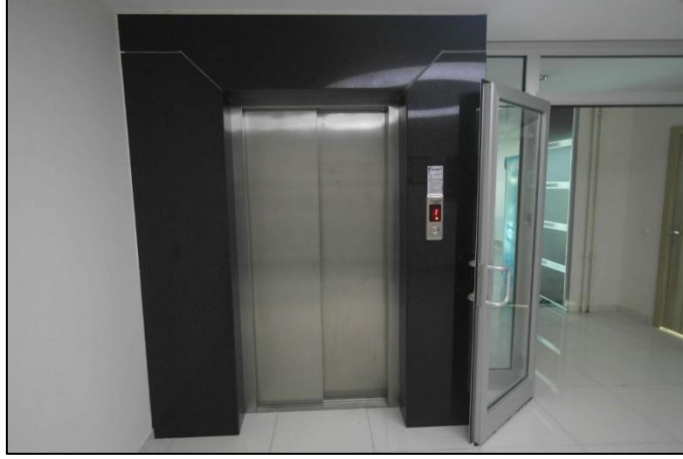
Photograph 12. Elevator
(Demirkan, 2015)

1. There isn't a space of 122 cm width and 76 cm deep for approach from the side (TS 9111, Appendix A).
2. There isn't two-way communication systems in the elevators (TS 9111, Appendix B)
3. The elevator call panel isn't placed between the height of 90 cm and 137 cm. TS 9111, Article 4.7.1.2
4. The size of the elevator cage doesn't fit the size of 150 cm width and 150 cm height (TS 9111, Article 4.7.1.2)
5. There is no accessible elevator (with all qualities) sign (TS 9111, Article 4.7.1.2)
4. There is no evacuation elevator in the building (TS 9111, Article 4.2)
5. There is no warning "don't use elevators during fire" in the elevator since there isn't an evacuation elevator. (TS 9111, Appendix B)

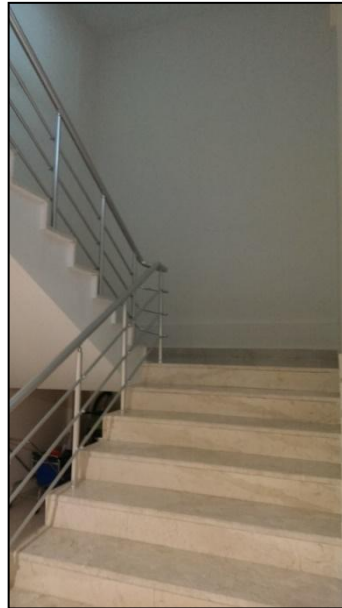
Photograph 13. Staircase
(Demirkan, 2015)

1. There is no information signs with braille on the railings.
* Since there isn't warning surface on the landing, warning tapes aren't placed on landing in rectangle and shape and crosswise

* The stairs doesn't fit the formula of $2a(\text{riser}) + b(\text{the depth of stair}) = 60-64 \text{ cm}$ * No landing for each 8- 10 stairs (TS 9111, Article 4.7.1.3)

2. There is no 30 cm and 60 cm length perceivable surface at the end and beginning of the stairs and on the landing, respectively (TS 9111, Article 4.7.1.3)

3. There is no non-skid tape on any of the stairs (TS 9111, Article 4.7.1.3) The stair material is composed of slippery and shiny materials (TS9111, Article 4.7.1.3)

4. There is no visual warning tape (preferably yellow) on the first and last stairs of stairway and on the landing (TS 9111, Article 4.7.1.3)
5. The front of the stairs is nosing (TS 9111, Article 4.7.1.3).

6. There is no rail at the height of 70 cm on the railings (TS 9111, Article 4.7.1.3)

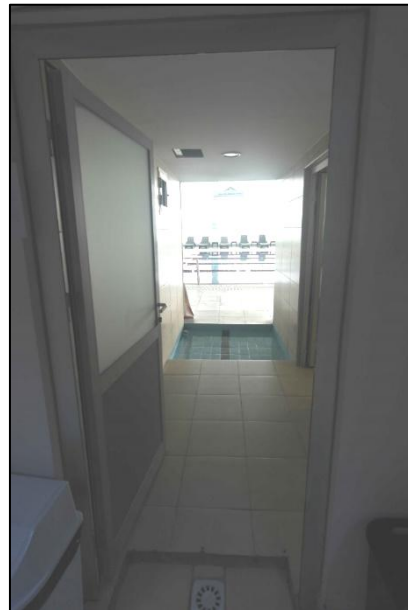
Photograph 14. To the pool (Demirkan, 2015)

1. There isn't a space of 90 cm width and 220 cm height without obstacles inside the corridors.
2. Floor coverings are made of slippery materials (TS 9111, Article 4.6.1)

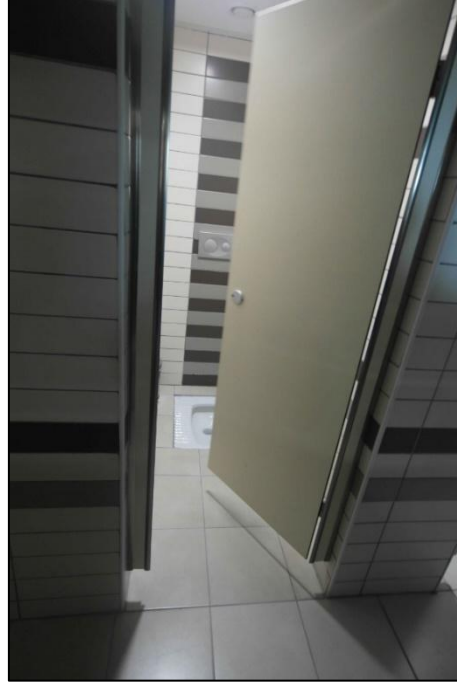
Photograph 15. Toilets
(Demirkan, 2015)

1. There is no protective plate of 40 cm height under the door. (TS 9111, Article 4.6.2)
2. Floor coverings are made of slippery materials (TS 9111, Article 4.6.1)
3. There is no U shape pushing handle between the height of 80 and 110 cm on bathroom doors (TS 9111, Article 4.6.2)

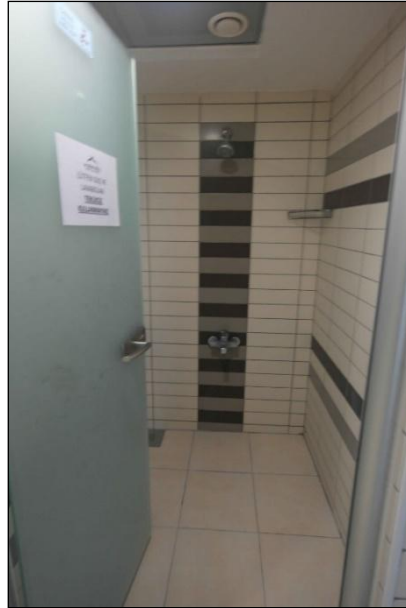
Photograph 16. Baths
(Demirkan, 2015)

1. The height of the soap dispenser isn't between 80 and 110 cm (TS 9111, Article 4.7.3).
2. The doors are made of glass and there is no singing for visually impaired individuals (TS 9111, Article 4.6.2).

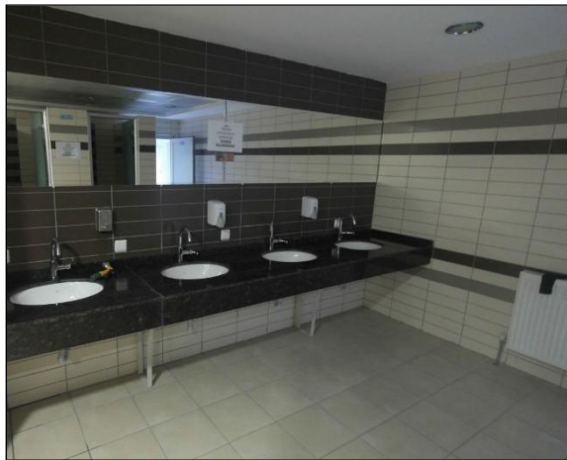
Photograph 17. Baths
(Demirkan, 2015)

1. The distance from sink to tap is more than 30 cm (TS 9111, Article 4.7.3).
2. There is no enough space under the lavatory so that a wheelchair could enter (20 cm depth 75 cm height) (TS 9111, Article 4.7.).
3. The height of the lavatory front from the floor is more than 86 cm (TS 9111, Article 4.7.3).
4. The floor covering is slippery (TS 9111, Article 4.6.1). The height of the bottom of the mirror from the floor is more than 90 cm (TS 9111, Article 4.7.3.)
5. The height of the soap dispenser from the floor isn't between 80 and 110 cm (TS 9111, Article 4.7.3)

6. There is no handle bar on the edges of the lavatory for people who have difficulty in standing * The height of tissue dispenser or hand dryer from the floor isn't between 80 and 110 cm (TS 9111, Article 4.7.3.).

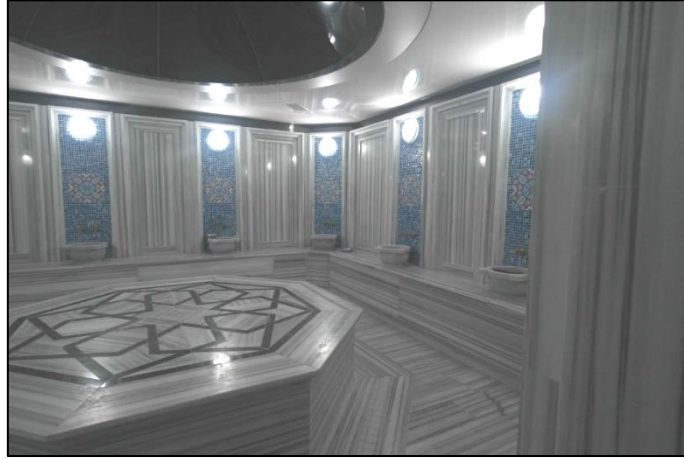
Photograph 18. Hamam
(Demirkan, 2015)

- 1.The doors are made of glass and there is no singing for visually impaired individuals (TS 9111, Article 4.6.2)
2. There is an obstacle of 4 cm height on the entrance.
3. There is no visible alarm system.
4. There is no hearable audio alarm (TS 9111 Article 9.1)

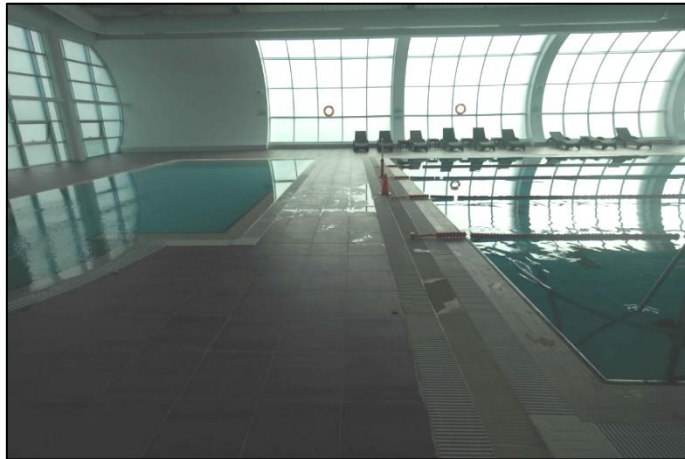
Photograph 19. Pool
(Demirkan, 2015)

1. There is no hearable audio alarm. Article 9.1
2. There is no visible alarm system.
3. There is no necessary warning sign.
4. There is no perceivable floor. (TS 12576 Article 5.1.5.1)
5. There is no pool elevator or lift for disabled individuals.

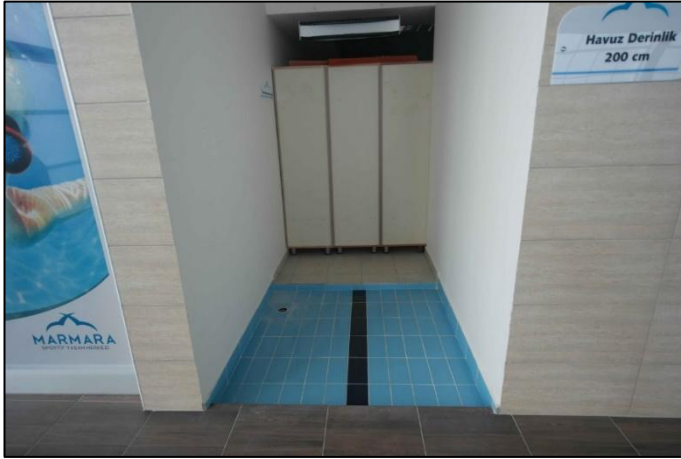
Photograph 20. Pool
(Demirkan, 2015)

- 1.The guideboards aren't made of flat material and there isn't enough lighting (TSE, 2011)
- 2.There are obstacles on accessible route. One of the pool entrance is cancelled; a locker is placed there.

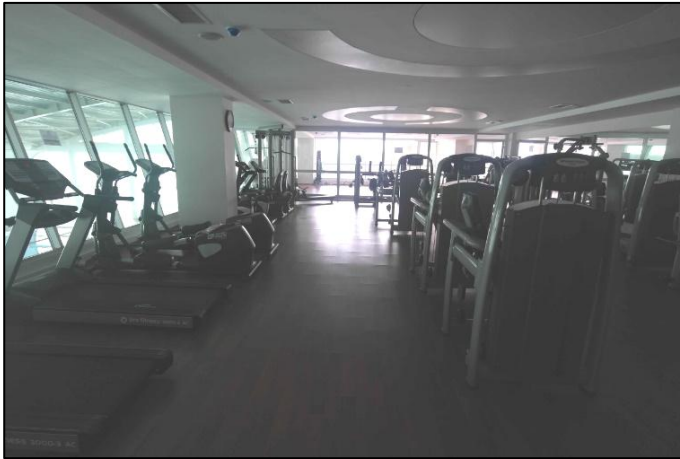
Photograph 21. Fitness
(Demirkan, 2015)

- 1.There is not enough information about fire exit.
- 2 .There isn't enough room for maneuver of wheelchair
3. The place hasn't got enough lighting.
4. There is an obstacle on the way to the terrace.
5. There is no necessary warning sign.
6. The necessary warning boards and signs that show the fire exit is absent.
