**13TH INTERNATIONAL  
ISTANBUL SCIENTIFIC  
RESEARCH CONGRESS  
ON LIFE, ENGINEERING,  
AND APPLIED SCIENCES  
PROCEEDINGS BOOK**

# INVESTIGATION OF THE RELATIONSHIP BETWEEN EARTHQUAKE INTENSITY AND CONCRETE PROPERTIES, THE EXAMPLE OF HATAY PROVINCE

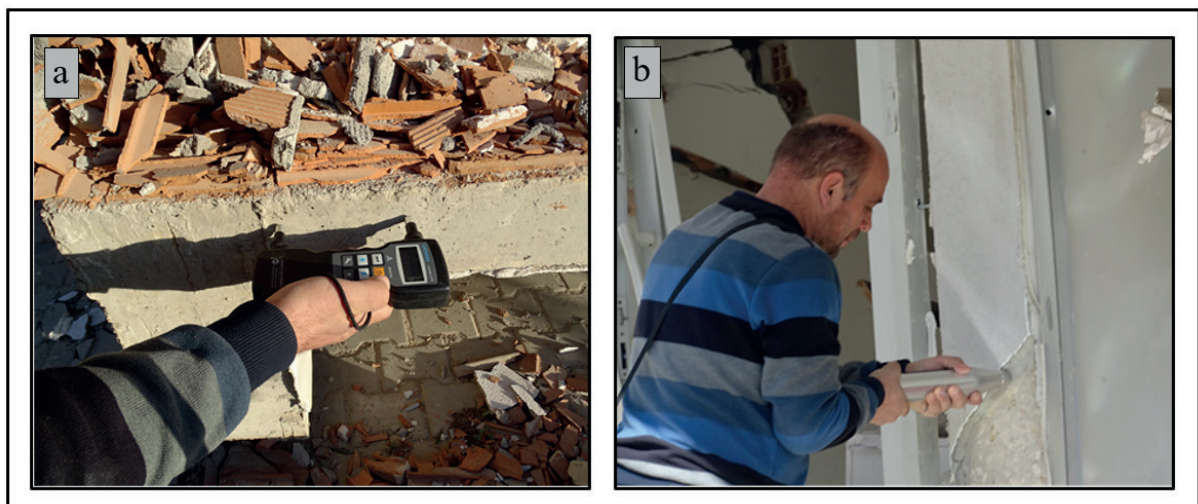
Figure 1. NDT measurements on building concrete

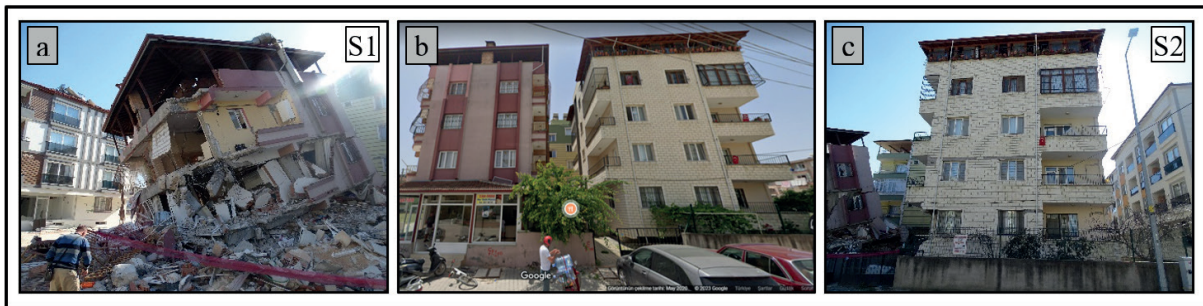
After the earthquakes that occurred in Kahramanmaraş on February 6, 2023, the damages observed in the structures in the two selected locations are given in Figure 2, and Figure 3. When Figure 2 is examined, it was determined that the first floor of S1 failed at the junction of the column and beam (Figure 2a). It was also determined that this building was buckling around its axis. In S2, however, no deformation was observed in the structural system of the structure, and shear cracks were detected on its walls (Figure 2c).

Figure 2. View of buildings with different types of damage on Uğur Mumcu Street (location 1), a) Building 1 (S1), b) Google.maps image of buildings before earthquake (<https://www.google.com.tr/maps/>), c) Building 2 (S2)

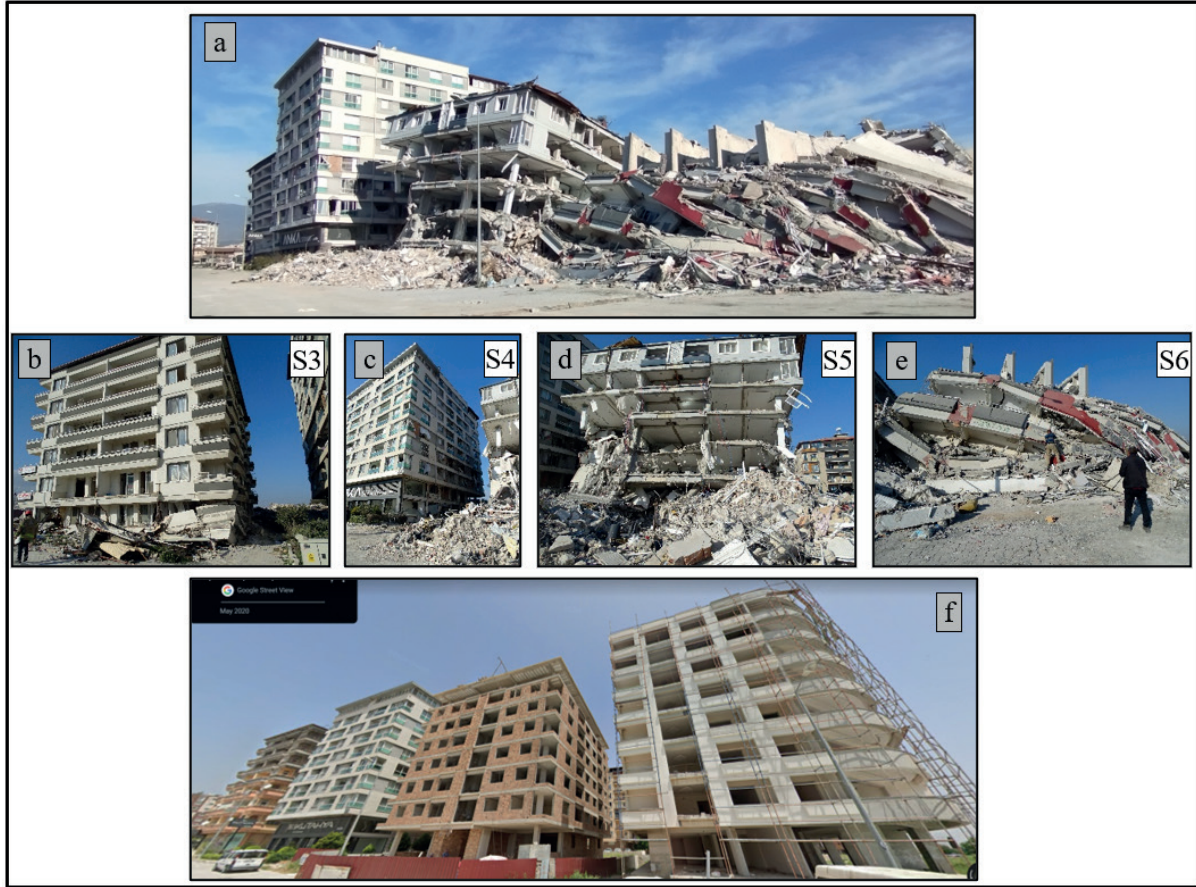
When Figure 3 is examined, it has been determined that the first floor of S3 has lost storey as a result of plastic failure between weak columns and strong beams and the collapse of the soft storey (Figure 3b). In S4, there are only shear cracks on the walls of the building (Figure 3c). Plastic failures occurred at the junction of the column and beam of the structure in S5 (Figure 3d). Building 5 (S5) was hit while building 6 (S6) was collapsing, causing an increase in the damage rate. The structure in S6 collapsed in the form of a press. It was also determined that the building was slightly buckled around its axis (Figure 3e). Plastic failure has occurred at the junction of the column and beam of the ground floor of the building.

Figure 3. a) View of buildings with different types of damage on Atatürk caddesinde (location 2), b) Building 3 (S3), c) Building 4 (S4), d) Building 5 (S5), e) Building 6 (S6), f) Google.maps image of buildings before earthquake (<https://www.google.com.tr/maps/> )
