**CURRENT DEBATES ON
NATURAL AND ENGINEERING
SCIENCES**

The Evolution Of Deterioration In Historical Buildings After Restoration: The Example Of Hagia Eleni Church (Konya-Turkey)

Mehmet Can BALCI¹
İsmail İNCE²
M. Ergün HATIR³

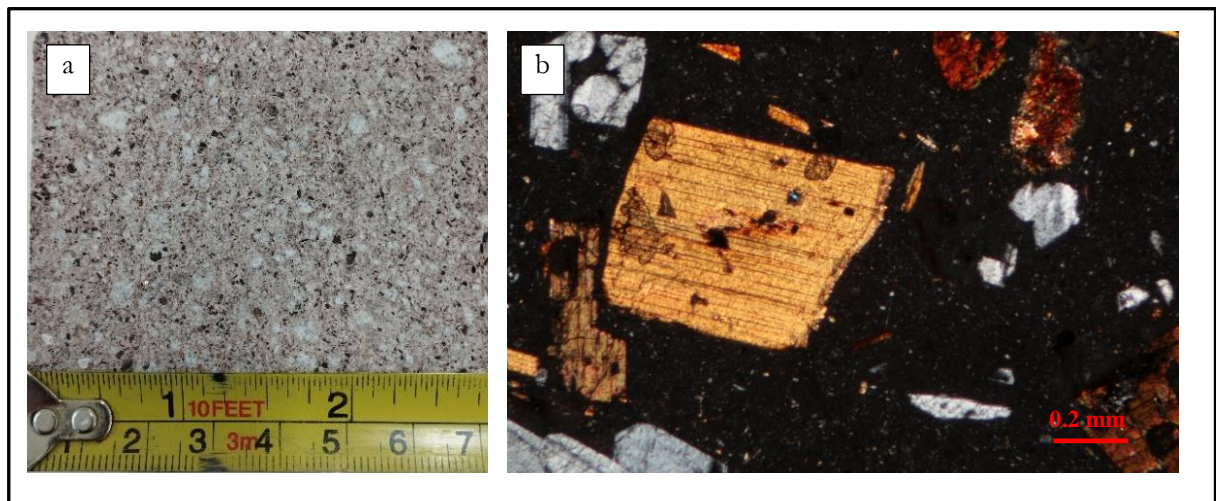
Macro examination of Sille stone displays plagioclase, biotite and quartz phenocrysts floating in a light-dark pink-coloured paste (Figure 2). The mineralogical composition of the rock includes 32% plagioclase, 16% biotite, 16% plagioclase microlites, 10% quartz, 3% opaque minerals and 23% volcanic glass. Due to the mineralogical composition, this can be defined as "plagioclacite" according to Streckeisen (1979). It was determined that Sille stone has a hypo crystalline porphyritic texture in thin sections. In addition, Hatr (2020) defined the rock as dacite based on the anaoxide values.

Figure 2. The appearance of Sille stone (a) macroscopic image, (b) microscope image (Crossed polars)

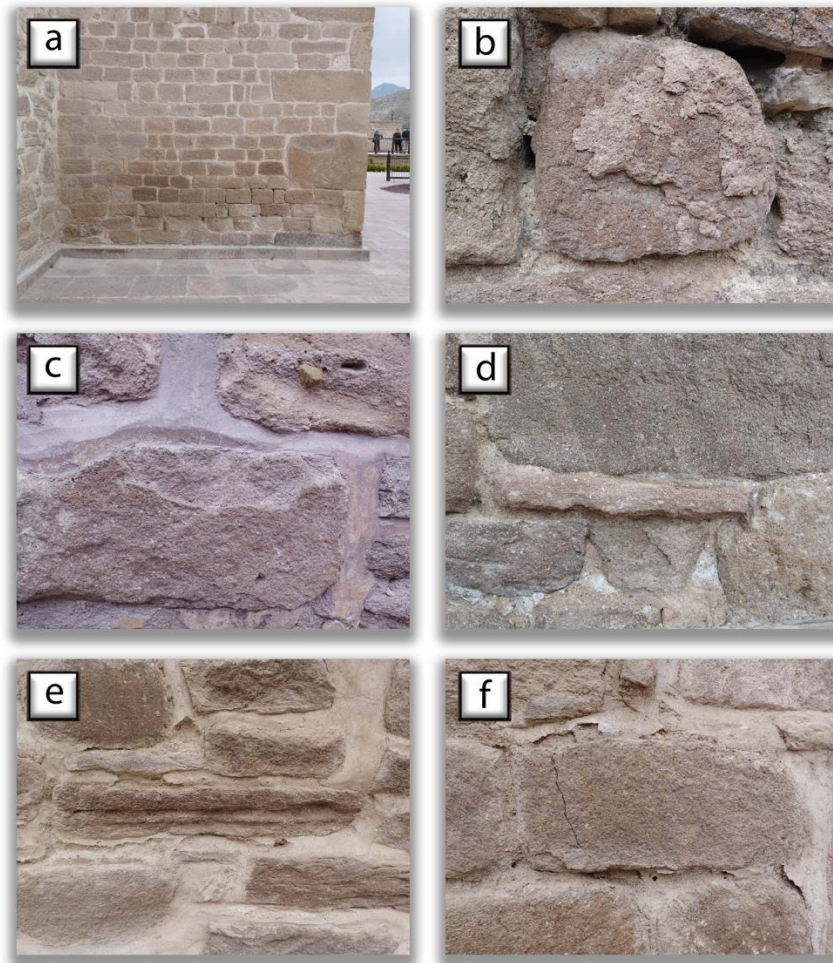
Restoration implementations of historical buildings are significant for the maintenance of the monuments. However, in cases where the implementations are not based on scientific grounds, the deterioration processes in monuments may accelerate and their structural integrity may be at risk to larger threat. In this study, the deterioration observed in the monument after the restoration works carried out in the church of Hagia Eleni in the Sille region of Konya in the year 2012 is evaluated. After the restoration of the monument, a moist area was examined due to capillarity (Figure 3a). This occurred because the drainage lines were not designed and implemented during the restoration works.

Figure 3. Types Of Deterioration Observed on The Building Stones of Hagia Eleni Church; a) Moist Area, b) Flaking, c) Contour Scaling, d) Efflorescence, e) Differential Erosion, f) Crack

Moist area development caused widespread flaking (Figure 3b), contour scaling (Figures 3b and 3c) and efflorescence deterioration (Figure 3d) in the capillary zone. The sensitivity of the rock to freeze-thaw, wetting-drying and salt crystallization processes were the main factors in the development of these processes. In other parts of the church, differential erosion (Figure 3e) type developed concerning the textural characteristics of Sille stone. As a result of the deterioration processes of the monument, cracks (Figure 3f) were observed in the building stones whose strength properties were weakened as a result. In addition, the metal railings of the building's windows have been corroded over time and have caused subsequently staining type on the building stones.

- Failure to examine the fundamental causes of deterioration processes in historical buildings before restoration reduces the success rate of the implementations. Failure to design the drainage infrastructure in Hagia Eleni Church resulted in a moist area throughout the monument.

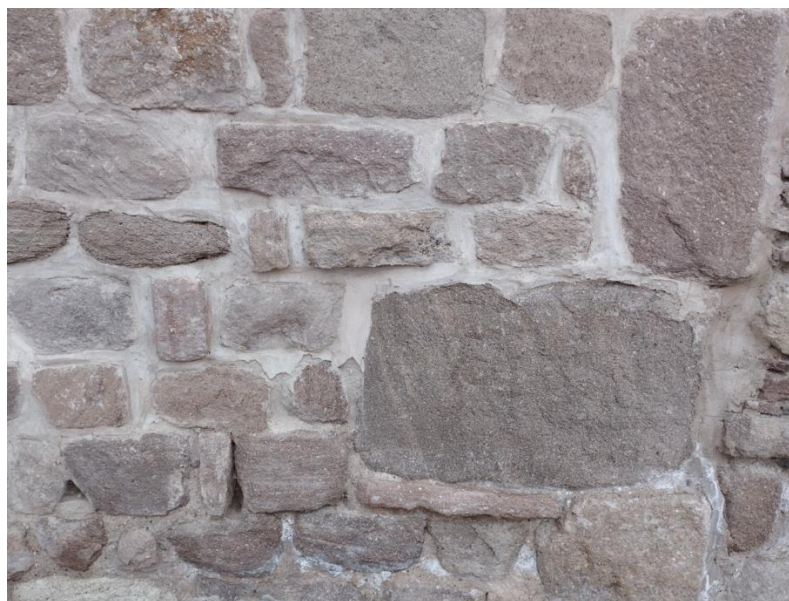
The fact that the mortar used in the restoration of the monument was incompatible with the original material was a factor in the acceleration of the deterioration process. In this process, the chemical additives in the mortar dissolved with the effect of capillary water. In the next stage, the increase in temperature caused the intensification of efflorescence development around the mortars in the capillary region. In the following stage of this cycle, the mortars gradually lost their binding properties and in places disintegrated (Figure 4). As a result of the increase in the contact surfaces of the water with the building blocks in the missing joint areas, the degradation mechanisms became more influential and increased the development of deterioration.

Figure 4. Mortar losses in monument joints

- Not utilizing the original building materials of the monument in restoration implementations may accelerate the deterioration processes. The mortar used without determining the original properties of the structure caused deterioration starting from the joint areas of the monument.
