INVESTIGATION OF DETERIORATION DEVELOPMENT IN CULTURAL BUILDINGS DUE TO ATMOSPHERIC AND HUMAN INFLUENCES, THE EXAMPLE OF YOUNG JESUS CHURCH

Mehmet Can Balcı^{1*}, İsmail İnce², M. Ergün Hatır³

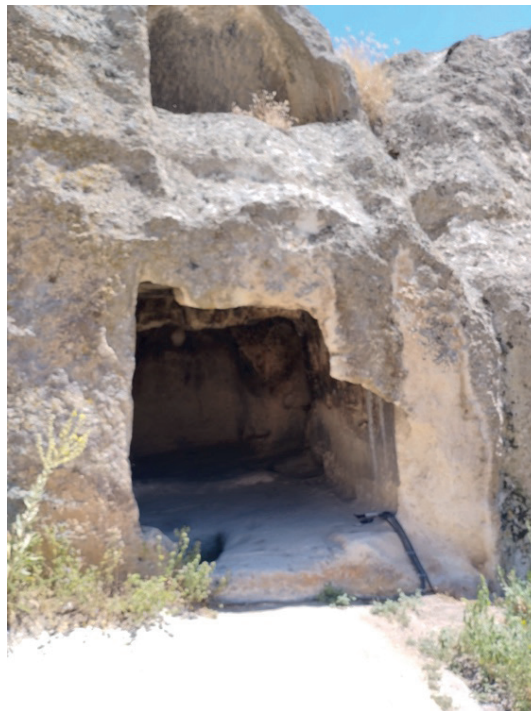
Figure 1. Young Jesus Church

Young Jesus Church, built by carving into the pyroclastic rock, has a single nave plan type (Figure 1). The naos (cella) is covered with a gable roof and there is a bench to the north of this monument. Although there are figures on the church walls, they cannot be identified due to damage. It is estimated that the monument was built between the 11th and 12th centuries.

Another type of deterioration due to atmospheric processes observed in the monument is biological colonization. Lichen and higher plant growths were detected on the exterior surfaces of the church (Figure 1). The loss of a fragment on the front façade of the monument, to the right of the entrance, is most likely of human origin, based on the impact marks.

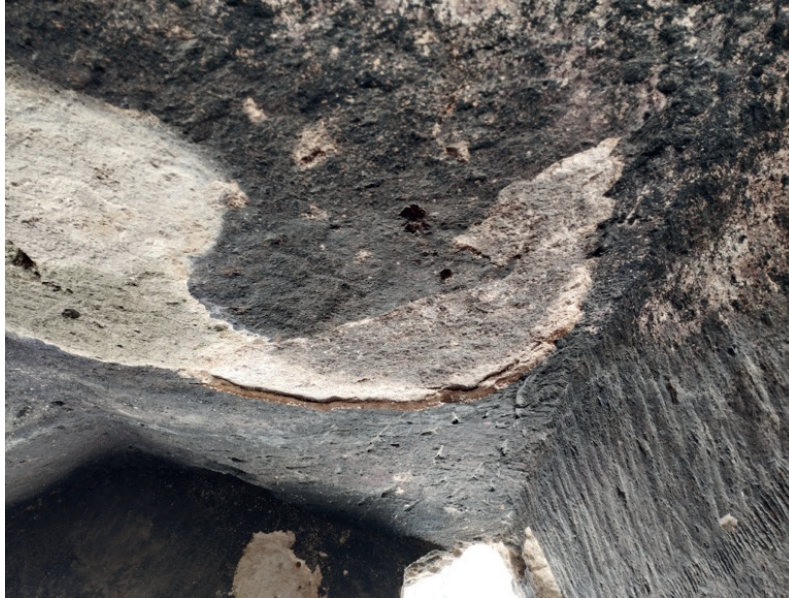
The deterioration of the rock-carved Young Jesus Church is concentrated on the façade and the ceiling of the monument. Large-scale contour scaling (Figure 2) type and black crust (Figure 3) anomalies were observed on the ceiling of the monument. This is thought to be caused by the ventilation gap opened in the ceiling of the monument (Figure 4).

The water seeping through this gap was absorbed by the ceiling and caused freeze-thaw processes to be active. In addition, these waters caused the surface to remain moist and triggered the formation of black crust (Figure 4).

Figure 2. Contour scaling and black crust on the monument ceiling

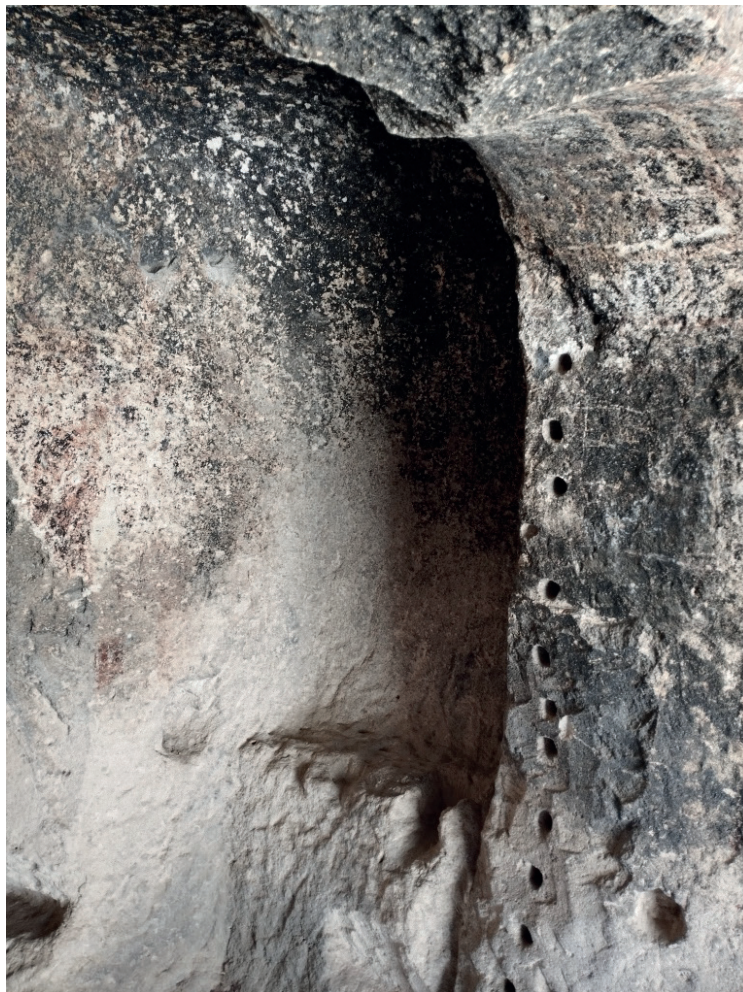
Figure 3. Black crust observed in the church

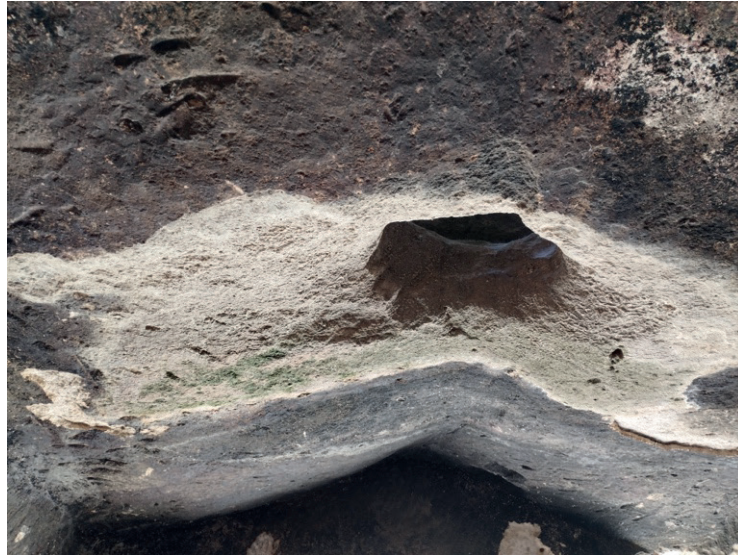
Figure 4. The gap in the ceiling of the monument for ventilation

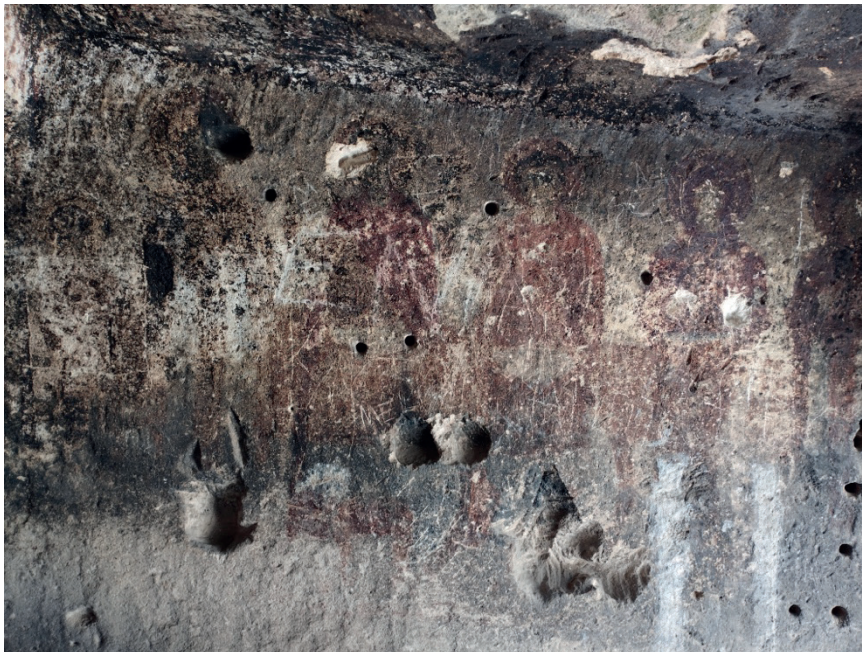
The other cause of deterioration in the church is human influences. It was determined that these influences were the biggest factor in the destruction of the figures inside the monument. There are scratches on the figures and pits and fragment losses due to impact (Figure 5).

Figure 5. Anthropogenic influences on the figures

Reducing anthropogenic influences is of great importance in the transfer of historical buildings to future generations. For this, it will be important to control historical sites with security and camera surveillance.
