2ND INTERNATIONAL "ARTEMIS" CONGRESS ON LIFE, ENGINEERING, AND APPLIED SCIENCES

INVESTIGATION OF STRUCTURAL PROBLEMS AND DETERMINATIONS RESULTING FROM RESTORATION APPLICATIONS

Key words: Building stone, Deterioration, Structural problem, Kızılören Küçükhan, Konya.

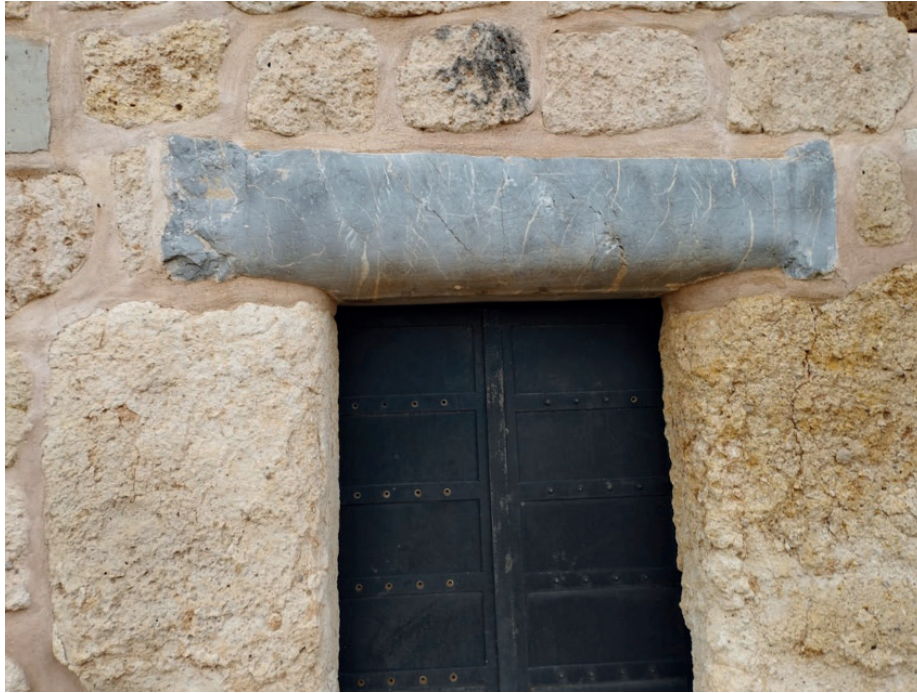
In Kızılören Küçükhan, low-density pyroclastic stones were utilized and marble rock (Figure 2) was preferred only in one block. However, the dry unit weights and uniaxial compressive strength of the pyroclastic rock chosen for restoration are high and the porosity is quite low. The restoration stone has a high dry unit weight and caused excessive load on the original blocks. As a result of the low uniaxial compressive strength of the original rock, it could not bear the load on it. This situation resulted in the development of cracks in the original blocks (Figure 3). In addition, the excessive loads in the areas where the restoration stone was excessive caused different settlements on the soil and large diagonal cracks occurred in the Han (Figure 4).

Figure 2. Marble block on the door

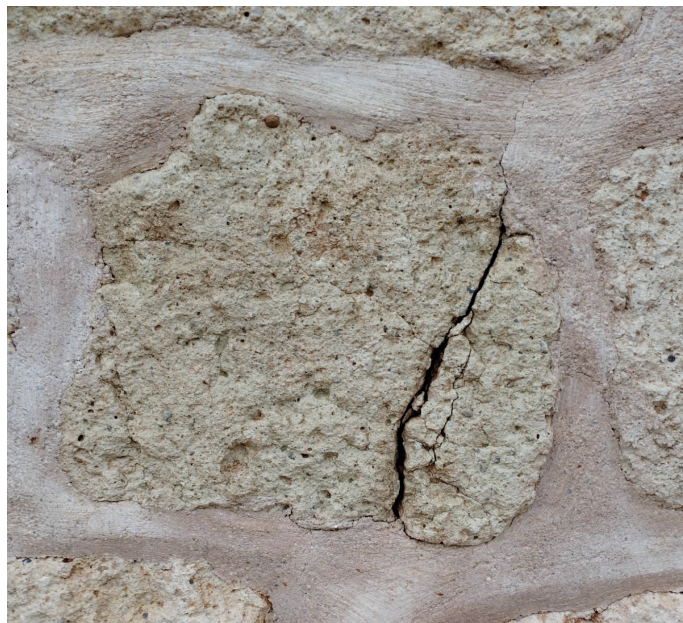
Figure 3. The crack type that develops in the monument

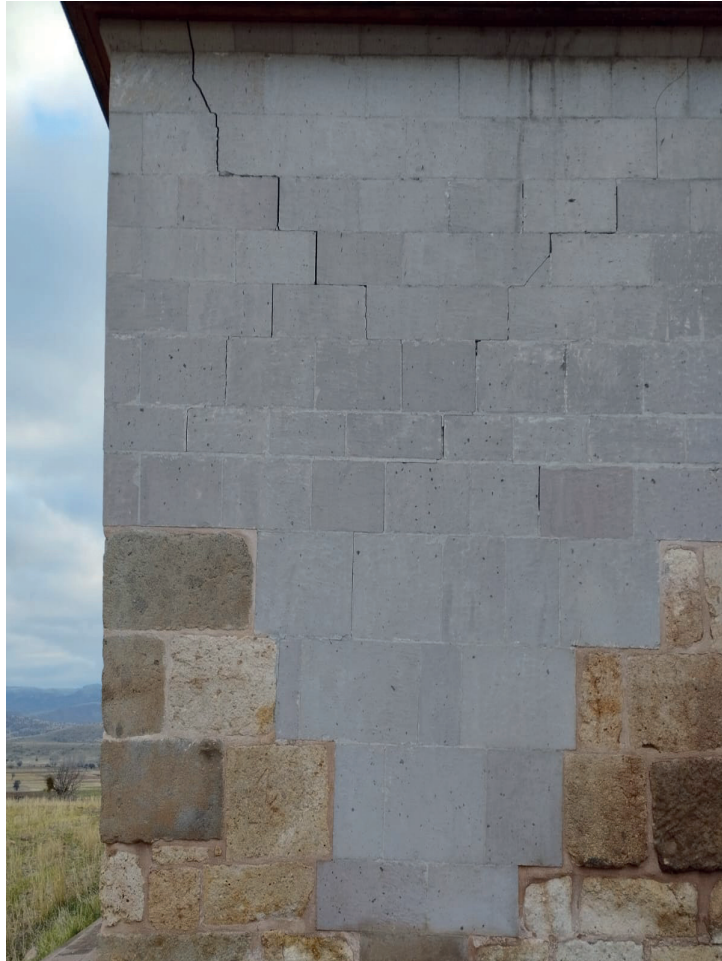
Figure 4. Crack development caused by restoration stones

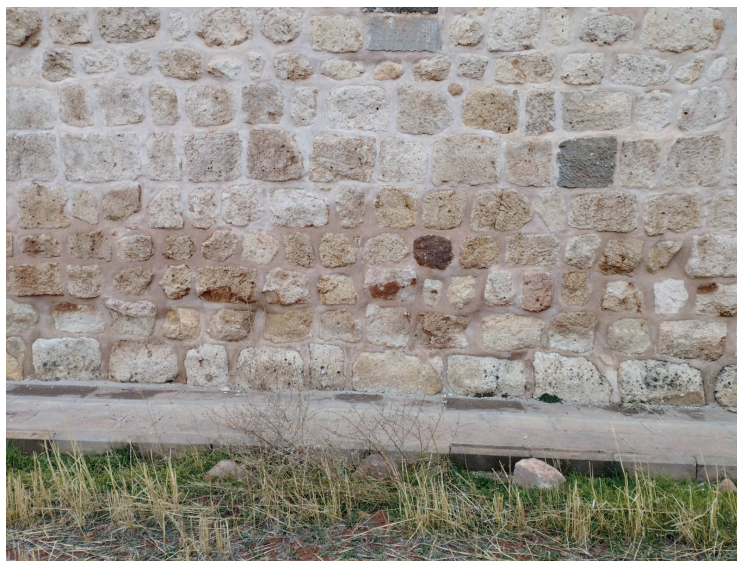
Another major problem in the monument is the humidity associated with the capillary zone (Figure 5). The presence of moisture in the capillary zone has led to the atmospheric phenomena of freeze-thaw, wetting-drying and salt crystallization. Efflorescence type occurred as a result of the ascent of water soluble salts with capillary effect and evaporation with the sun (Figure 6).

Figure 5. Moist area observed in the structure

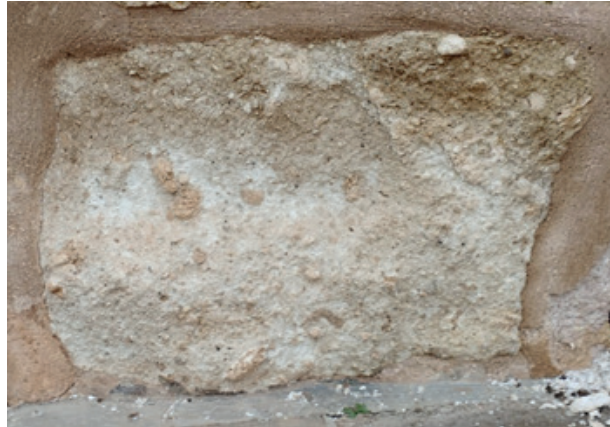
Figure 6. Efflorescence type

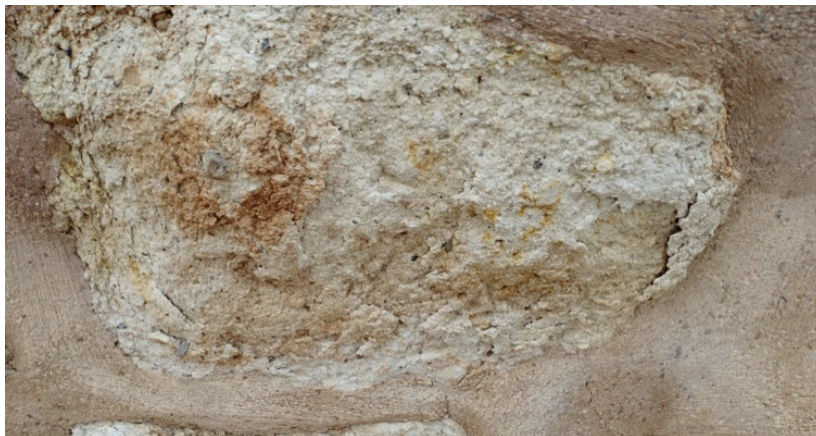
Freeze-thaw and wetting-drying processes primarily caused flaking type in building Stones (Figure 7). In the repetition of these processes, contour scaling type deterioration ranging from mm to cm scale has developed (Figure 8).

Figure 7. Flaking type

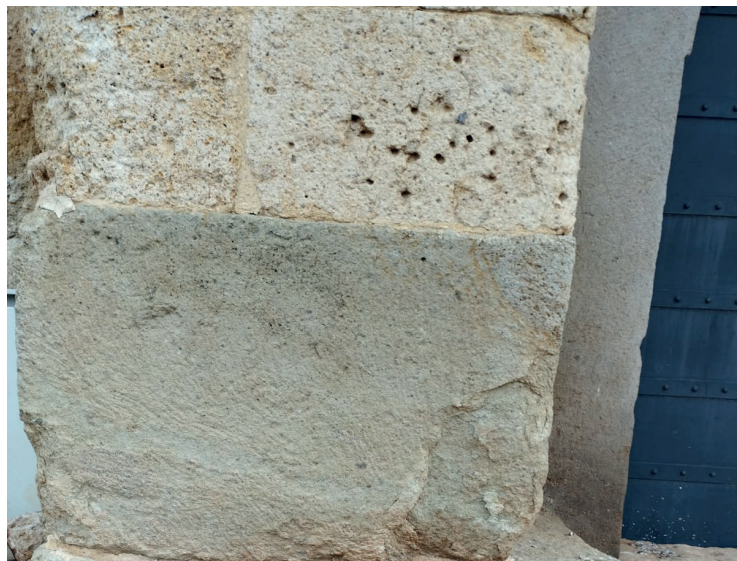
Figure 8. Contour scaling development

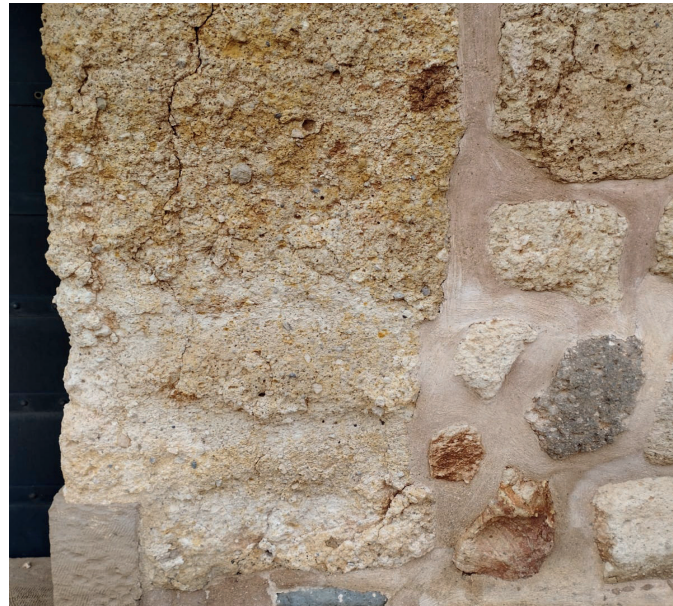
In addition, differential erosion due to textural differences between the matrix of the pyroclastic rocks and the phenocrysts and/or rock fragment was detected in some of the building Stones (Figure 9).

Figure 9. Differential erosion caused by matrix loss

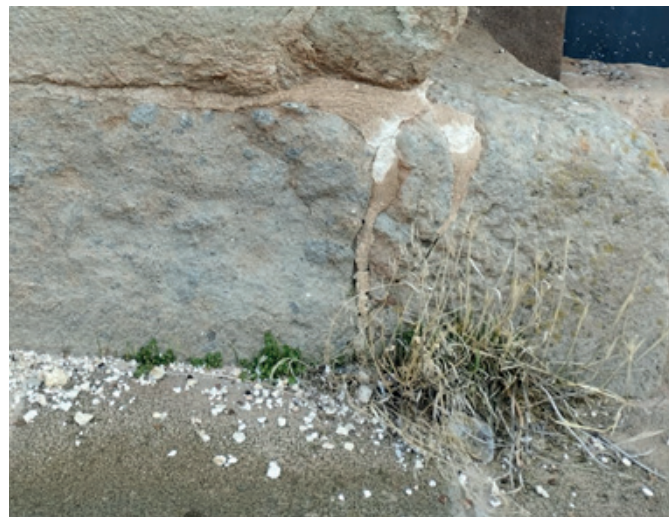
Another problem arising from moisture in the monument is biological colonization. Biological formations that can develop rapidly under humidity, organic matter and appropriate temperature were detected at the capillary zone of the structure (Figure 10).

Figure 10. Developing biological colonization of the monument
