**9TH INTERNATIONAL "BAŞKENT"
CONGRESS ON PHYSICAL,
ENGINEERING, AND APPLIED
SCIENCES PROCEEDINGS BOOK**

MAY 20-23, 2023

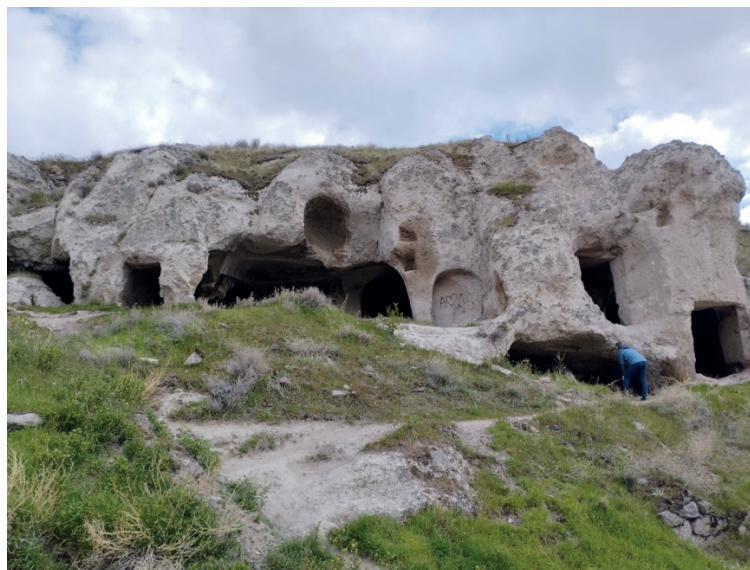
Figure 1. General view of the Koimesis Tes Panagias Church

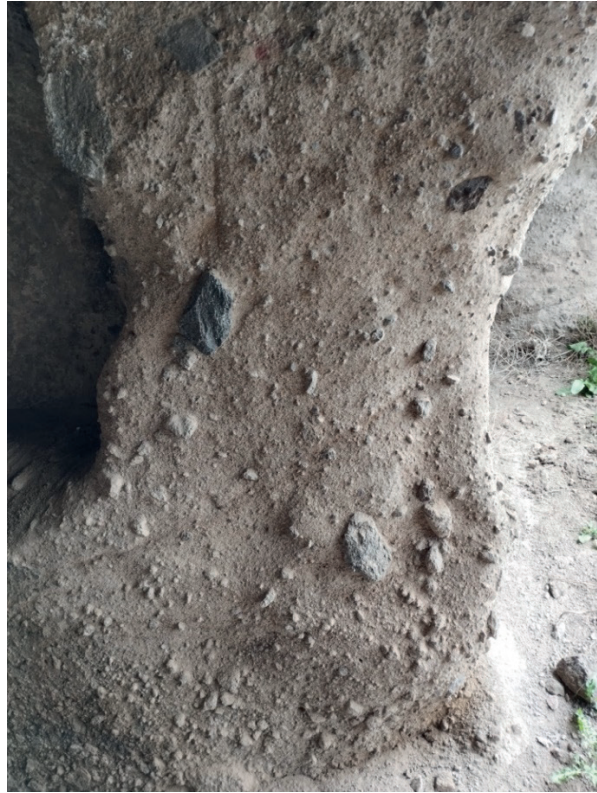
Figure 2. Flaking and differential erosion types observed in Koimesis Tes Panagias Church

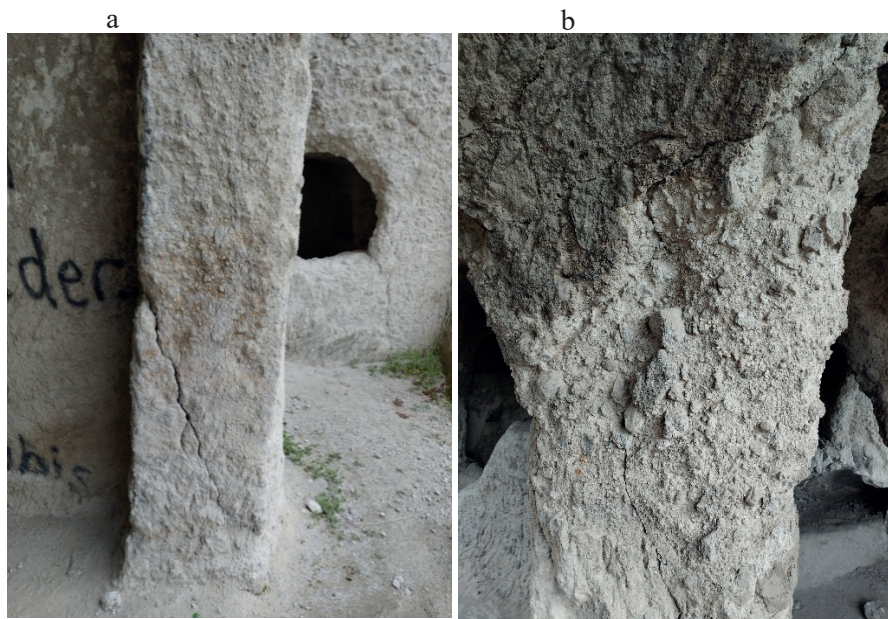
Figure 3. a-b) Examples of crack-type deterioration detected in the structure

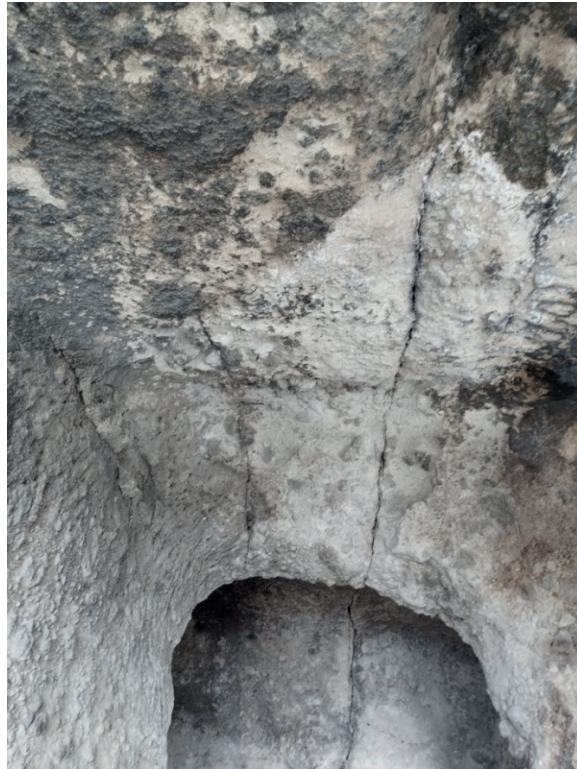
Figure 4. Discontinuous on the structure

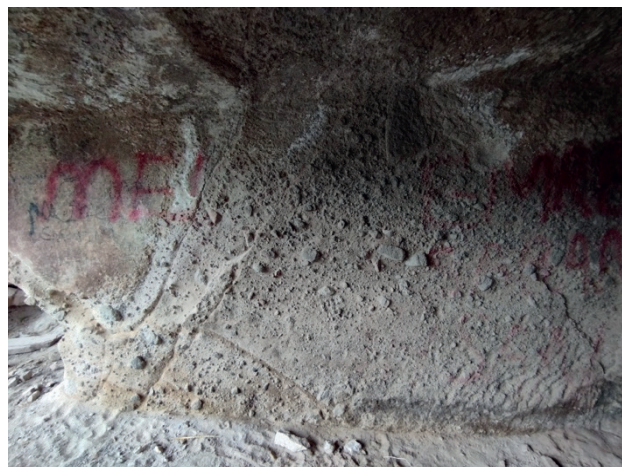
Figure 5. Efflorescence-type deteriorations in the structure

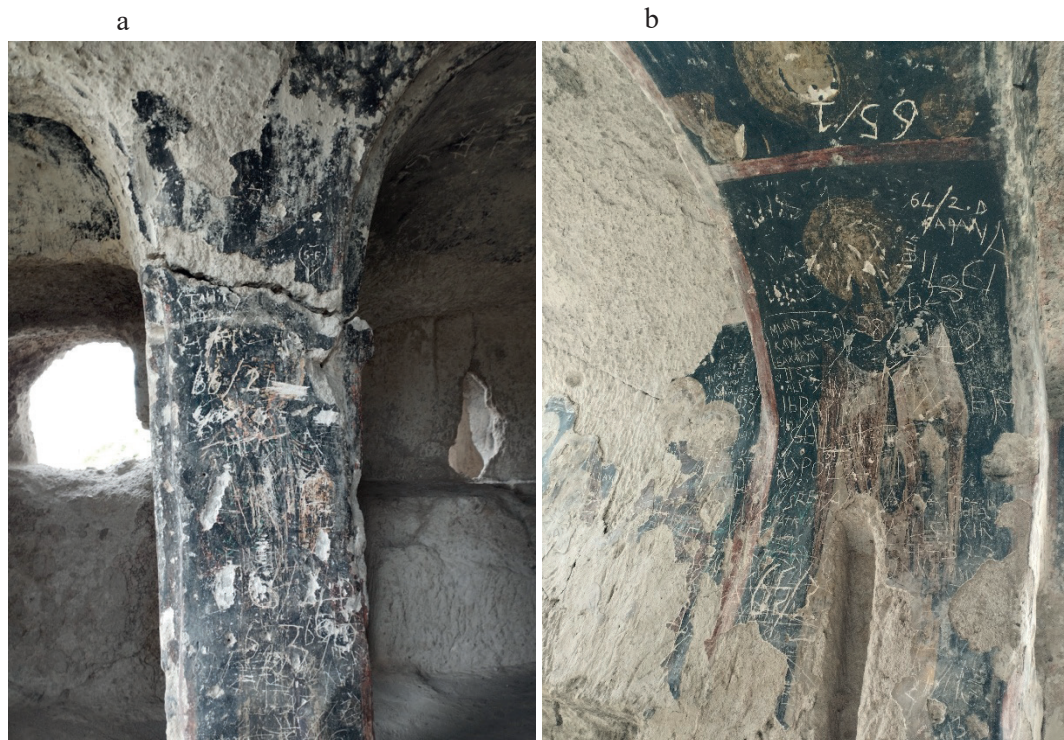
Figure 6. a) Loss of fresco, graffiti, and crack detected in the structural system of the monument, b) Loss of fresco and graffiti observed on the wall

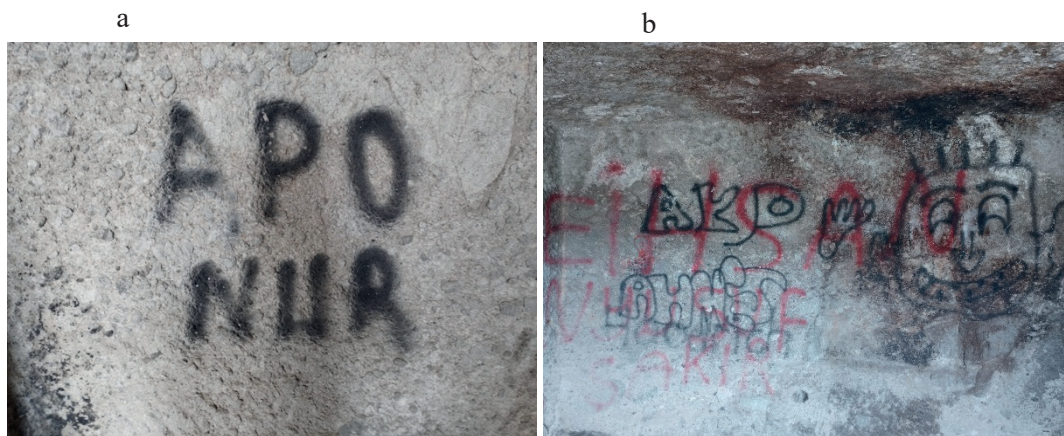
Figure 7. a-b) Graffiti examples on the structure walls
