# Urban Conservation Proposal: The Case of Şile Balibey District

Betül Aydin Cura\*  
Kemal Kutgün Eyüpgiller\*\*

## Abstract

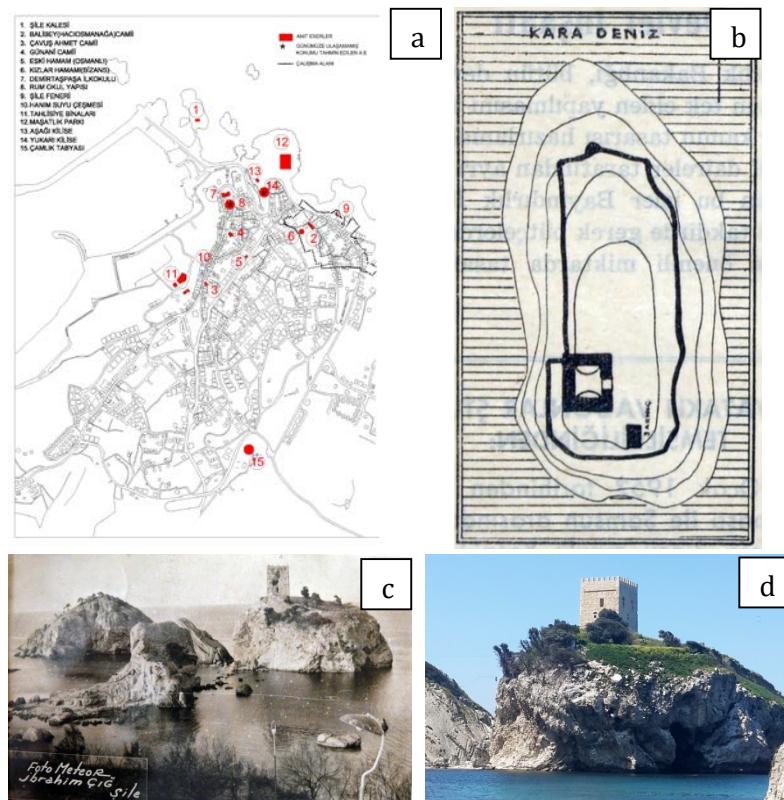
**Figure 2.** a) The location of the monuments in the center of Şile (*Drawing: Aydin, 2017*). b) Şile Fortress, fortification wall and cistern (*Firatlı, 1952, p. 18*). c) Şile Fortress (*Photo: İbrahim Çığ*). d) Şile Fortress after restoration (*Photo: Aydin, 2017*).

**Şile Fortress:** It is located on Block 135 Lot 1 on the Ocaklı Island (Fig.2: a, c, d) (Ertek, Kozak & Evren, 1998, p. 262). The fortress is also named after the Ocaklı Island (Temir, 2010, p. 100). The Şile Fortress was registered on 10.07.1981<sup>5</sup>. The fortress located on the crest of the hill is surrounded with fortification walls (Fig.2: b) (Fıratlı, 1952, p. 18). There are different opinions about the construction of the fortress. Although it is believed that the fortress is a Byzantine building from the 13th century (Ertek, Kozak & Evren, 1998, p. 262; Uykucu, 1973, p. 365; Temir, 2010, p. 102) yet some sources state that it was built by the Genoese (Temir, 2010; Güner, 2013, p. 22).

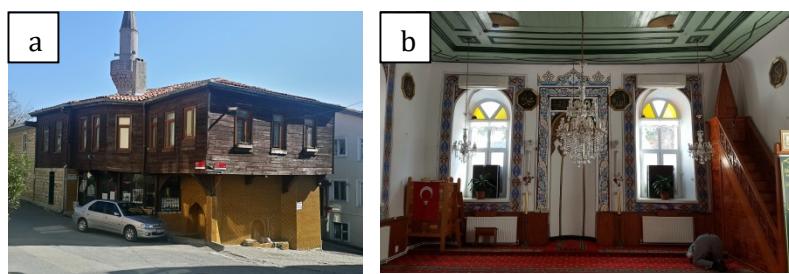
**Figure 4.** a) Haciosmanaga Mosque and wooden building (*Photo: Aydin, 2017*) b) Haciosmanaga Mosque, mihrab and edge of the window (*Photo: Aydin, 2017*).

**Balibey (Haciosmanaga) Mosque:** It is located on the corner of Cami Yokuşu and Cami Streets in the Balibey District (Fig.2:a ; Fig. 4). The building on Block 48 Lot 1 was registered on 28.01.1992<sup>6</sup>. The construction date is unknown.

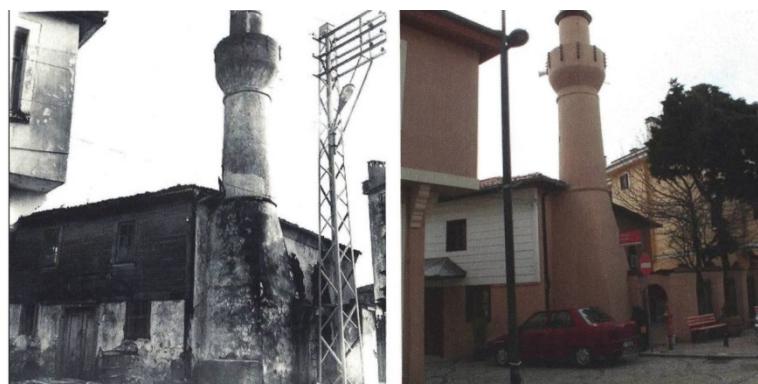
**Figure 5.** Çavuş Ahmet Mosque, before and after intervention (*Güner, 2013, p. 32; Picture 2.13*).

**Çavuş Ahmet Mosque:** It is located on Block 93 Lot 30 on the corner of Üsküdar Road and Çavuş Ahmet Street (Fig.2:a). Although the building date of the mosque is unknown it is believed to be a 20th century monument (Fig.5). The mosque was registered on 28.01.1992<sup>7</sup>.

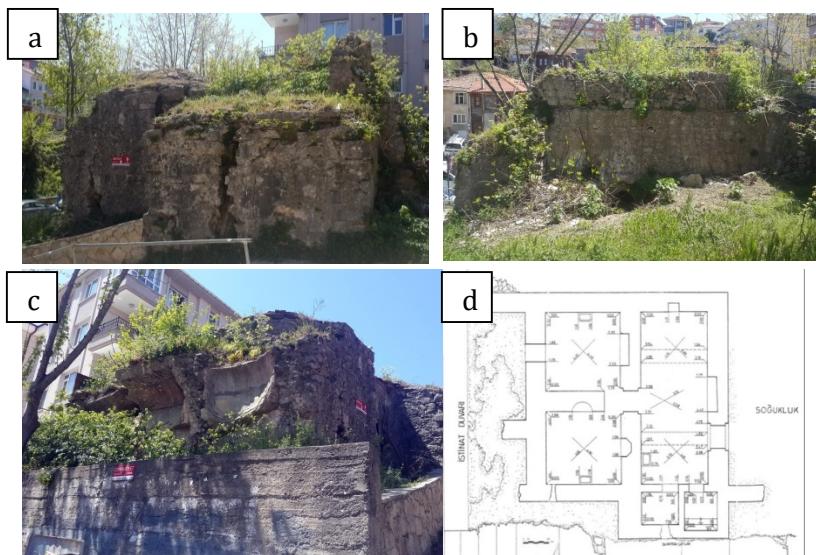
**Figure 7.** a) Eski Hamam (Old Hammam), 2017. b) Eski Hamam (Old Hammam), 2017. c) Eski Hamam (Old Hammam), 2017. d) Eski Hamam plan (Old Hammam) (Teker, 1992).

**Eski Hamam (Ottoman) (Old Hammam):** It is located on Block 10 Lot 2 on the Cumhuriyet Road at the Hamamdere District of Şile (Fig.2:a; Fig.7). It was registered on 28.01.1992<sup>9</sup>. Although its building date is unknown, some sources state that it is an Ottoman monument (Ertek, Kozak & Evren, 1998, p. 264; Şile Tanıtım Kitabı; Temir, 2010, p.110).

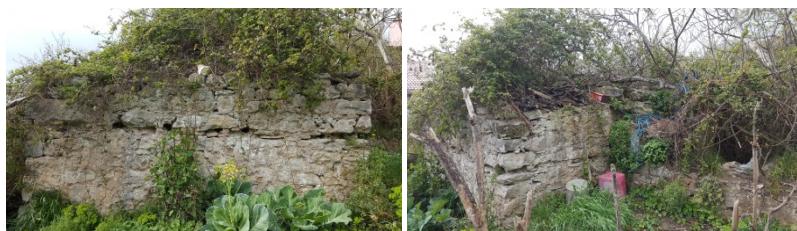
**Figure 8.** Ruins of the Girls' Hammam, 2017

**Kızlar Hamamı (Byzantine) (Girls' Hammam):** These ruins believed to be from the Byzantine period are mentioned as Girls' Hammam (Uykucu,1973, p. 366; Kasar, 1987, p. 58; Teker, 1992, p. 24; Şile Tanıtım Kitabı, 1995; Temir, 2010, p.110). Its ruins are on Block 46 Lot 8 on the Cami Yokuşu Street near the Fener site (Fig.2:a; Fig.8).

- The ruins of a hammam, believed to be from the Byzantine period, located on the Cami Yokuşu Street, block 51 plot 8, is proposed to be unearthed and used as both an exhibition and recreation area (Fig.41).
- Besides exhibiting the natural and historical environment of Şile, the town, which is rich in archeological finds also, needs a museum building to exhibit these. It is proposed to include a museum building in the project called "Şile Harbor Renovation and Recreation Project" run by the Şile municipality to transform the harbor into an active tourism area covering an area of 120 thousand square meters.

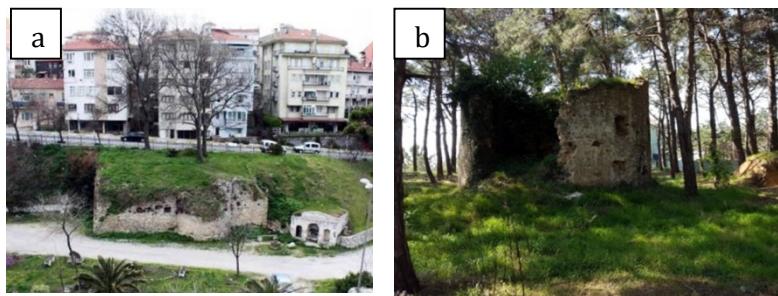
**Figure 14.** a) The ruins of the church (*Güler, 2013, p. 34; Picture 2.17*). b) Ammunition depot (*Photo: Aydin, 2017*).

19th century. These ruins were registered on 03.02.2006<sup>15</sup> (Fig.2:a; Fig.14: a).

**Çamlık Redoubt and Arsenal:** There are ruins of an arsenal where the ammunition of the redoubt was kept and a position area and a cistern next to an old reservoir in the park (Fig.2:a) located on Block 70 Lot 3 at the Üst Çamlık Area of the Çavuş District (Fig.14:b). The building ruins are believed to be 100-150 years old. The park belongs to the Treasury and was registered on 22.12.1992<sup>16</sup>.

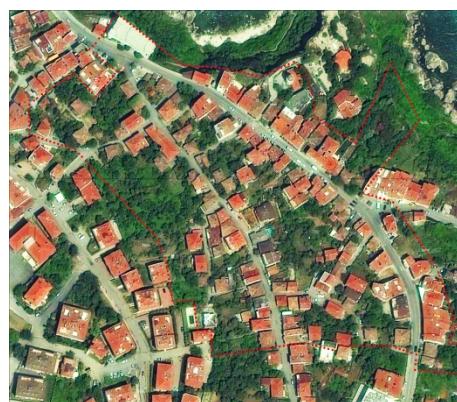
**Figure 16.** Satellite Image of Şile Balibey District Work Area.

The area of study analyzed in the scope of this paper is at the Balibey district situated at the north of Şile town. It forms part of the urban site area determined by the Cultural and Natural Heritage Regional Committee and comprises the immediate surroundings of Fener road and Cami Street (Fig. 16). At its north, it is limited by the cliffs that are natural borders and at its east comprises all the buildings facing Atatürk road. There are the Kızlar Hamamı believed to be from the Byzantine period, the Şile Lighthouse built in 1857, Balibey (Hacıosmanoğlu) Mosque believed to date from 19th century and examples of civil architecture with traditional characteristic.

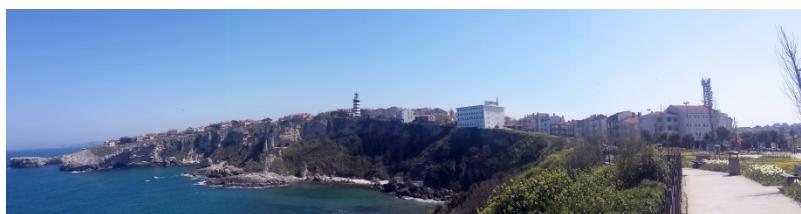
**Figure 19.** Balibey District Coastal Silhouette from the park, (*Photo; Aydin, 2017*).

parallel to the grade lines have caused a gradually rising texture and the housing texture along the Fener road is different from the traditional texture of the area and is formed by high-rise buildings (Fig. 19).

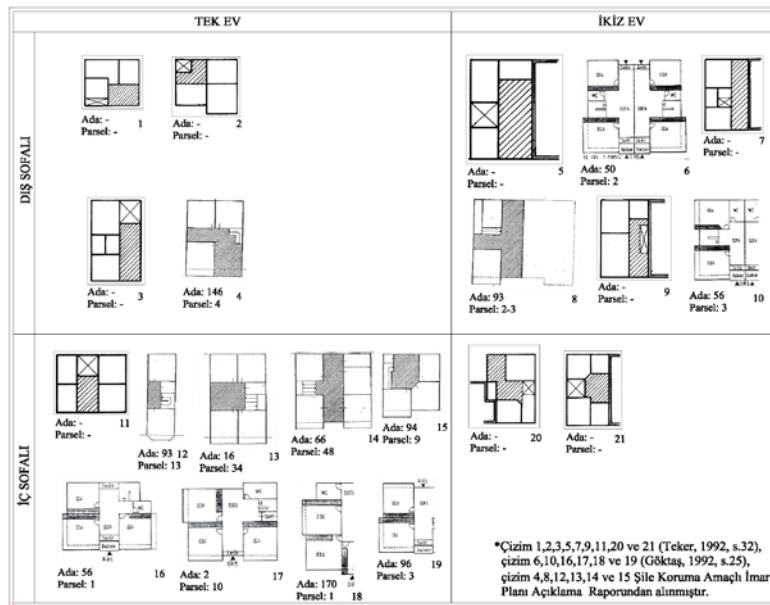
**Figure 20.** Sile houses plan typology (*compiled from Teker, Göktaş and Şile KAİP*).

When the traditional housing space setup is observed, it is seen that the ground floor comprises daily living space and the upper floor has bedroom units (Eraslan, 2010, p. 29; Göktaş, 1992, p. 23). The ground floor comprises a room with a stove used as the kitchen, common spaces such as the daily living room and the toilet (Göktaş, 1992, p. 23). There is a link between the sofa on the ground floor and the units of the house (Göktaş, 1992, p. 23; Teker, p. 31). The windows of the living rooms that are placed on the façade that can best see the street are at the same time designed to see the street and the entrance door. The above-mentioned room with a stove and the living room are sometimes a single unit in some examples (Göktaş, 1992, p. 23). The upper floor rooms are cantilevered to benefit from the view. There are large closets (yük'lük) for mattresses, bedding, quilts and clothing. One unit of these closets that consist of three parts is designed as a bath closet (Göktaş, 1992, p. 24). As a result of the documentation study made in the area, it was determined that most of the single and twin buildings have symmetrical plans and facades with regard to their middle axis. When all data is studied it is possible to make a new classification for the plan types with respect to their sofas (Fig.20).

- With exterior sofa
- With interior sofa

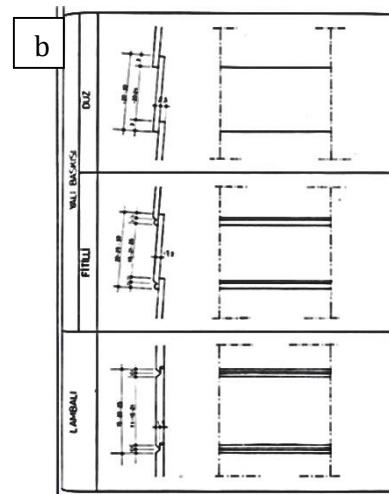
**Figure 21.** a) Facade cladding types in wooden structures (*Göktaş*, 1992, p. 71; *Table 9*). b) Facade cladding types in wooden structures (*Teker*, 1992, p. 42; *Table 8*).

Weather boarding made of chestnut tree wood with dimensions of 15-20-30 cm, flat or ribbed grooved profiles are used (Fig. 21:a,b) for the facades. The boarding is used in natural form without any synthetic paint or varnish. Some buildings are whitewashed on their ground floors (Göktaş, 1992, p. 68; Teker, p. 43). Masonry garden walls made of rubble stone are usually low. The building is not hidden behind high walls (Göktaş, 1992, p. 72; Teker, p. 44). As a result of the data from different sources and documentation studies, it is possible to make a new classification for the types of façade under twin house and single house groups according to the position of the cantilevers on the façade and according to whether there is window or balcony on the central axis (Fig.22).

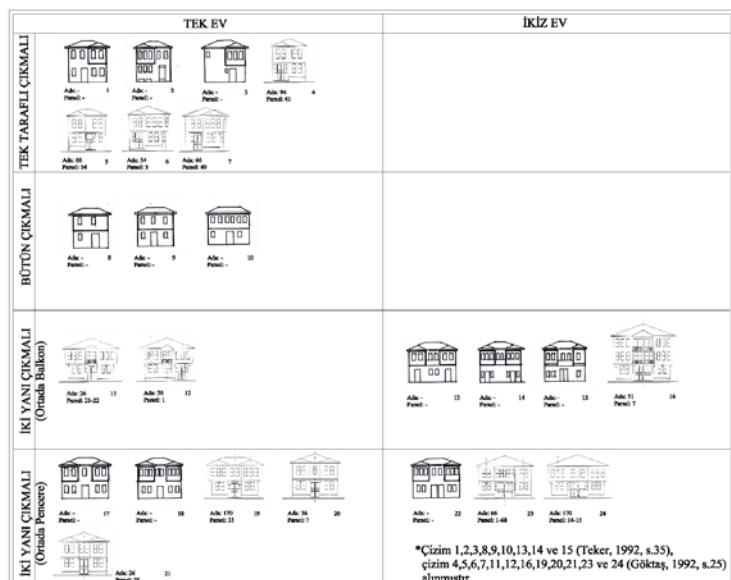
**Figure 22.** Sile houses facade typology (compiled from *Teker*, *Göktaş* and *Şile KAİP*).

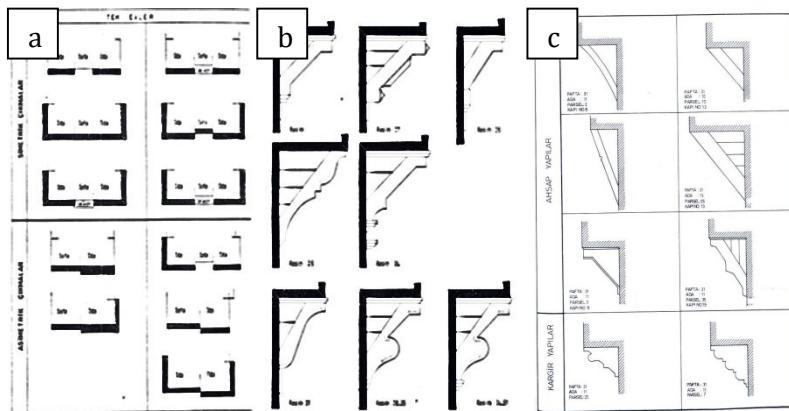
**Figure 23.** a) Cantilevers typologies in wood structures (Göktaş, 1992, p. 49; Tab. 5). b) Buttresses typologies in wood structures (Göktaş, 1992, p. 51; Table). c) Buttresses typologies in wood structures (Teker, 1992, p. 37; Table 5).

When the plan characteristics of the traditional housing architecture in the town is studied, it is observed that the cantilevers of single and twin houses use the axis of the central sofa as the axis of symmetry. In facades where the entrance is on one side of the façade, asymmetrically ordered cantilevers are the continuation of the ground floor movements on the upper floors. Another type of cantilever in the area is where the whole surface makes a cantilever on the first floor (Fig.23:a).

The height of the buttresses supporting the cantilevers limited to 40-50 cm in the Şile houses vary between 50 and 90 cm (Teker, 1992, p. 38). All buttresses used in the traditional housing architecture are made of wood. They are different variations of certain geometric forms (Fig.23: b,c) (Göktaş, 1992, p. 50).

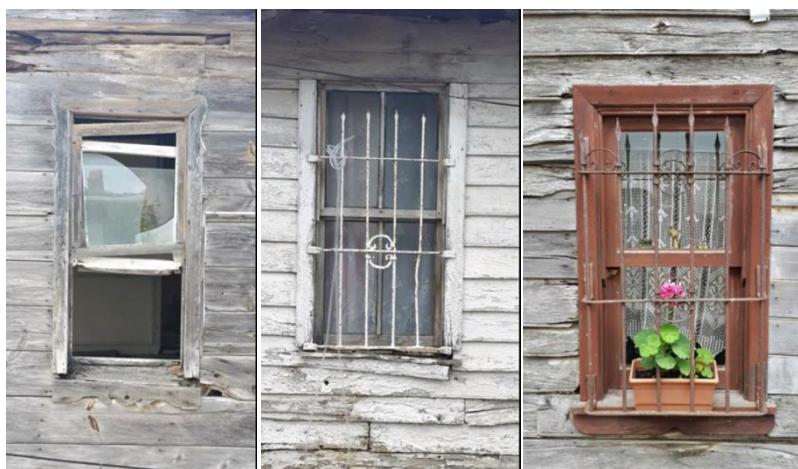
**Figure 24.** Examples of windows from the area on the left, building inventory 97, building inventory no. 96 in the middle and building inventory no. 128 on the right (Photo; Aydin, 2017).

Although sash windows that are the period's traditional system are used in the traditional housing architecture of Şile, they are replaced by casement windows in some examples. The windows are placed on the façade as modules with a ratio of 1/2. They are detached from each other with rhythmic gaps within the façade arrangement. In some very rare examples, the windows are emphasized in an integrated form. The sides of sash windows with lintel are usually enclosed with an 8-10 cm wide molding. In some examples the lower molding is decorated with various profiles (Fig.24) (Göktaş, 1992).

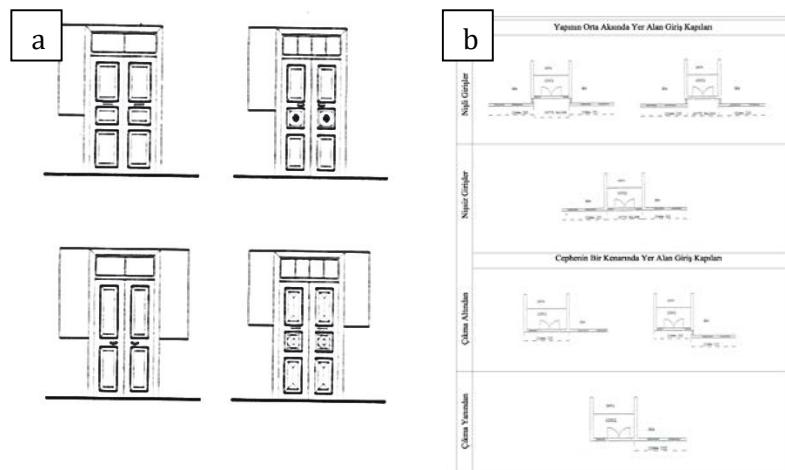
**Figure 25.** a) Types of entrance doors in wooden buildings (Göktaş, 1992, p. 64; Table 8).

- Next to the cantilever (Fig.25: b).

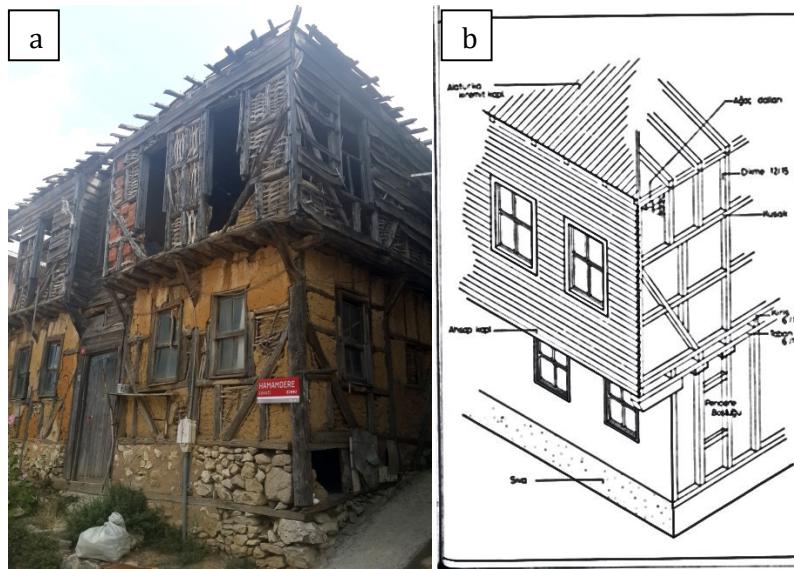
**Figure 27.** a) The building located at Hamamdere Street no: 44 (*Photo; Aydin, 2017*). b) Construction techniques and materials in wooden structures (*Teker, 1992, p. 45; Table 9*).

The basic material used for civil architecture in Şile is wood (Temir, 2010, p. 116; Göktaş, 1992, p. 76; Teker, 1992, p. 47). The buildings are mostly constructed on a stone wall acting as a foundation and reaching the plinth level. Loadbearing wooden frames are filled with mudbrick made of straw and mud (Fig. 27) (Göktaş, 1992, p. 76-77).

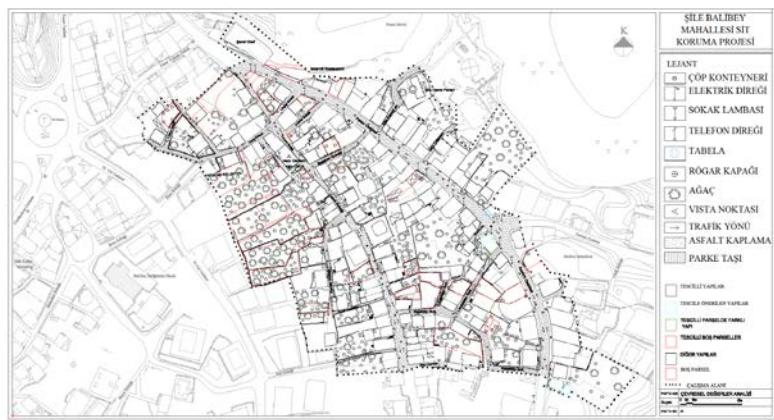
**Figure 28.** Environmental Analysis.  
(Drawing: Aydin, 2017).

**Environmental values analysis:** In this analysis urban elements such as streets determining building blocks, traffic flow direction, paving materials, vista points, traffic signs, electricity, water and telephone poles, manhole covers, garbage containers and trees were identified and marked on the drawings (Fig.28).

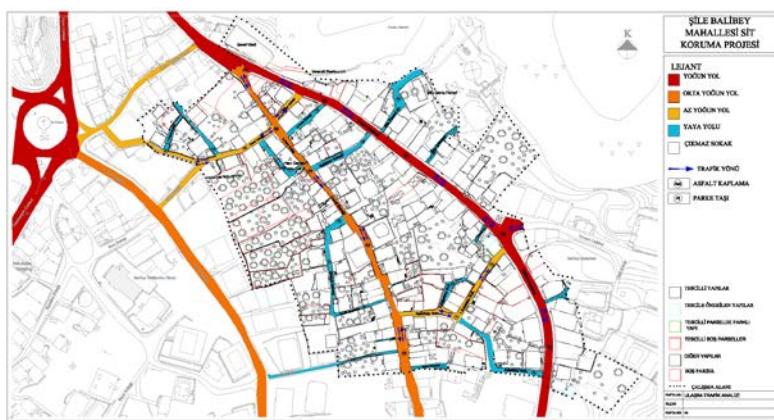
**Figure 29.** Traffic Analysis  
(Drawing: Aydin, 2017).

**Traffic analysis:** Fener Road is the densest axis that connects the work area to the town center. There are four dead-ends in the area: Güz Çıkmazı (dead-end), Sarp Çıkmazı and two others without a name. As a natural result of the topography and the land subdivision, curvy and narrow pedestrian ways (pathways) are formed (Fig.29).

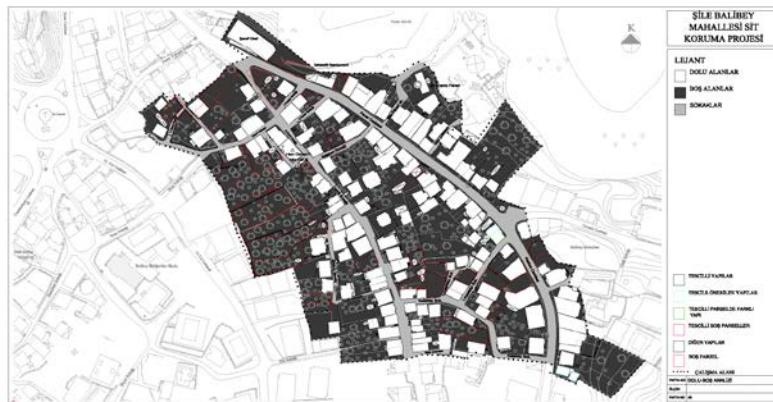
**Figure 30.** Spatial Analysis  
(Drawing: Aydin, 2017).

Spatial analysis: Within the scope of this analysis, it was determined that plots with large gardens create dense emptiness whereas contiguous building groups on the Fener Road create denseness in the area (Fig.30).

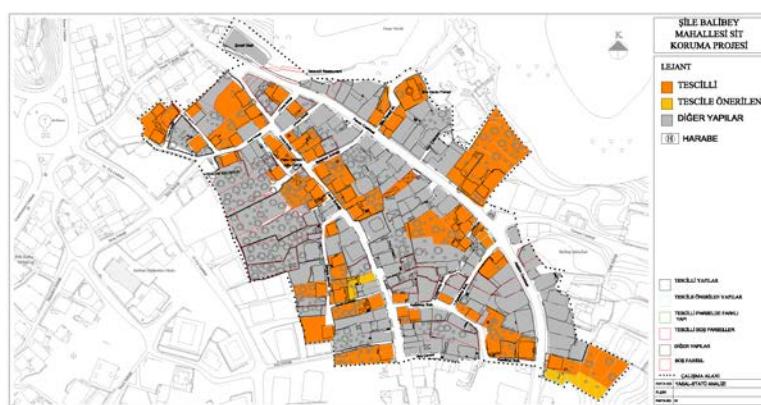
**Figure 31.** Legal Status Analysis  
(Drawing: Aydin, 2017).

Legal status analysis: Analysis of the registration status of buildings in the said area determined that out of 137 buildings, 50 buildings were registered. 3 of the registered buildings were abandoned. There was 1 registered empty plot, 1 registered plot with a different building and 2 buildings proposed for registration in the area (Fig.31).

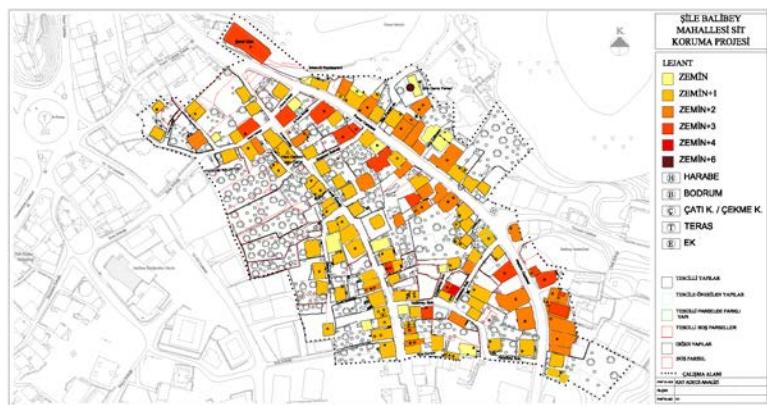
**Figure 32.** Number of Floors Analysis (Drawing: Aydin, 2017).

floors: Ground (%9), Ground +1 (%57), Ground +2 (%22), Ground +3 (%10), Ground +4 (%1), Ground +6 (%1) (Fig.32).

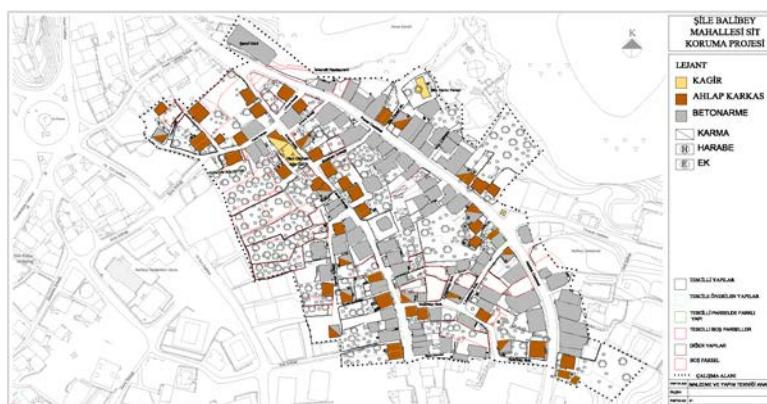
**Figure 33.** Construction System and Material Analysis (Drawing: Aydin, 2017).

**Construction system and material analysis:** The following was observed in the evaluation of the buildings within the area with respect to construction techniques: 62% reinforced concrete, 23% wooden framed, 12% reinforced concrete + wood, 2% stone and 1% stone + wood (Fig. 33).

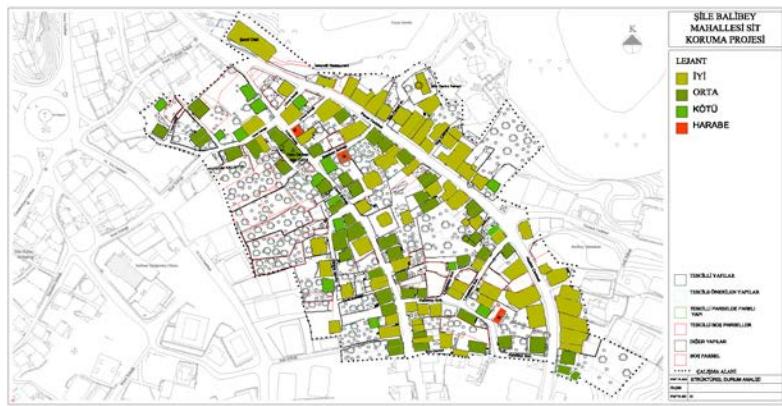
**Figure 34.** Structural Condition Analysis (Drawing: Aydin, 2017).

**Structural condition analysis:** Evaluation with respect to structural status determined that 12% pose danger in terms of load-bearing systems and were unusable. Most of these buildings were abandoned and there was no one living inside them. The walls, roofs and floors of the ruined buildings that form 2% of the area, have collapsed and there is very little left of (Fig. 34).

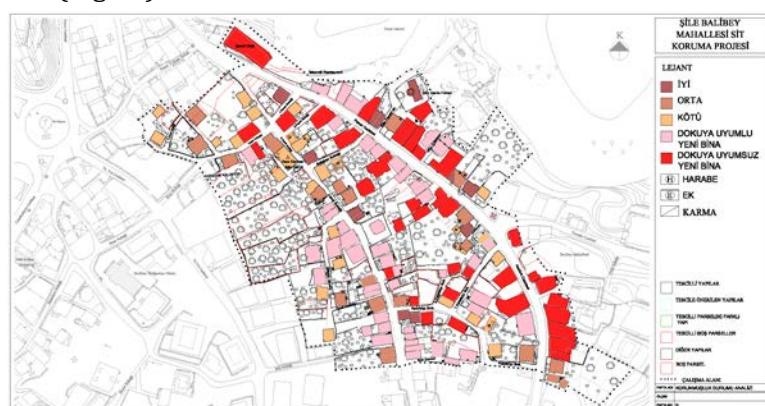
**Figure 35.** Evaluation of Cultural Property Analysis (Drawing: Aydin, 2017).

**Evaluation of cultural property analysis:** The registered buildings were evaluated with regard to originality and wholeness values and almost half of the 50 registered buildings and 2 buildings proposed for registration were determined not to be in a good state of conservation. 48 buildings out of 137 are well adapted to the original urban texture in terms of position on the plot, number of floors, ratios of façade and similar characteristics. 37 buildings on the Fener Road are noncompliant with the area and the topography with their number of floors, usage of plot and façade ratios (Fig.35).

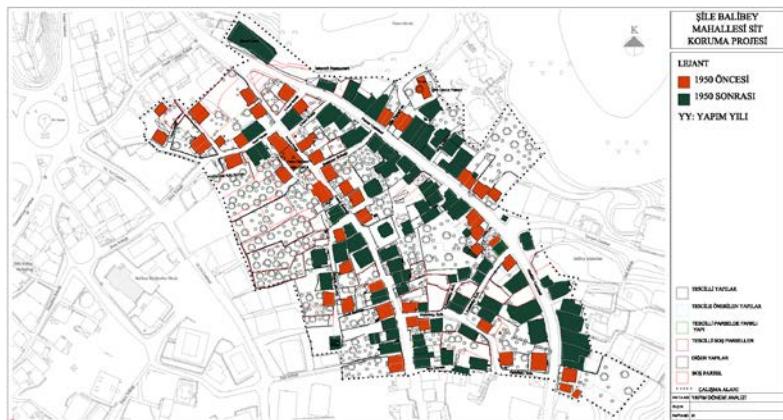
**Figure 36.** Chronological Analysis  
(Drawing: Aydin, 2017).

**Chronological analysis:** There are 2 monumental works valuable in terms of history in the area: The Şile Lighthouse built in 1859 and the Haci osmanaga Mosque that is an Ottoman monument. The buildings, examples of civil architecture in the area, are believed to be 100-150 years old (Fig.36).

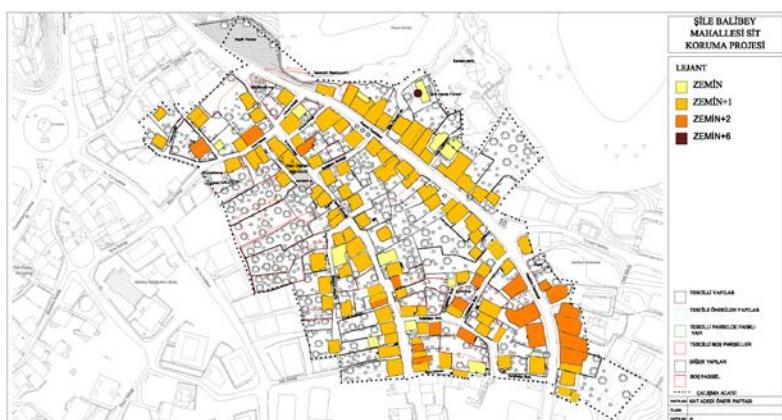
**Figure 39.** Use of Building Stock Proposal Analysis (Drawing: Aydin, 2017).

- Re-functioning of the buildings on Fener axis and creating refreshment spaces required by the area will revive trade. This axis must serve the housing + trade functions. On another axis, the Cami Street many buildings with large gardens are either abandoned or neglected. With restorations along the street a qualified axis will be created. House-guesthouse type buildings where main user and guests will meet are proposed (Fig.39).

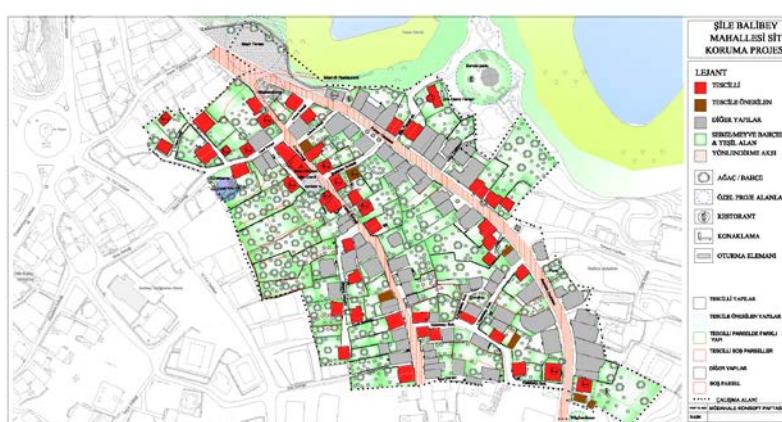
**Figure 41.** Intervention Porposal Analysis-II (Drawing: Aydin, 2017).

- As a result of studies carried out in the Balibey district, it was determined that the present built-up areas are saturated. Therefore, further housing in the area must not be allowed and the present building stock must be used effectively. If housing continues, new buildings will cause the vegetable gardens and orchards to disappear. When the buildings complete their useful economic lives, housing compatible with the historic texture with modern design criteria are proposed on these plots. The proposals are presented as plan marks. Gentrification proposals for the pavements and width of Fener Road were also made (Fig.41).

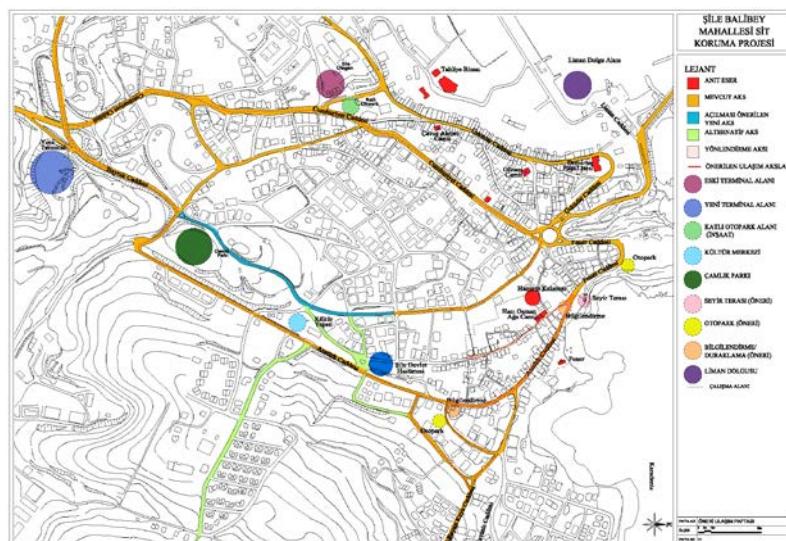
**Figure 42.** Traffic Proposal Analysis (Drawing: Aydin, 2017).

- The vehicle traffic in the area must also be revised. It is important to pedestrianize the Fener-Atatürk road in terms of the planned urban layout. The alternative axis for the Fener-Atatürk road is the 75th Year road. This redirection aims at the Şile Cultural Center located outside the area at the end of the Atatürk Road, not a very busy place, to host cultural and art activities. The Çamlıkkale Tea garden and picnic areas are located at the continuation of this axis that was created. These can also present a recreative function to the area (Fig.42).

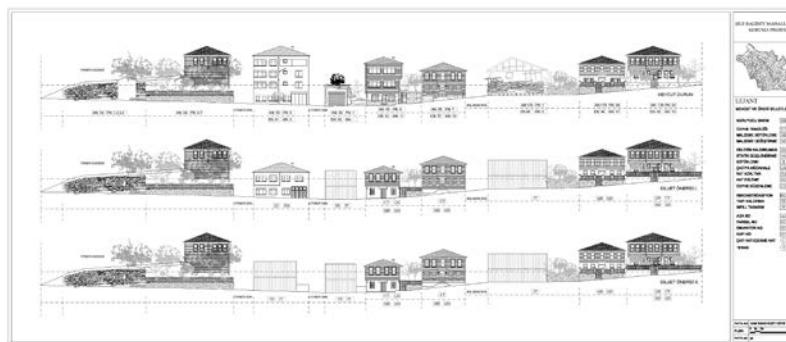
**Figure 43.** Silhouette 1 Cami Street North Facade Proposal (Drawing: Aydin, 2017).

- Cami Street was chosen as a pilot axis in the area for this study. In the silhouette work on the Cami Street, proposed intervention decisions were reflected on the project. Besides simple repair decision such as color changes, material changes and completion on the facades, intervention decisions such as removing or adding storeys, removing late period additions or changes in the façade system were dealt with on the single building scale. Additionally, decisions such as reconstruction of the buildings that have not survived, infill design or removing some buildings were indicated on the silhouette work (Fig.43, 44, 45, 46).

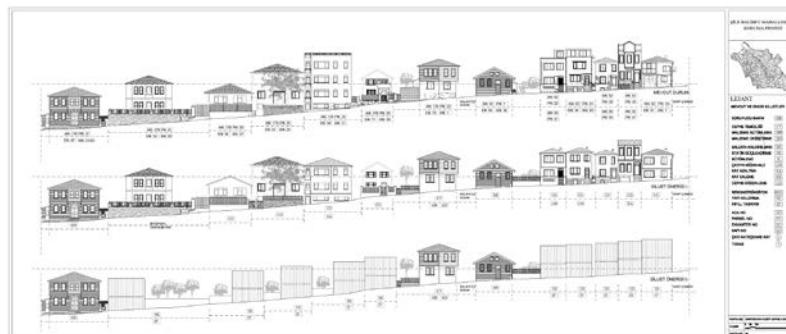
**Figure 44.** Silhouette 2 Cami Street North Facade Proposal (Drawing: Aydin, 2017).

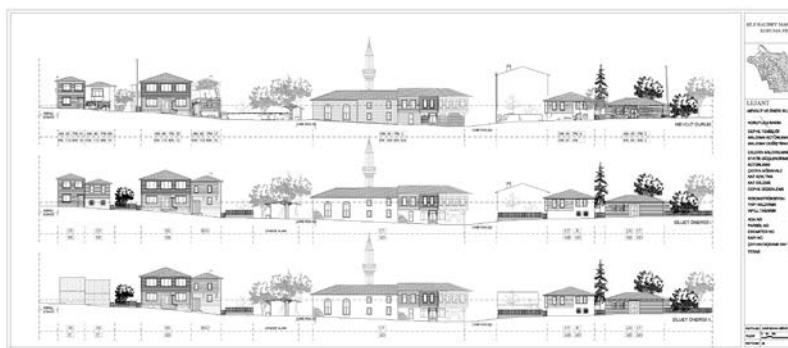
**Figure 45.** Silhouette 1 Cami Street South Facade Proposal (*Drawing: Aydin, 2017*).

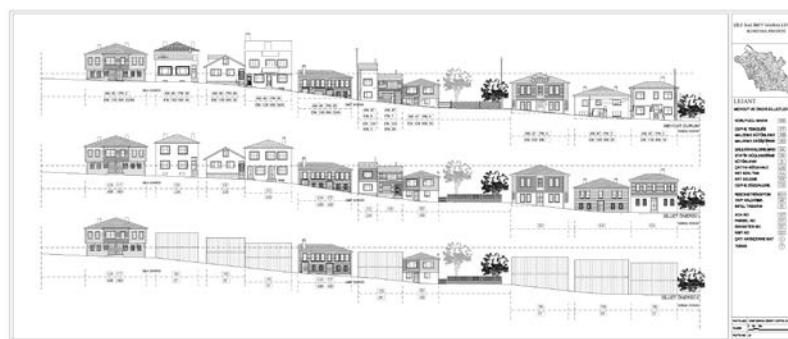
**Figure 46.** Silhouette 2 Cami Street South Facade Proposal (*Drawing: Aydin, 2017*).
