SHAKING TABLE EXPERIMENTS ON MASONRY BUILDING PROTOTYPES PRODUCED WITH DIFFERENT BOND

Key Words: Shaking Table, Failure Mechanism, Masonry Buildings, Bond Type, Elastic Seismic Load, Response spectrum

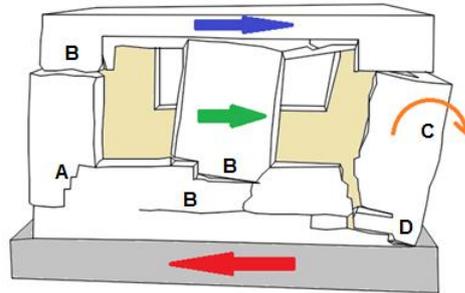
Figure 1. Failure mechanisms of masonry buildings.

Diagonal Shear Failure: Diagonal shear cracking caused by the maximum tension stress exceeding the tension strength of the wall. Diagonal shear cracks may occur in a stair-stepped manner through the bed-joints or may pass directly through the bricks. The separation of the walls from the joints into vertical or diagonal cracks is due to loads caused by the earthquake at perpendicular to the plane of the wall and the direction of the plane.

Bed-joint sliding – (Sliding failure) Sliding failure is caused by horizontal shear cracks in the bed-joint. When the loads coming from the wall plane exceeds the mortar strength between the bricks. These cracks are caused by the forces in the plane of the wall exceeding the strength of mortar between bricks. Generally, these cracks occur in the horizontal direction of the window and door corners.

Out-of-Plane Behaviour (Overturning): Because of earthquake loads, inertia forces are generated by the mass of the walls. The walls of masonry buildings perpendicular to the direction of the dominant earthquake are usually damaged by out-of-plane behavior. The cause of such damage is that the tops of the walls are not connected by a rigid slab, a ridge, or joists and beams. In times of earthquake, if there is insufficient resistance in the orthogonal walls, these walls push each other out of the plane at the corner, causing damage or even collapse of the walls.

Rocking: The rocking of the wall in the plane begins with the flexural cracks that develop in the upper and lower parts of the wall. As the displacement increases, the wall separating from the slab tries

to rotate in a plane as a rigid body and eventually partially damages the toe region. Toe crushing is typically observed after rocking deformations.

A. Shear crack B. Sliding crack C. Overturning D. Rocking

Strength in masonry structures is provided by adherence between brick and mortar. As the cracks created by the earthquake increase, the dynamic characteristics of the masonry buildings change, the natural frequency decreases and the displacements increase. As the lateral movement continues, the cracks are interrupted by vertical load and friction, forming independent wall blocks on the wall surface and the movement in the direction of the cracks increases. These cracks occur in regions with high-stress intensity. The cracks at the edge of the door and window are caused by the vertical bending to the wall plane or the shear stresses that occur in the plane direction. In long walls without door and window openings, these loads perpendicular to the wall plane form vertical or diagonal cracks in the horizontal cracks and wall joints in the lower region. The major damages encountered during the earthquake are the formation of shear cracks and sliding cracks in the plane of the walls, the overturning of the walls out-of-plane, the separation of the walls from the corners and slabs (Balendra, 1993, Arya *et al.*, 2014). Different types of failure modes in walls of masonry buildings are shown in Figure 1.

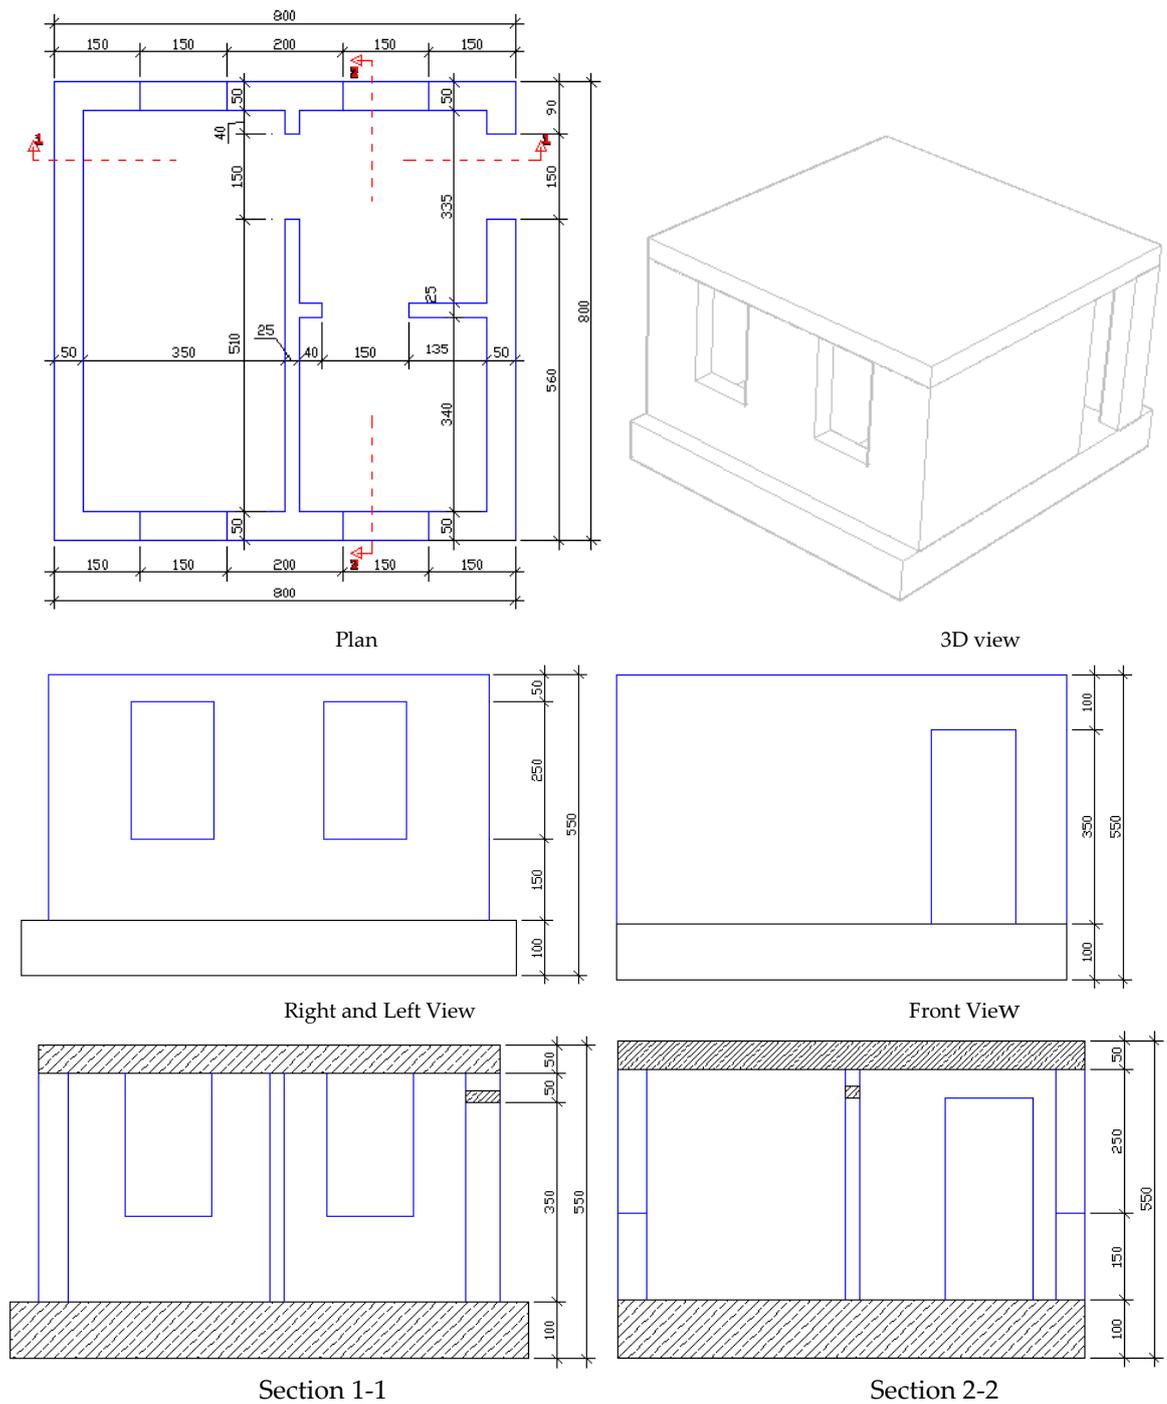
Figure 3. Dimensional details of the general specimen (dimension: mm)

The height of one story was 450 mm (2700 mm in 1:1 scale real dimensions). The length of the specimen was 800 mm from one wall to another wall. The slab' dimensions were 800x800 mm and 50 mm thickness. Dimensional of the specimens are shown Figure 3.

All specimens had 150x250-mm window openings on two faces and one 150x400-mm door opening. The thickness of the outer wall was 50 mm and the thickness of the inner wall was 25 mm. All specimens contained three-compartment. The brick dimensions were 30x50x25 mm. The gypsum-mortar used for the tested specimens was prepared with sand/plaster and water/plaster ratios of 1:2. Production stages of specimens are shown in Figure 4. The different bonds of test specimens are shown in Figure 5.

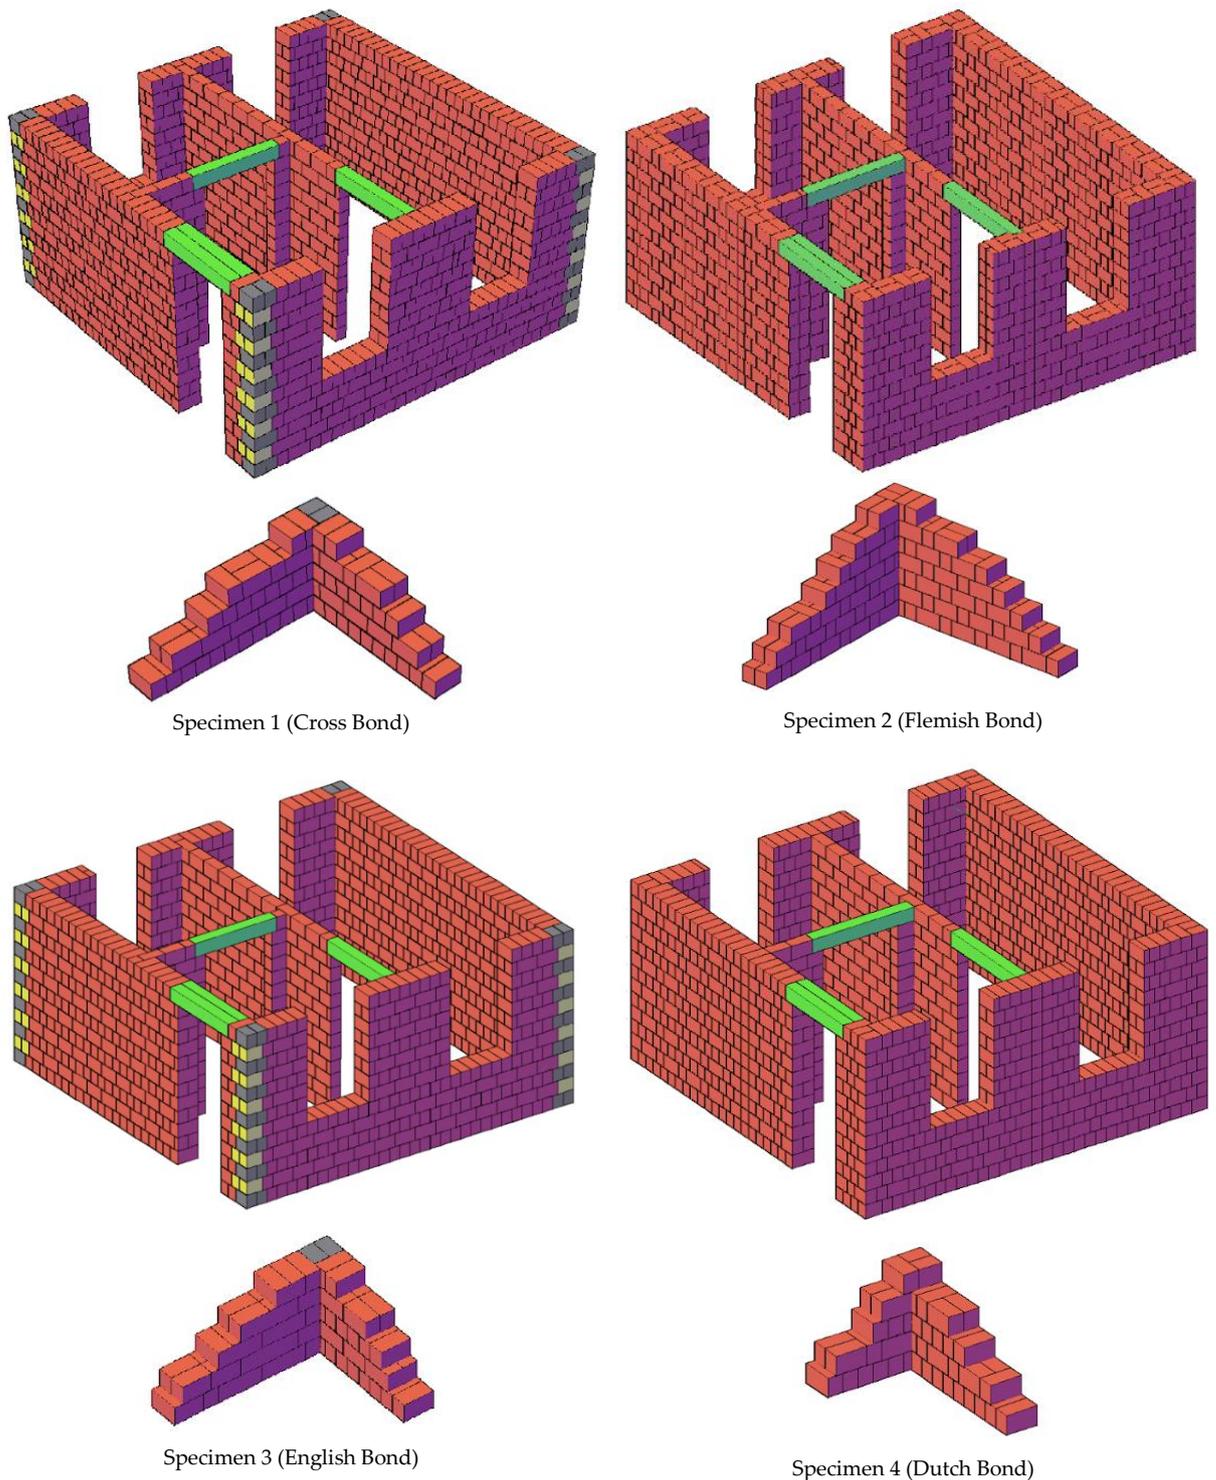
Figure 5. Different bonds of Specimens

In this experimental study, four one-story, 1/6 scaled, three-compartment masonry building prototypes were tested on the shaking table until the failure mode. Each prototype was built using a different bond type. The used bond types contained deficiencies commonly observed in residential buildings in Turkey. The experiments were manufactured and tested in the Structural Testing Laboratory at the Necmettin Erbakan University–Konya–TURKEY (Figure 2) (Balendra, 1993). All four tested specimens were produced with the same walls geometry and mortar. Specimen 1 was produced with the cross bond. Specimen 2 was produced with the flemish bond. Specimen 3 was produced with the english bond. Specimen 4 was produced with the dutch bond.

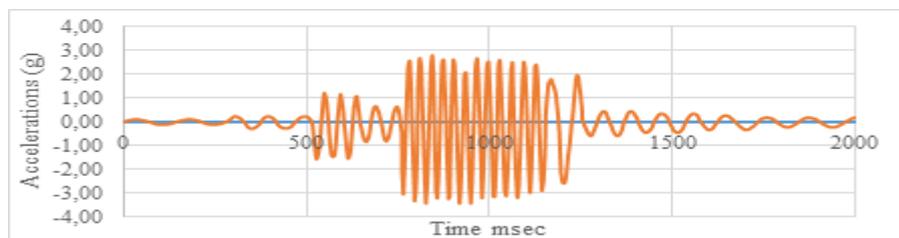
**Figure 6.** Acceleration data of ground motion

The working principle of the shaking table used in experiments is converted from rotary motion to linear motion. The specimens were tested under constant axial load and sinusoidal cyclic were imposed to simulate the seismic action. This axial load of 980 N was given by the three plates located on top of the specimens. Besides, the sinusoidal cyclics were processed by the DAQ-Card (Labjack-U3) (Labjack, 2015). The acceleration data of ground motion are shown in Figure 6. The test setup for the experimental study is shown in Figure 7.

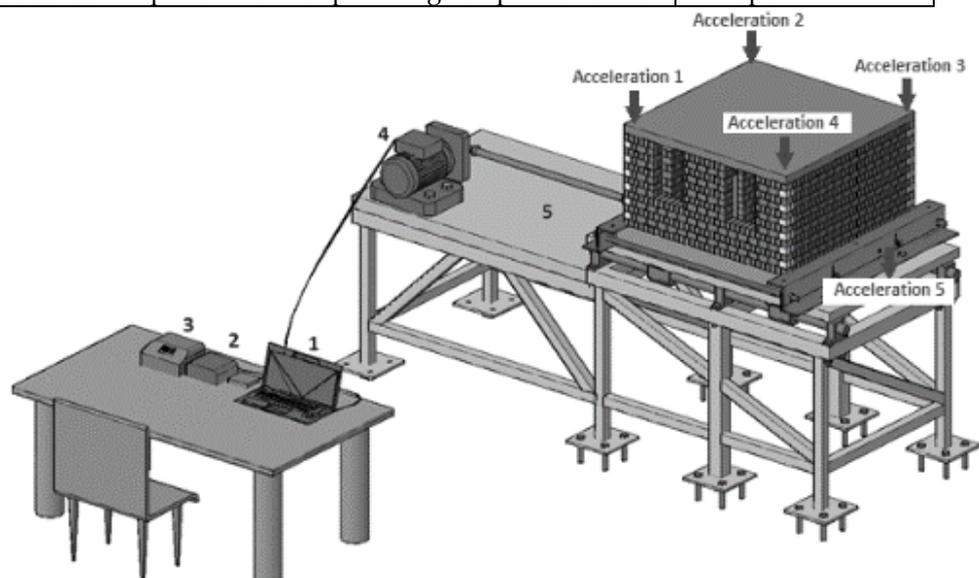
Figure 7. Test setup

1.Computer 2. Labjack-U3 3. Simatic-G120 4. Motor+ Gear Speed Reducer 5. Shaking Table

Parameters	Values Units
Size of the platform	80 mm x1200 mm
Maximum mass of load	15kN
Maximum displacement of the platform	± 20 mm
Maximum acceleration of the platform	± 4 g
Frequency	0~50 Hz
Maximum power of motor	4 kW
Maximum output torque of gear speed reducer	100518 mNm
Maximum input rotational speed of gear speed reducer	3000 rpm
Maximum output rotational speed of gear speed reducer	380 rpm

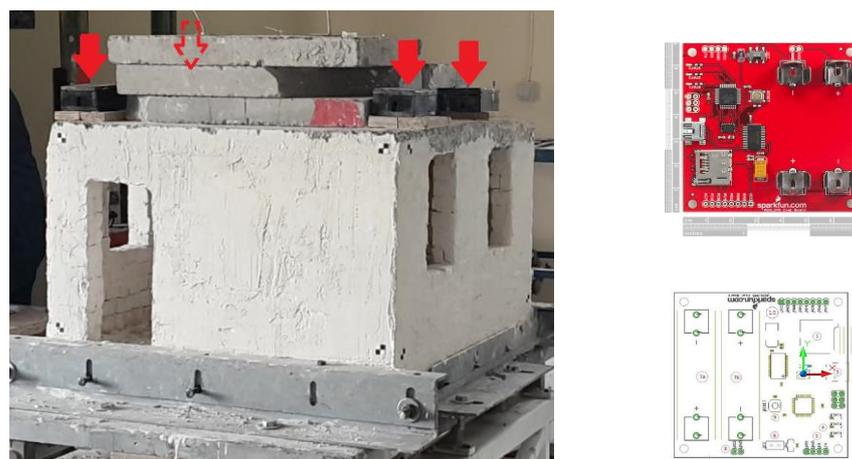
**Figure 8.** Location points of accelerometers and the ADXL 345 accelerometer

Acceleration data of the test specimens were measured with ADXL345 accelerometers in experiments (Figure 7-8). In the experiments, four accelerometers were used on the specimens and one accelerometer on the shaking table. The average of the accelerometers data on the samples was used in the comparisons. The ADXL345 is a complete 3-axis acceleration measurement system with a selectable measurement range. ± 4 g measurement range was selected in the experiments. It measures both dynamic

accelerations resulting from motion or shock and static acceleration (ADXL345, 2009). The shake table accelerations were measured at X-direction.

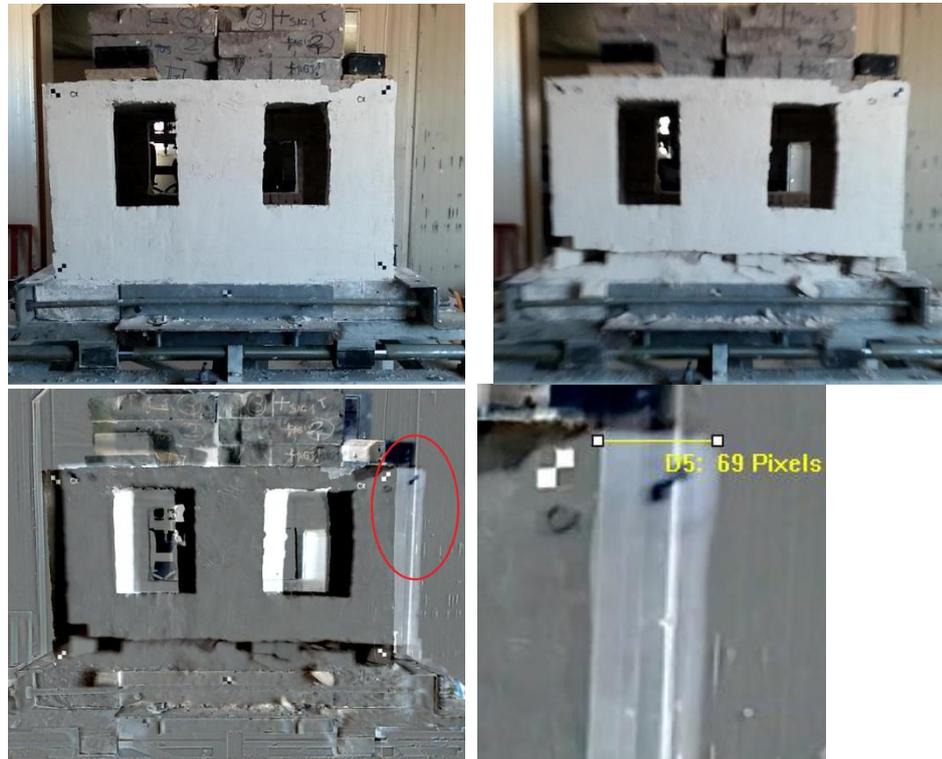
Figure 9. The background subtraction method

Displacements were calculated using the image processing method. The displacements were measured from the left and the right faces of the prototype structure. The displacements in the experiments were calculated using the Image-Pro v.6 demo version (Image Pro). The camera was calibrated for displacement calculation by image processing before each experiment was performed. These experimental studies have occurred with ± 1 mm margin. A background subtraction method was used for image processing. The application stage of this method is given in Figure 9. This method was used to compare the active image to the background image, and pixels deemed to be part of the background were replaced with a value close to the mean background intensity. The algorithm is based on the following formula:

$$CI_{x,y} = I_{x,y} - BI_{x,y} + M \quad (1)$$

$I_{x,y}$ is a pixel value of the original image at the location (x,y);

$BI_{x,y}$ is a pixel value of the background image at the location (x,y);

M is the average pixel value of the background image;

$CI_{x,y}$ is the new pixel value in the corrected image.

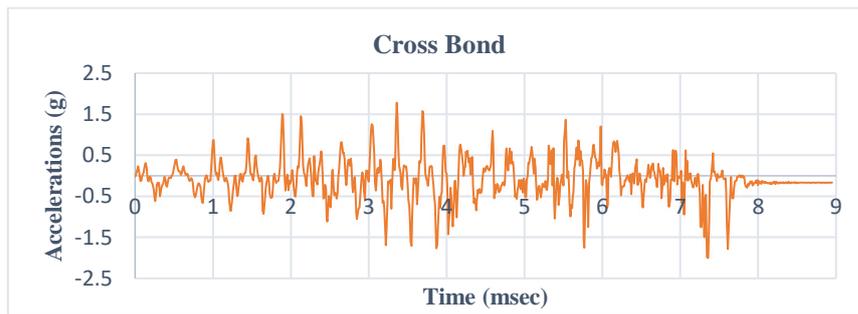
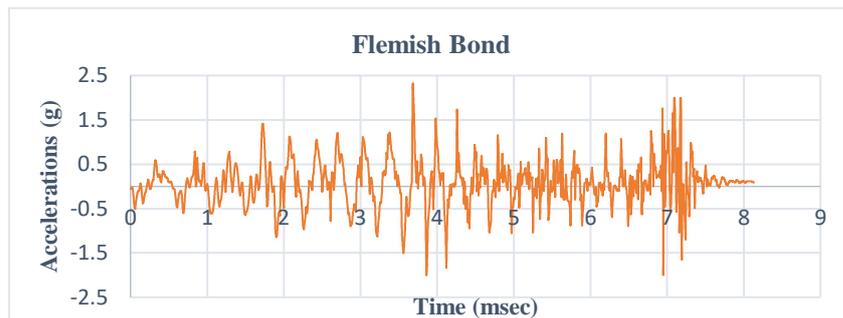
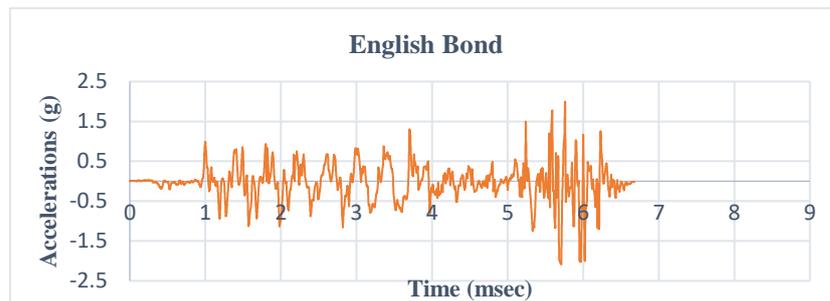
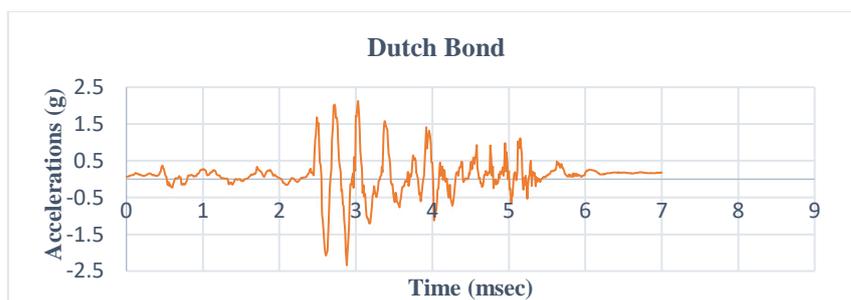
Acceleration data of test specimens on the 1st story level at X-direction were measured. The measured acceleration data (Balendra, 1993) of Specimen 1, Specimen 2, Specimen 3, and Specimen 4 are shown in Figure 10, Figure 11, Figure 12, and Figure 13, respectively. First cracks and damages at the failure modes of Specimen 1, Specimen 2, Specimen 3, and Specimen 4 are shown in Figure 14, Figure 15, Figure 16, and Figure 17, respectively.

Figure 10. Acceleration data of Specimen 1

Figure 11. Acceleration data of Specimen 2

Figure 12. Acceleration data of Specimen 3

Figure 13. Acceleration data of Specimen 4

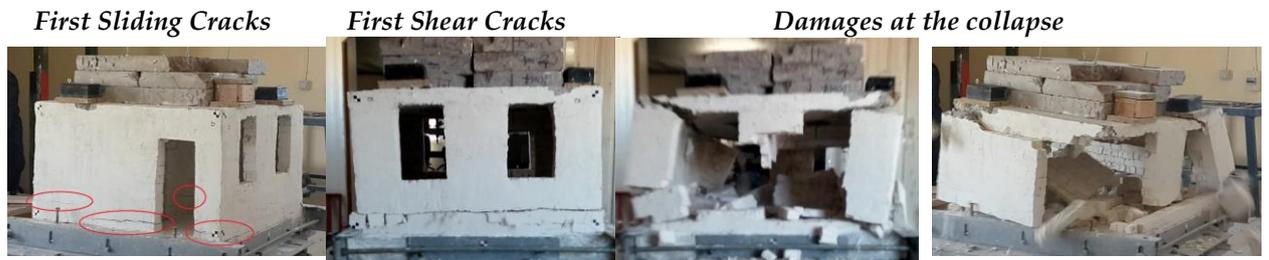
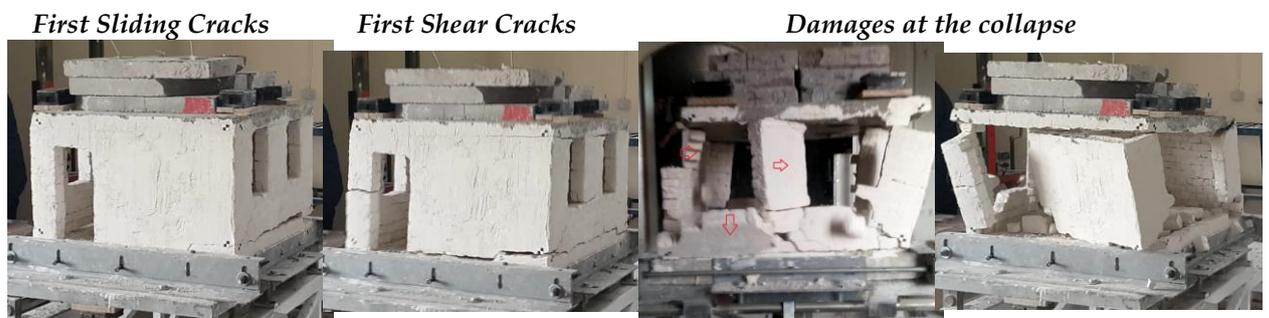
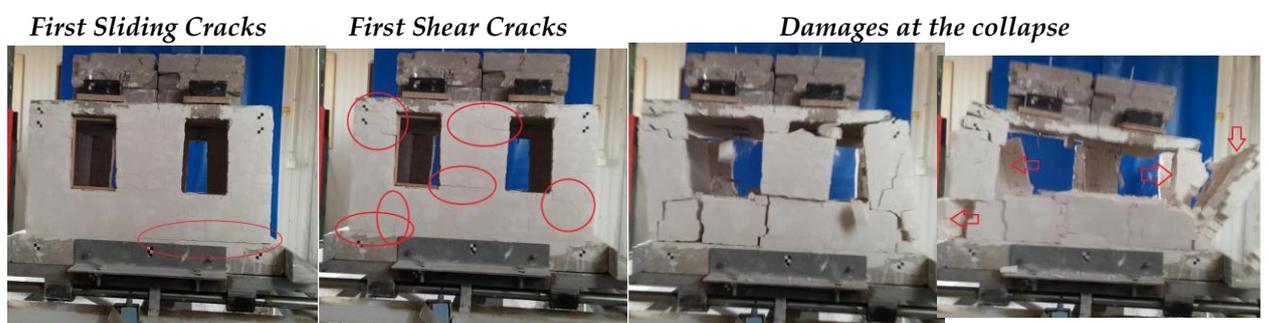
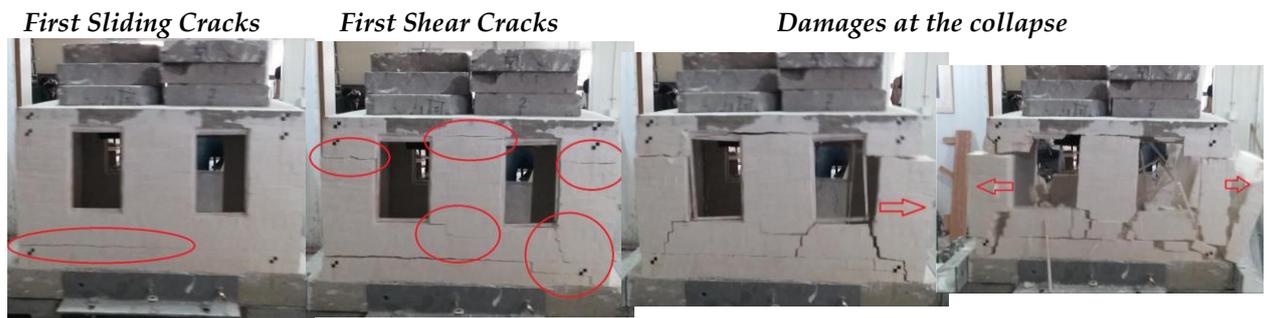
In the experimental studies, different types of failure modes and cracks that could occur during the earthquake were observed. The shear and sliding cracks occurred at the windows and door corners. The out-of-plane behavior occurred at the orthogonal wall of the earthquake direction and the walls below the window. The wall between the two windows separating from the slab tried to rotate in a plane and this wall collapsed as out-of-plane. The first cracks of all specimens occurred near the base of the wall (under the windows) as sliding crack. The crack formations of Specimen 1 and Specimen 2 were observed similar. The reason for the longer failure duration of Specimen 1, the first crack occurred later than the other specimens. In addition, the first cracks of Specimen 1, Specimen 2, Specimen 3, Specimen 4 occurred at 4.55 sec, 2.29 sec, 3.37 sec, and 3.57 sec as sliding cracks, respectively. The shear cracks and other type

cracks that cause collapse of Specimen 1, Specimen 2, Specimen 3, and Specimen 4 were also begun at 5.39 sec, 4.84 sec, 3.77 sec, 3.92 sec, respectively. According to the obtained results, Specimen 1 and Specimen 2 were more reliable than the other specimens because first and second rows of brick members of these specimens were designed perpendicular to each other at long walls. Due to this design, Specimen 1 and Specimen 2 were later collapsed as other specimens.

Figure 14. Cracks and damage were observed at the Specimen 1

Figure 15. Cracks and damage were observed at the Specimen 2

Figure 16. Cracks and damage were observed at the Specimen 3

Figure 17. Cracks and damage were observed at the Specimen 4

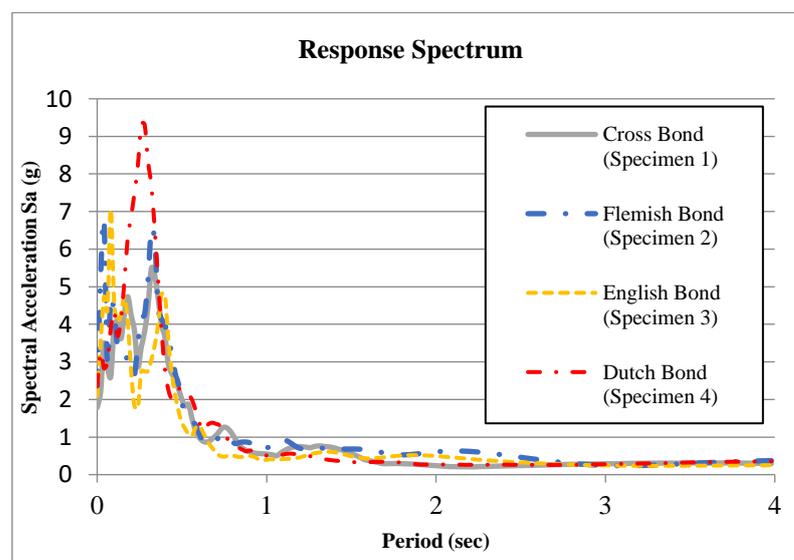
Figure 18. The response spectrum graphs of test specimens by 5% damping.

The building exposed to earthquake loads first vibrates during the period that it is subjected to earthquake and then by its own period. If the members of the building do not have damping properties, resonance occurs in the building and causes the building to collapse. The basic items that reduce the period of the building are the weight of the building and irregularities in the building. The exposure of a building to earthquakes at different times can cause the building's period to be greater in the next same magnitude of the earthquake. Because of the vibrations in different periods during the earthquake, the behavior of the building is called the Earthquake Spectrum Graph, which shows the characteristics of the behavior in terms of maximum displacement, acceleration, and velocity. Since Response Spectrum method is useful for approximate evaluation of seismic reliability of structures, this method is favored by earthquake engineering (Balendra, 1993). These graphs of the test specimens are given in Figure 18.

According to the acceleration response spectrums, Specimen 4 occurred to the highest accelerations compared to the other specimens. In addition, Specimen 4 was measured to the largest mean period compared to the other specimens. The mean natural period of Specimen 1 was calculated as 0.276 sec, Specimen 2 was calculated as 0.30 sec, Specimen 3 was calculated 0.266, and Specimen 4 was calculated also as 0.324 sec. The greater the period value, the greater the amount of damage. In addition, the specimens with a low natural period are more rigid. Specimen 1 has more rigid compared to the other specimens.

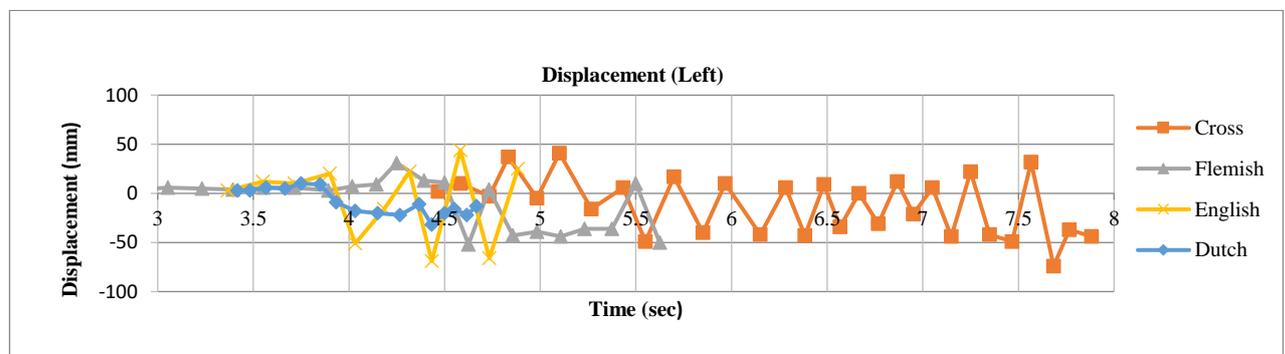
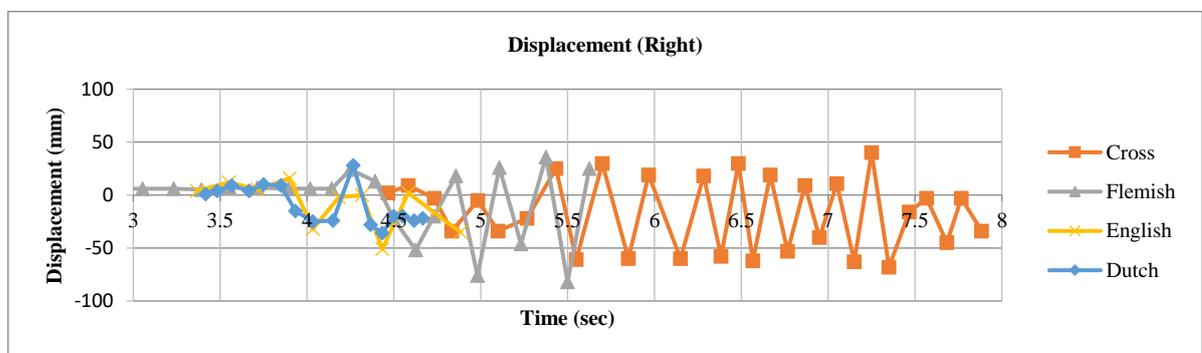
The displacements were measured from the left and the right faces of the test specimens. At the left face, the maximum displacement of Specimen 1 was measured as -74 mm at 7.68 sec, Specimen 2 was measured as -52 mm at 4.63 sec, Specimen 3 was measured as -69 mm at 4.43sec, and Specimen 4 was also measured -32 mm at 4.43 sec (Figure 19). At the right face, the maximum displacement of Specimen 1 was measured as -68 mm at 7.35 sec, Specimen 2 was measured as -76 mm at 4.98 sec, Specimen 3 was measured as -51 mm at 4.43sec, and Specimen 4 was also measured -36 mm at 4.43 sec (Figure 20). At all specimens, the maximum displacements occurred as a negative value. At the maximum displacement of the shaking table, the maximum displacements due to the inertial force of the specimens were measured at negative values. That is, the maximum displacements were formed in the opposite direction to the movement of the shaking table.

Figure 19. Max displacement of all specimens (left face)

Figure 20. Max displacement of all specimens (right face)

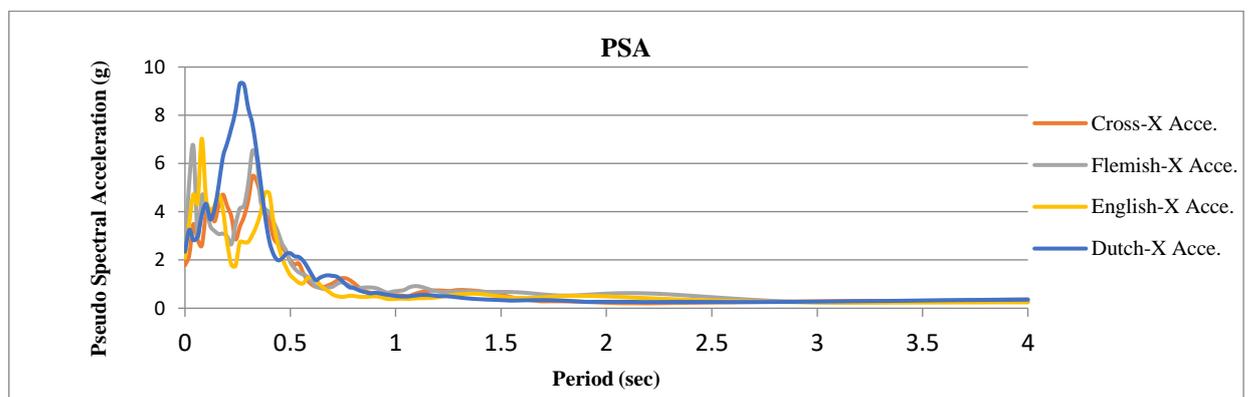
Figure 21. The Response Pseudo Spectral Acceleration graphs of test specimens by 5% damping.

In the analysis of the dynamic behavior of buildings, each earthquake has its own unique acceleration spectrum (Balendra, 1993; Bahadir, 2020). According to the natural period and damping rate of the building, the maximum response value obtained from the acceleration response spectrum is the absolute acceleration value which influences the building. This spectrum is the envelope curve plotted from the peaks of maximum acceleration with the corresponding vibration time (T) of each of single-degree-of-freedom systems. In the spectrum to be used in the calculation of inertia force of the internal forces formed in the structure, the acceleration value to be used is not the total acceleration value ($\ddot{u}(t) + \ddot{u}_g(t)$), but the acceleration value ($\omega^2 SD$) at maximum displacement. This acceleration is called Pseudo Acceleration and this spectrum is called Pseudo Spectral Acceleration (Balendra, 1993). The relationship between pseudo-spectral acceleration and spectrum displacement is given in Equation 2. Under the influence of seismic activities, the building carrier system must be able to withstand at least this elastic seismic load (Equation 3). If the masses of the specimens are approximately the same, these values can be used as a comparison.

According to the PSA data obtained from the experiments (Figure 21), Specimen 4 subjected to the highest elastic seismic load compared to the other specimens. This shows that this specimen did not provide the required seismic performance compared to other specimens. Specimen 1 provided the highest seismic performance. The elastic seismic loads of Specimen 2, Specimen 3, and Specimen 4 have increased 1.23, 1.29, and 1.7 times more than Specimen 1 (respectively).
