INTERIOR DESIGN OF MOSQUES AND MADRASAS BELONGING TO SELJUK AND OTTOMAN CIVILIZATIONS IN KONYA

*Sahika ÖZDEMİR**, *Serhat ANIKTAR***, *Ahmet KURNAZ****

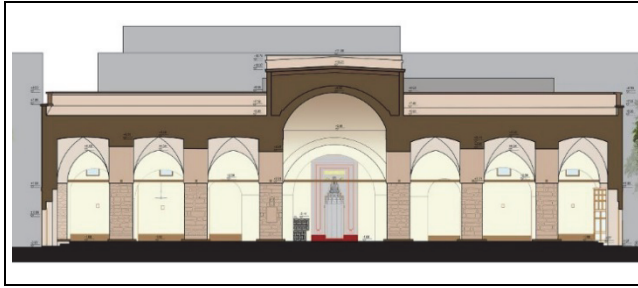
Figure 5. Iplikci Mosque interior section

İplikci Mosque could not survive to its original shape and was repaired at different times. The walls of the mosque are built of cut stones and bricks. The windows are opened in regular rows on the walls and the interior is well lit. The lateral spaces after the entrance were covered with cross vaults and a nave cradle vault adjacent to the mihrab wall. On the axis connecting the entrance and the altar, three domes along the three halls give an interesting view to the plan of the mosque. Today, the interior is covered with plaster XIX. There is an original mihrab beneath the 18th century baroque style mihrab. The original mihrab is one of the oldest examples of Anatolian Seljuk art (Figures 5 and 6).

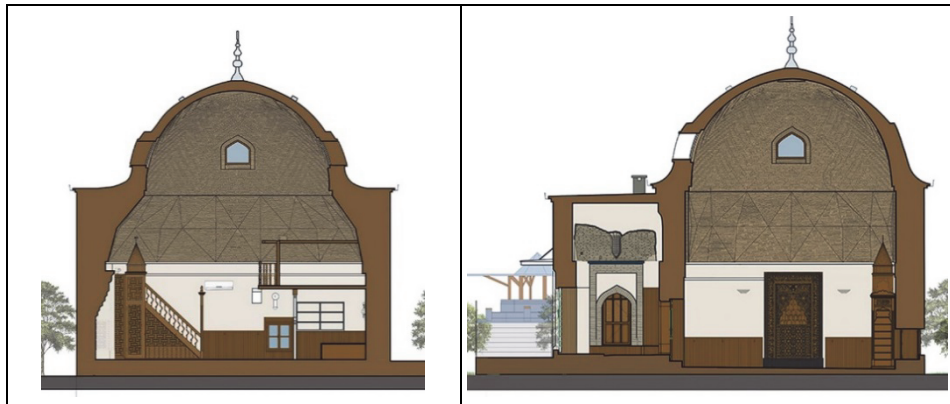
Figure 11. Beyhekim Masjid interior sections

Beyhekim Masjid consists of a domed place of worship and three sections adjacent to it. The entrance door of the masjid is opened between two windows of different size. Although the eastern facade of the masjid has a very careful cut stone workmanship, it is quite plain. The most important center of the masjid is the tiled mihrab. It is framed by a stalactite niche mihrab with two columnar columns on the sides. Mosaic tiles are covered with plates made in technique XIX. It was abducted to the Berlin Museum in the late 19th century (Figures 11 and 12).

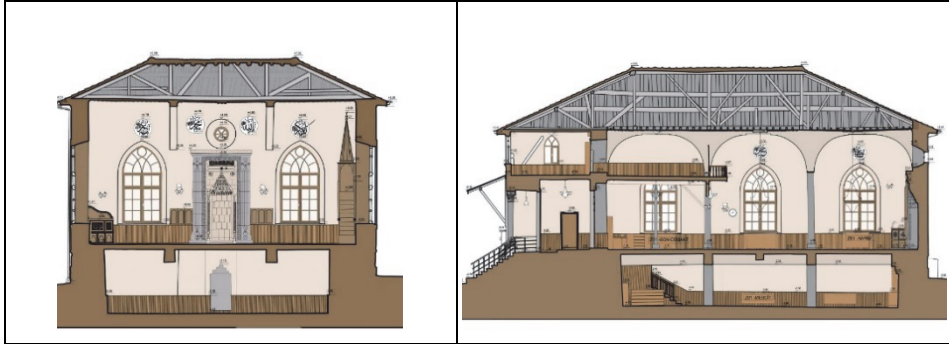
Figure 13. Hagia Hasan Masjid interior sections

Hagia Hasan Masjid sits on a high floor with a rectangular stone and rubble fill. It is built with a flat roof. The mihrab is marble and the pulpit is wooden. The windows are finished with a pointed arch. On the ceiling, motifs are made with wooden inserts (Figures 13 and 14).

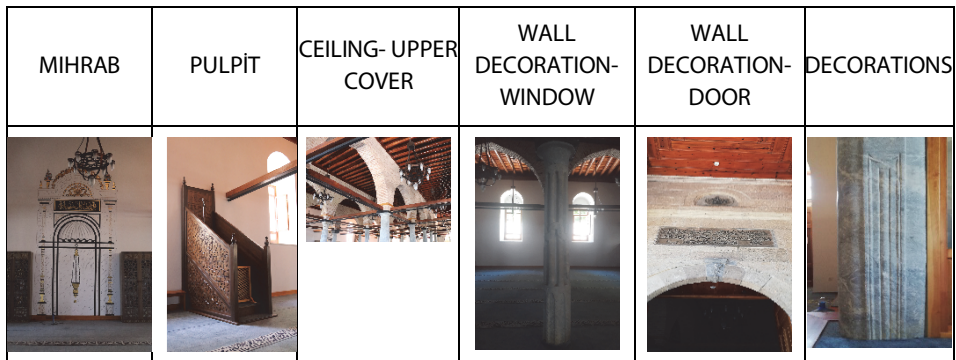
Figure 20. Alaeddin Mosque

Alaeddin Mosque was built in the style of Islamic architecture and covered with trees and soil. The interior resembles the forest of columns. It consists of 41 stone marble columns belonging to Byzantine and classical periods. One of the most interesting parts of the mosque is the pulpit. The pulpit is intertwined with ebony wood and is one of the best examples of Anatolian Seljuk woodworking. In front of the mihrab decorated with tiles, there is a field covered with tile decorated dome. The tiles of the mihrab and domes are partially cast (Figures 19 and 20).
