Solid Particle Erosion Behavior on the Outer Surface of Basalt/Epoxy Composite Pipes Produced by the Filament Winding Technique

Abstract: Basalt/epoxy composite pipes in a $[\pm 55]_4$ winding configuration were produced on CNC filament winding machines (10 N fiber tension and ~ 11 mm bandwidth). In the experiments, a 34 m/s impact velocity was set using the double-disc method, and five different particle impingement angles (30, 45, 60, 75, and 90°) were used to determine the erosive effect on the outer surfaces of filament wound composite pipes under the influence of 600 μm erodent particles with angular geometry in the test set, complying with the ASTM G76-95 standard. The winding patterns in the lamina (± 55 angle-ply laminate region) and zigzag (± 55 zigzag region) regions of BFR/EP pipes were determined to have significant effects on solid particle erosion resistance, as evidenced by the SEM images.

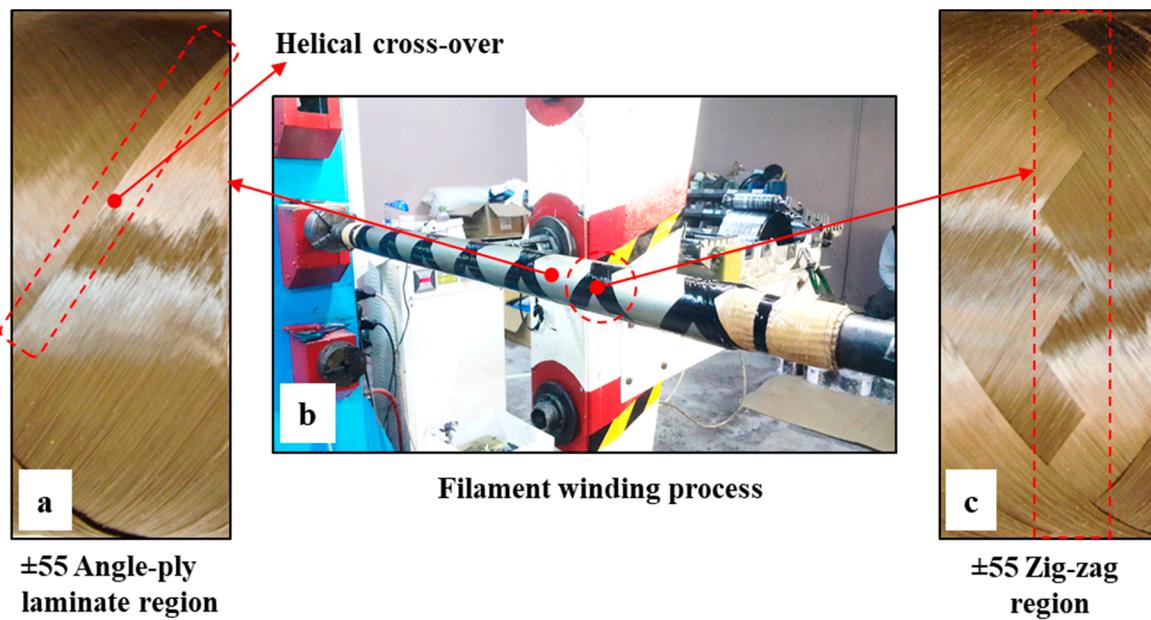
Figure 1. BFR/EP filament winding composite pipes: (a) ± 55 angle-ply laminate region, (b) filament winding process, and (c) ± 55 zigzag region.

In this study, basalt fiber-reinforced epoxy (BFR/EP) composite pipes were produced with the filament winding method in the Izoreel Composite Insulation Materials Ltd. (Izmir, Turkey) facility in a configuration of $[\pm 55]_4$ windings on a CNC filament winding machine with filament winding parameters of a 10 N fiber tension and an average bandwidth of 11 mm. Basalt fibers were wetted by being passed through an epoxy resin bath at 80 °C for impregnation and helically wound on a 1 m-long mandrel with a wall thickness of 1.85 mm and an outer diameter of 72.2 mm, as shown in detail in Figure 1b. After the filament winding process was completed, the composite pipes were first cured at 120 °C for three hours in a horizontal rotary kiln and finally post-cured at 140 °C for three hours.

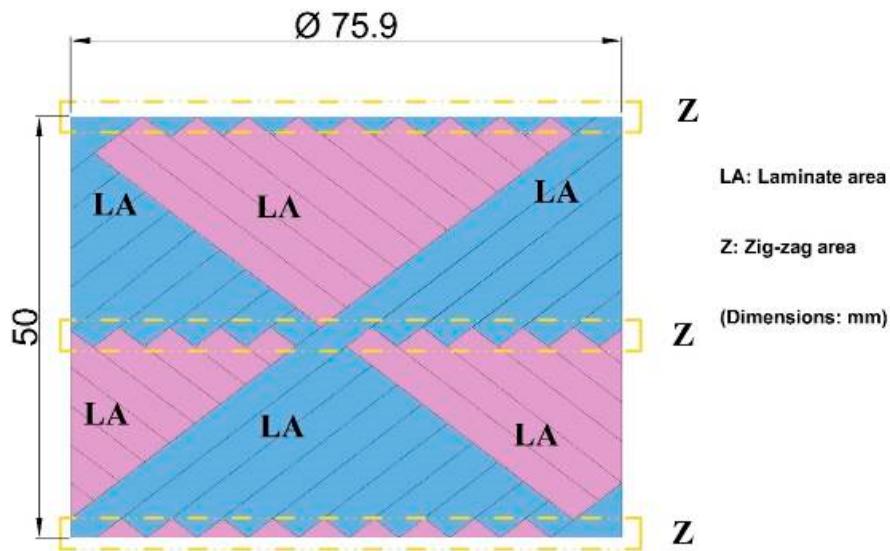
Figure 2. Filament winding variations on the outer surfaces of BFR/EP composite pipes.

The main aim of the study was to examine the erosion wear behavior on the surfaces of the pipes in the regions shown in Figure 2 of the BFR/EP composite pipes whose production processes had been completed. Considering this basic priority, to categorize the erosion resistance in the pipes against particle impact, erosion tests in a direction parallel and perpendicular to the pipe axis, which are predicted to contribute to the significance of the inner surface deformation priority, were evaluated. However, by concluding that the effects of external surface deformations of pipes on erosion resistance are more important in industrial applications and defense industry solutions, determining the erosion rate differences that occur in the zigzag regions of the intersection points and the laminate extending along the width of the basalt fibers obtained from the outer surfaces of the pipes according to the filament winding method was prioritized.

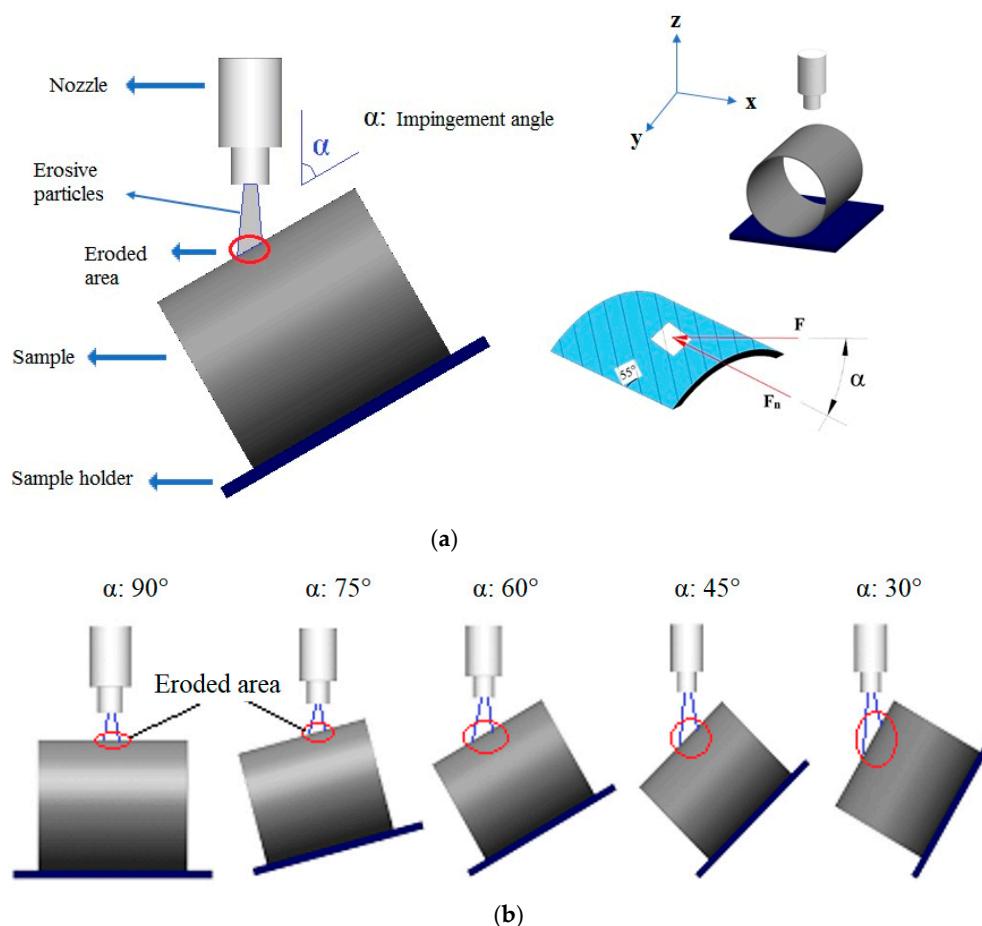
Figure 3. Pipe outer surface axial positioning test details: (a) SPE wear test design, and (b) schematic views of the variation of the impingement angle in the experiments (F: impact force, F_n : normal force on laminate).

in the tests of the internal flow direction of the pipe, that is, of the axial orientation, was constructed. In these experiments, the impact velocities of the particles in the laminated and zigzag regions were kept constant, and the results of the solid particle erosion wear tests at the five different impingement angles shown in Figure 3b were compared and examined.

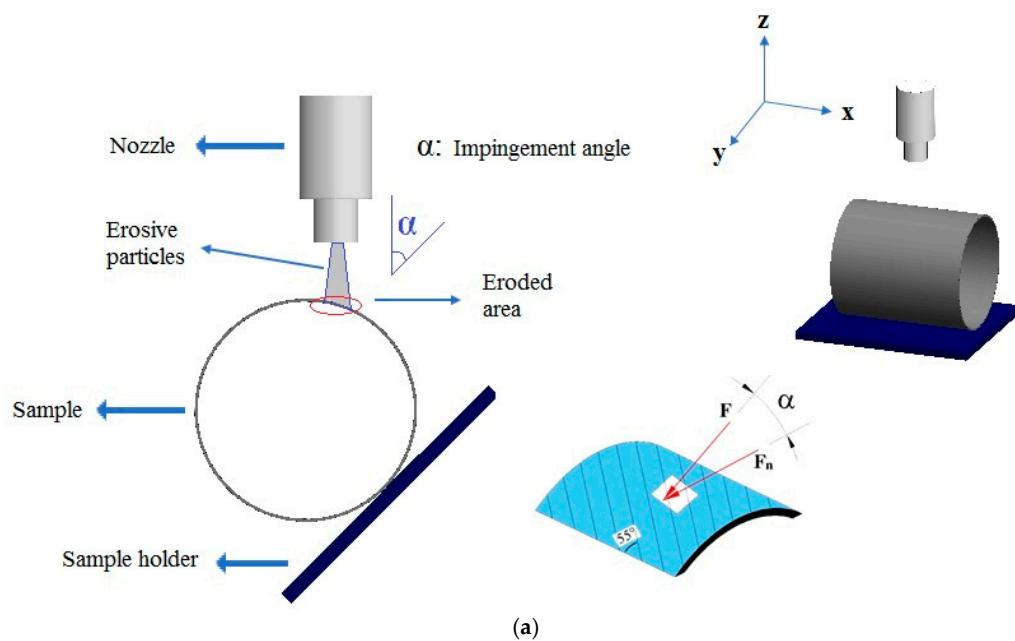
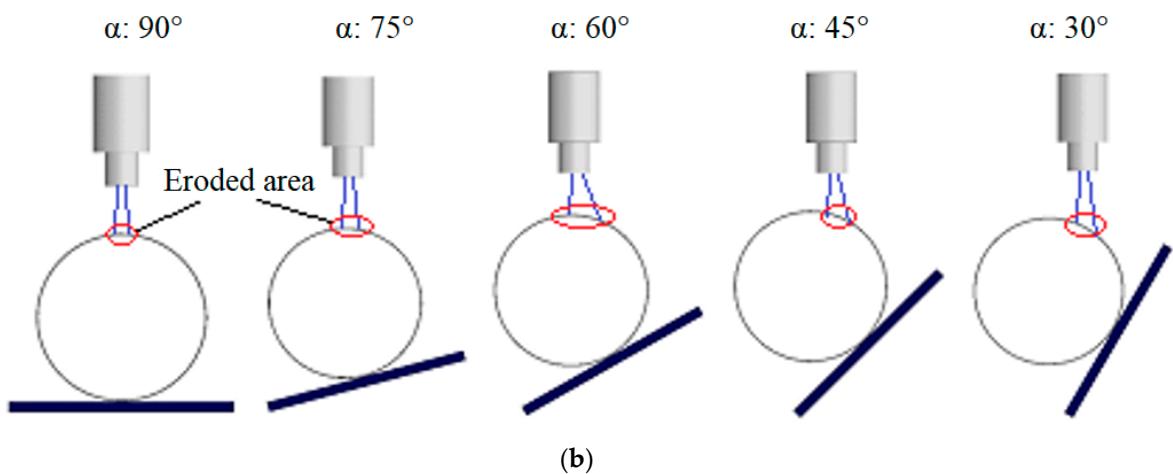
Figure 4. Pipe outer surface radial positioning test details: (a) SPE wear test design, and (b) schematic views of the variation of the impingement angle in the experiments (F: impact force, F_n : normal force on laminate).

The schematic design for the tests of the radial orientation of the outer surfaces of the BFR/EP composite pipes perpendicular to the sample holder is shown in Figure 4a. The impact velocity of the particles in the laminated and zigzag regions was kept constant in these experiments, and the results of the KPE wear tests at five different impingement angles are shown in Figure 4b.

As can be seen in the design in which the radial flow is defined in Figure 4, as the impingement angle decreases, the particle flow on the pipe surface changes due to the angular position between the sample and the nozzle, and the damaged area on the pipe's surface also changes. The effect of the cosine component of the impingement angle increases at 60° compared to 75° and 90° . The regional contact of the particles on the pipe's surface is in a larger area at 45° and 30° . The ploughing effect of the cosine component of erosive particles deeply damaged the pipe's surface, causing larger wear. Looking at the stereo microscope images in Figures 11–14, it has been shown that the eroded areas vary depending on the impingement angle. The effect of the cosine component of the impingement angle increases at 60° compared to 75° and 90° . The regional contact of the particles on the pipe's surface is in a larger area at 45° and 30° . As a result, the maximum wear occurred at 60° , depending on the impact angle and pipe surface position.

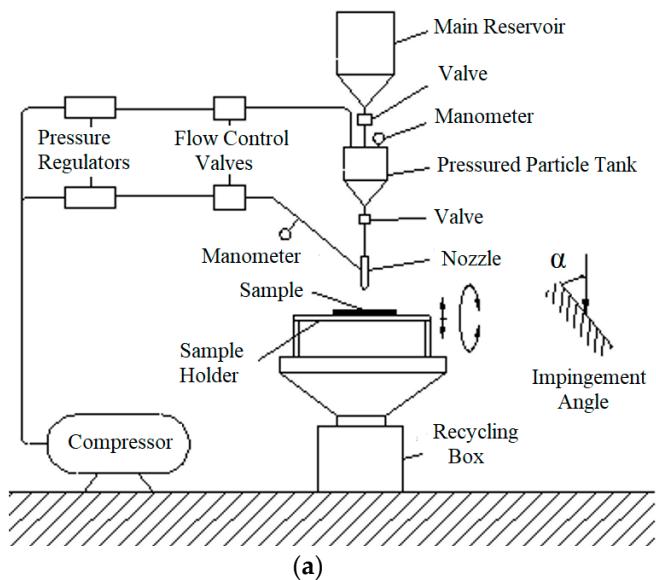
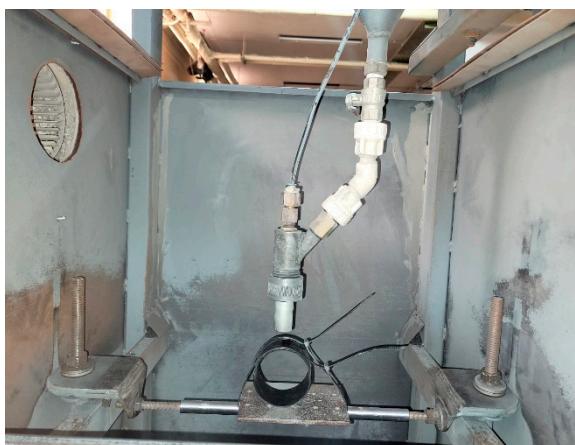
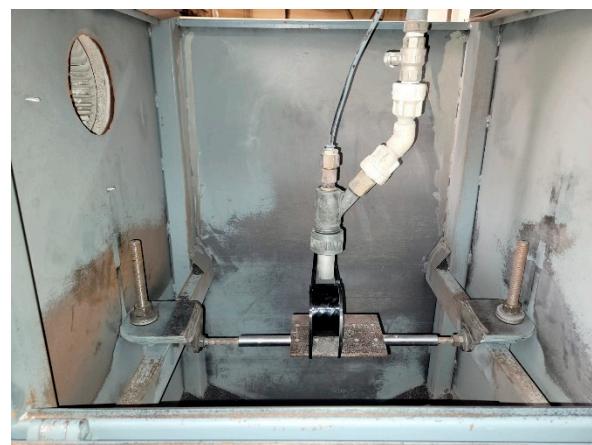
Figure 5. Experimental setup: (a) detailed schematic representation of components, (b) pipe axial positioning, and (c) pipe radial positioning.

The tests were performed in an erosion wear test installation that met the ASTM G76-95 standard requirements, as shown schematically (the main components used on the unit are indicated) and in photographs in Figure 5.

After transferring the abrasive particle to the main tank for use in the experiments, the valve between the tanks was opened, and the particles were transferred to the pressurized tank. The pressure-regulating valves used in the system adjusted the pressures at the entrance of the pressurized tank and the nozzle, and the settings were controlled by manometers. The sample holder component on the test installation was used to adjust the impingement angles of the test samples of 30, 45, 60, 75, and 90°, as well as the distance between the nozzle and the test sample in a way that did not affect the impact velocity.

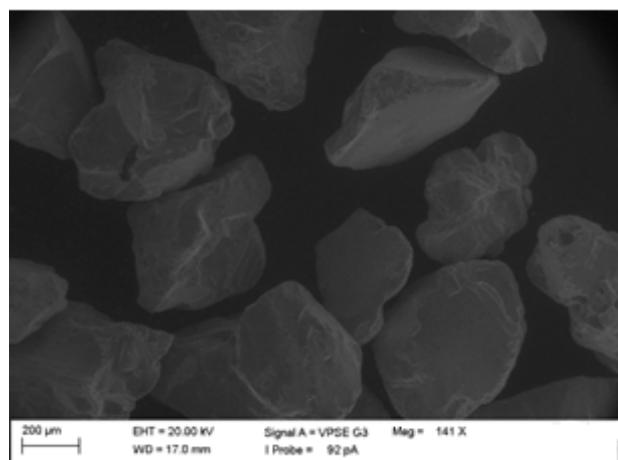
Figure 6. SEM image of Al₂O₃ abrasive particles with angular geometry.

Particle selection is critical in determining the abrasive particle impact rate, which has an important place in solid particle erosion wear. The SEM image is presented in Figure 6. The average $\sim 600 \mu\text{m}$ size of the Al_2O_3 abrasive particles (density 3.94 g/cm^3 , hardness 9 Mohs, and melting temperature 1950°C) was used.

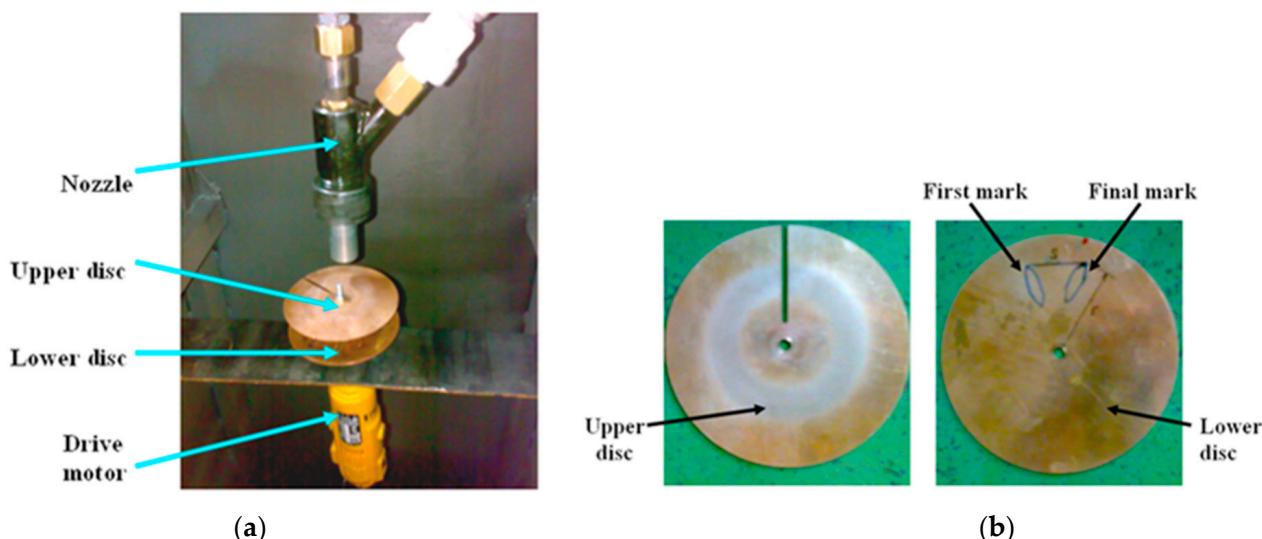
Figure 7. Double-disc method: (a) position of motor, nozzle, and discs, and (b) erosion marks on discs.

In the velocity measurement of particles, high-speed photography [21], a laser doppler anemometer [22], and the double-disc method [17] are velocity measurement techniques that are accepted as standard and widely used. The double-disc method is the most commonly used method for determining impact velocity values, and in the experimental study, the abrasive particle impact velocity was set at 34 m/s using this method, in which two metal discs made of phosphor bronze are connected to a common shaft that rotates beneath the nozzle, as shown in Figure 7a. These discs are connected to the drive motor, which precisely determines the rotation of the discs. After the interaction of the drive motor movement and the particles directed from the nozzle, the erosion wear marks formed on the lower disc by particles passing through the slit in the upper disc are shown in Figure 7b.

The distance between the discs (L) and the distance of the nozzle to the discs were defined at the start of the double-disc method and were determined based on the distance between the nozzle tip and the test sample. The drive motor could control the rotation speed (v) of the sample and the discs. At the end of the velocity measurement experiments of three replicates, the distance between the erosion marks formed on the lower disc (S) and the radius of the marks to the disc center (r) were measured and written in Equation (1), and the abrasive particle velocity (v) was theoretically calculated [17].

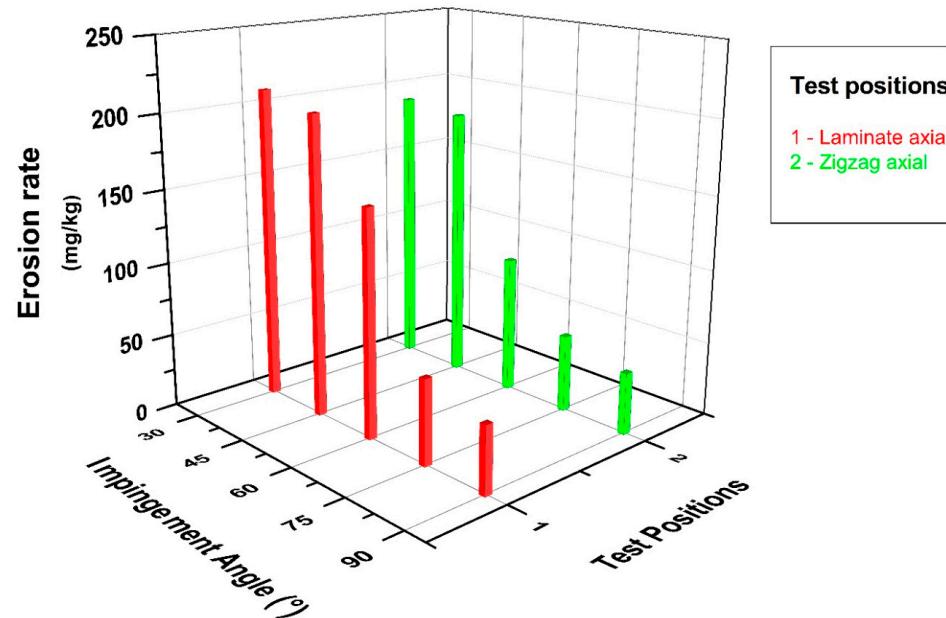
Figure 8. BFR/EP composite pipe outer surface axial orientation erosion rate–impingement angle relationship.

The graph in Figure 8 depicts the changes in impingement angle and erosion rate in the lamina and zigzag erosion wear test positions, where the effect on the pipe's outer surface in the axial direction was investigated. When the related graph is examined in depth, it may be concluded that while the lamina and zigzag forms exhibit similar tendencies, the impingement angle causes a difference in wear due to the differentiation of abrasive particles striking in parallel and perpendicular to the fibers due to the winding configuration $[\pm 55]_4$ feature. After the 30° impingement angle, it was determined that the erosion rate decreased in line with the increase in the angle between the nozzle and the pipes from oblique to vertical impact for both test positions. In particular, the 30° and 45° data exhibited close erosion resistance and are compatible with the literature; that is, a situation similar to ductile-prone erosional wear has occurred [12,23]. In other words, in these tests, the scraping effect of oblique impact was dominant, and separation from the surface was accelerated.

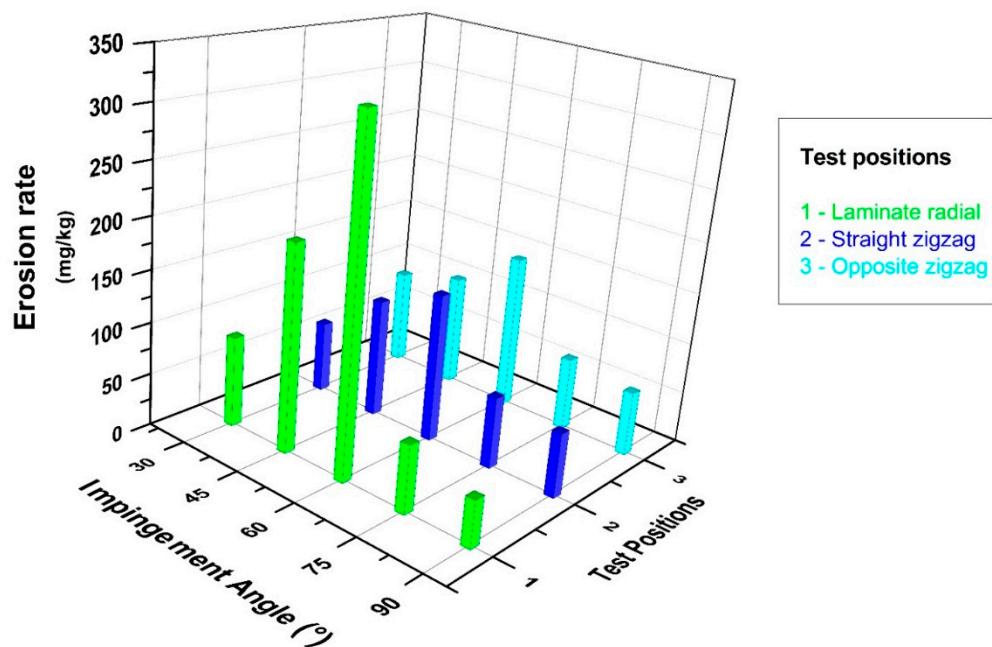
Figure 9. BFR/EP composite pipe outer surface radial orientation erosion rate–impingement angle relationship.

The graph in Figure 9, on the other hand, contributes to the comparison of the solid particle erosion resistance of the outer surface of the pipe as a result of the radial action of the erosive particles, examines the effects of the lamina form results and the zigzag form in

flat and opposite positions, and shows the changes between the impingement angle and the erosion rate. Although the erosion wear results in this direction are compatible with similar effects in the literature [20], it was observed that the formation of the wearing zone changed in the radial direction tests in contrast to the axial direction tests. It should be noted that a sample application of pipe form erosion wear tests had not been carried out until the current study. The deformation caused by the abrasive particles on the pipe surface reached its maximum level in these experiments at a 60° impingement angle. In other words, erosion resistance decreases after a 30° impingement angle up to a 45° and even a 60° impingement angle, and then significantly increases at 75° and 90° impingement angles, and the wear course of semi-ductile materials has been encountered in the literature [24,25].

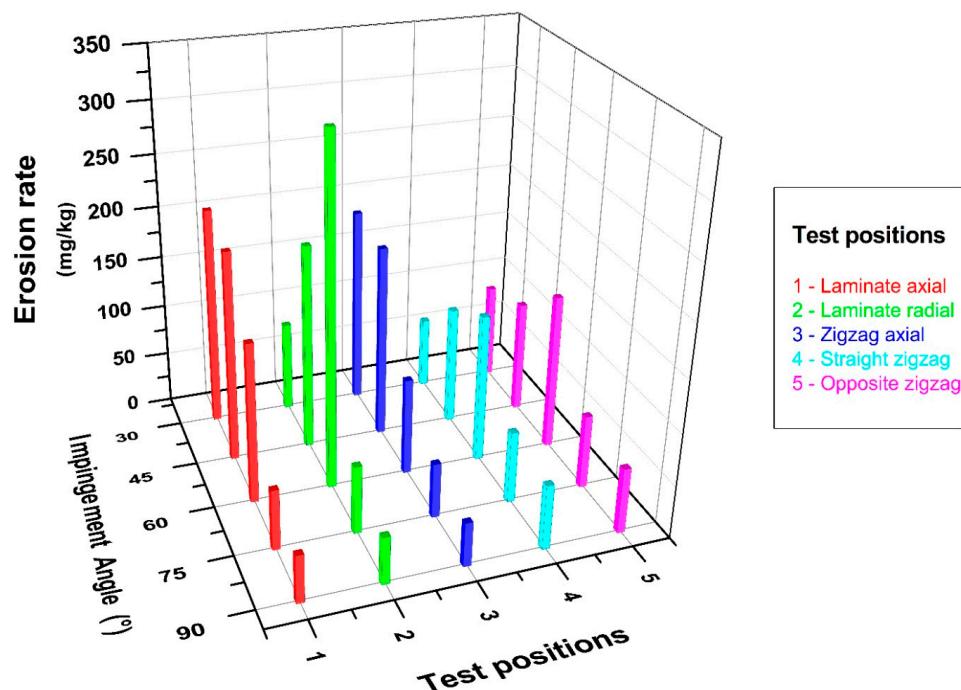
Figure 10. BFR/EP composite pipe outer surface radial and axial orientation erosion rate–impingement angle relationship.

Figure 10 shows a graphical representation of the changes in impingement angle and erosion rate for all composite pipe orientations whose wear conditions were questioned within the scope of this experimental study overall, with the effect of the combined comparisons on the significance highlighted. This graph shows, in particular, how important the impact of the test position on the impingement angle is. A strong wear resistance was observed in all test positions when conducted at a 90° impingement angle. When only axial tests were examined, it was discovered that the zigzag region had higher erosion resistance than the lamina region at the 30° impingement angle where the maximum wear occurred, and the erosion rate was reduced by 10%. When only the radial direction tests

were examined, it was discovered that the erosion rate in the zigzag regions decreased by 30% for the 60° impingement angle, which is where the most wear occurred, when tests were conducted in both radial and axial directions; however, it was clear that the zigzag region had the strongest tendency to resist wear. When the maximum erosion rate occurred in the lamina region in radial direction tests and in the lamina region in axial direction tests, the wear resistance increased by 30% in the axial direction tests with the same particle impact velocity and abrasive particle mass.

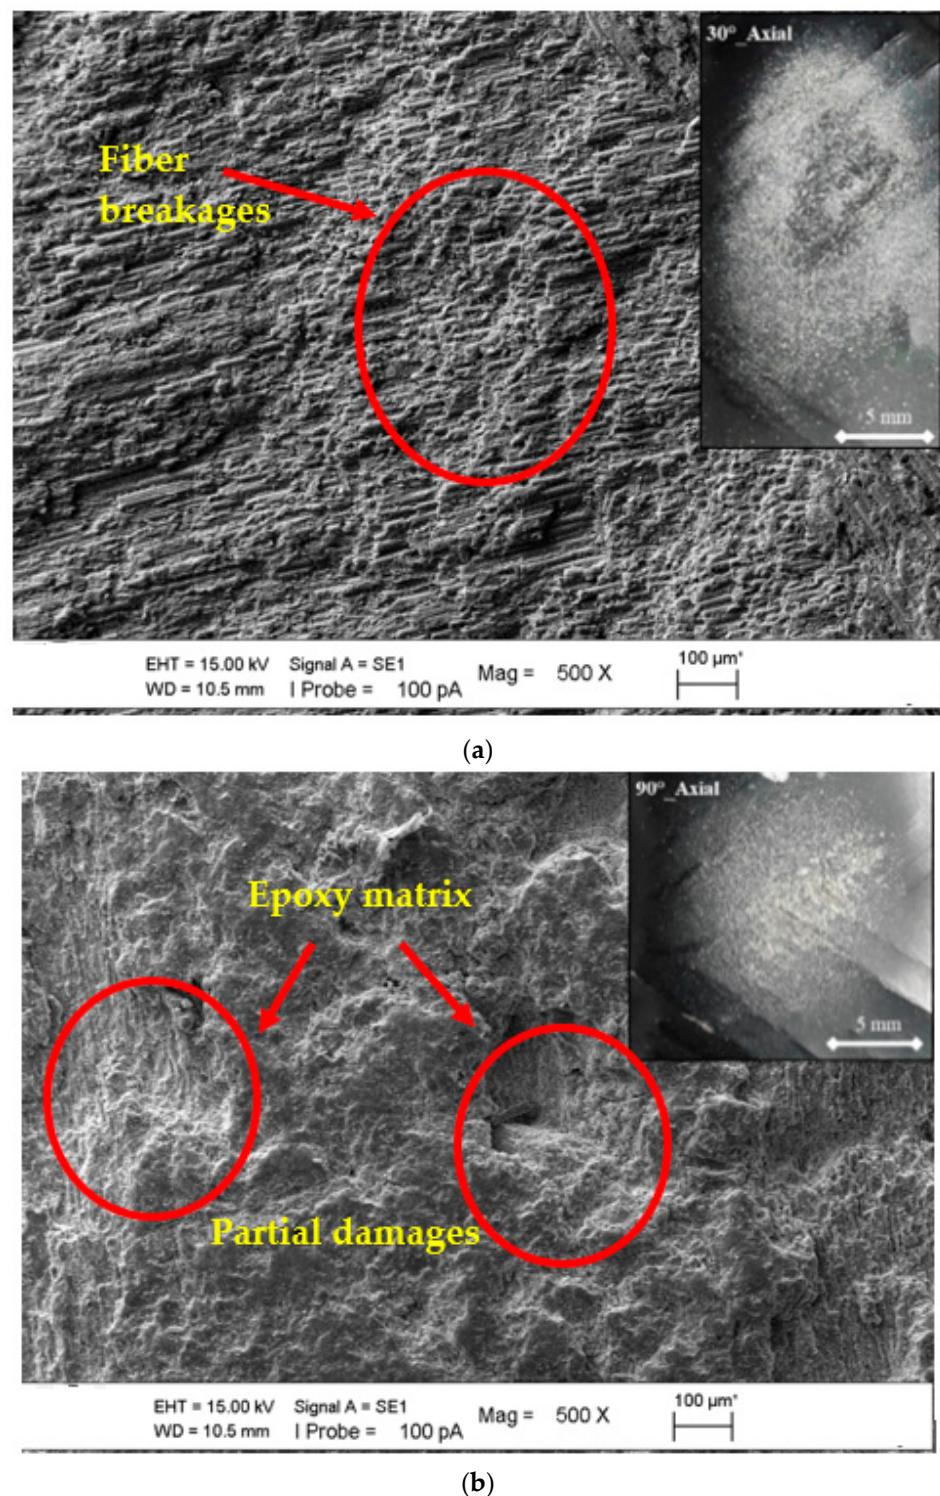
Figure 12. SEM images of matrix damages and fiber breakage on the surface at the axial orientation with the changing impingement angle: (a) 30° and (b) 90°.

In Figure 12a,b, the experiments were carried out in the axially oriented test position. However, when the main difference is the impingement angle (90°), it is understood that in the case of variability from the oblique impingement angle to the perpendicular impingement angle, the effect of the main difference observed in the surface form, especially in the abrasive particle ploughing role, turns into pressing the surface inward; that is, the embedding situation in a way that coincides with the existence of incubation. As a result, fiber breakages were seen at the 30° impingement angle, and partial matrix damages have been observed at the impingement angle of 90° . This showed that the erosion rate resulted in a decrease.

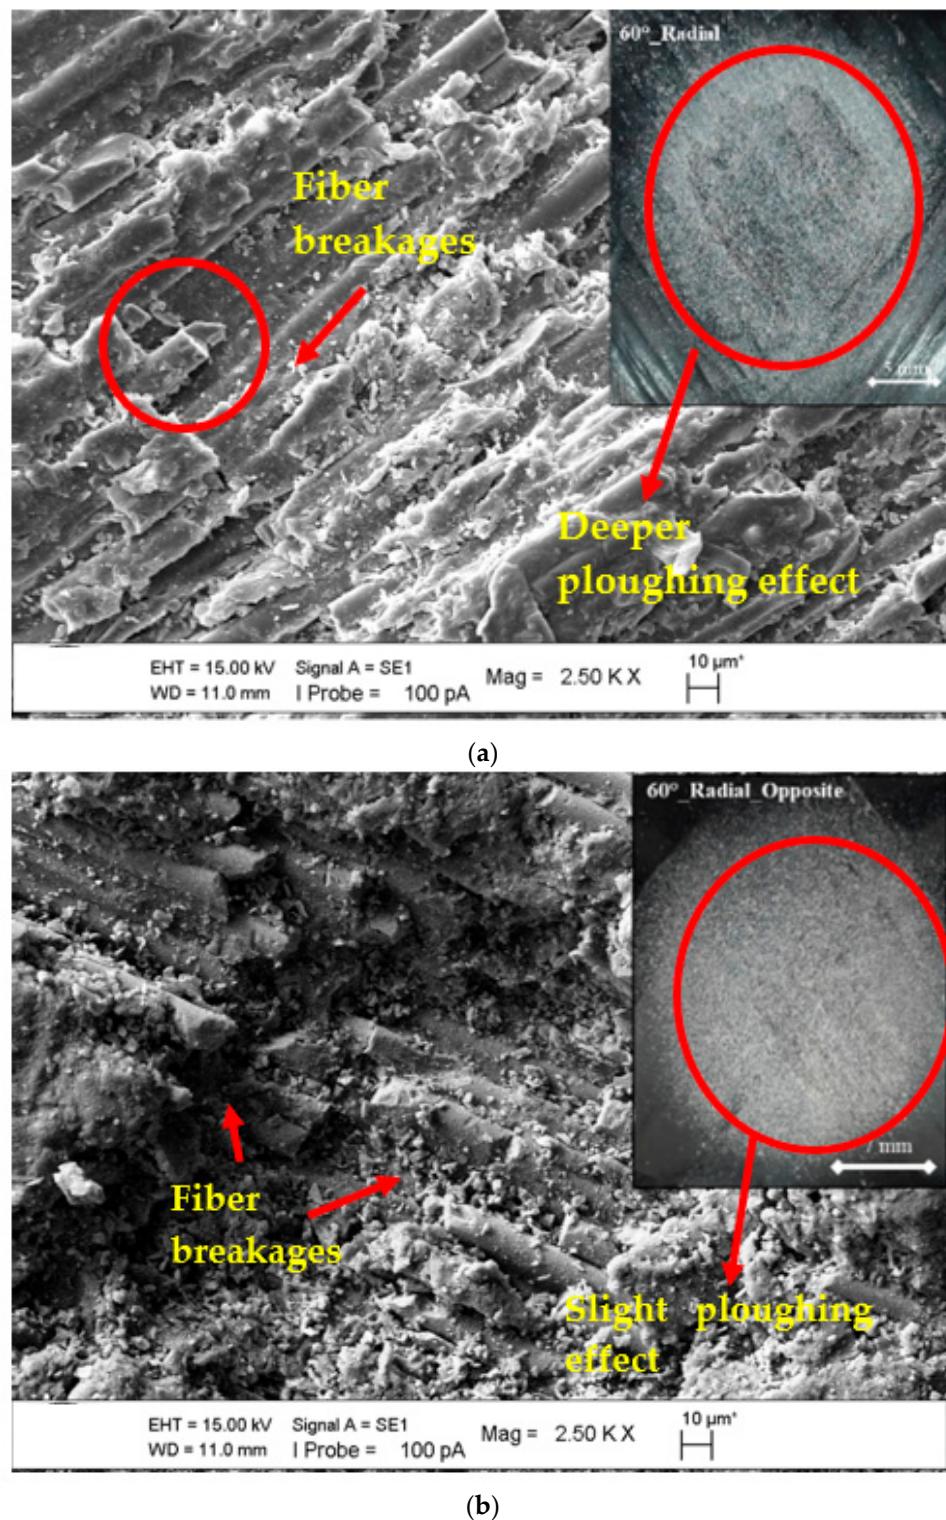
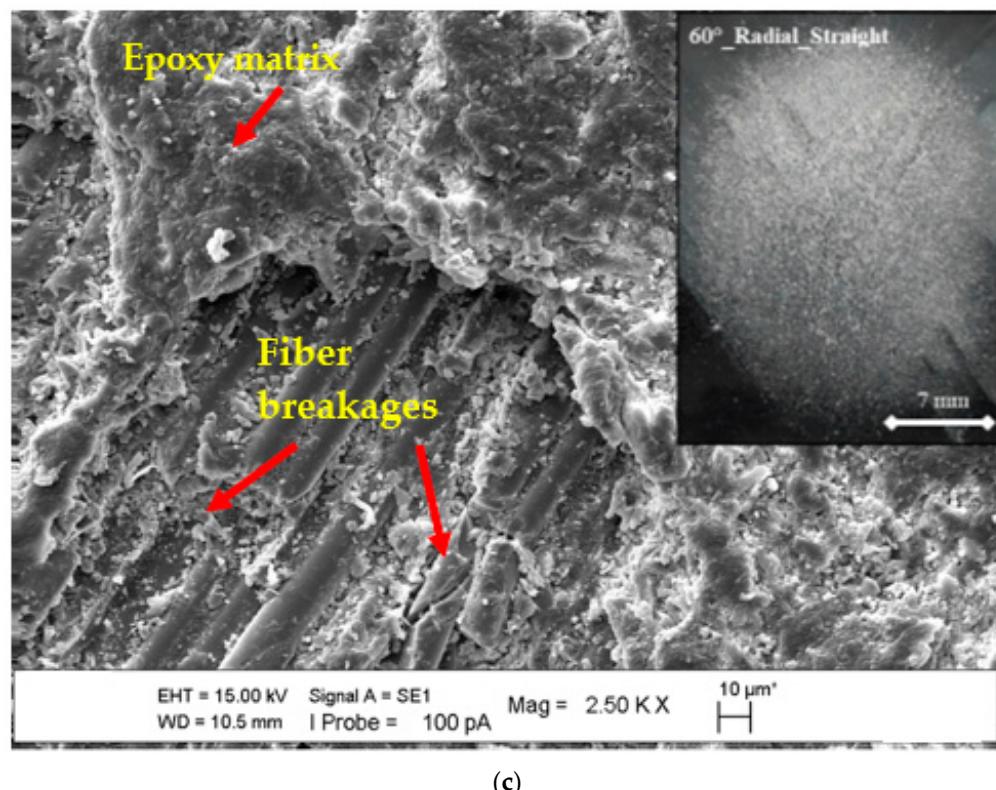
Figure 13. SEM images of matrix damages and fiber breakage on the surface at the 60° impingement angle with radial orientation: (a) lamina region, (b) zigzag opposite, and (c) zigzag straight.

As shown in the image of the stereomicroscope in Figure 13a, deeper damage occurred. In the region shown here, the matrix was ploughed, and the fibers were broken. In Figure 13b,c, the ploughing effect could not reach the depth, but the ploughing mechanism and fiber breaks occurred. Wear increased in the lamina area where deeper damage took place. In the zigzag regions, as shown in Figure 2, it was observed that the fibers supported each other and increased the erosion resistance.

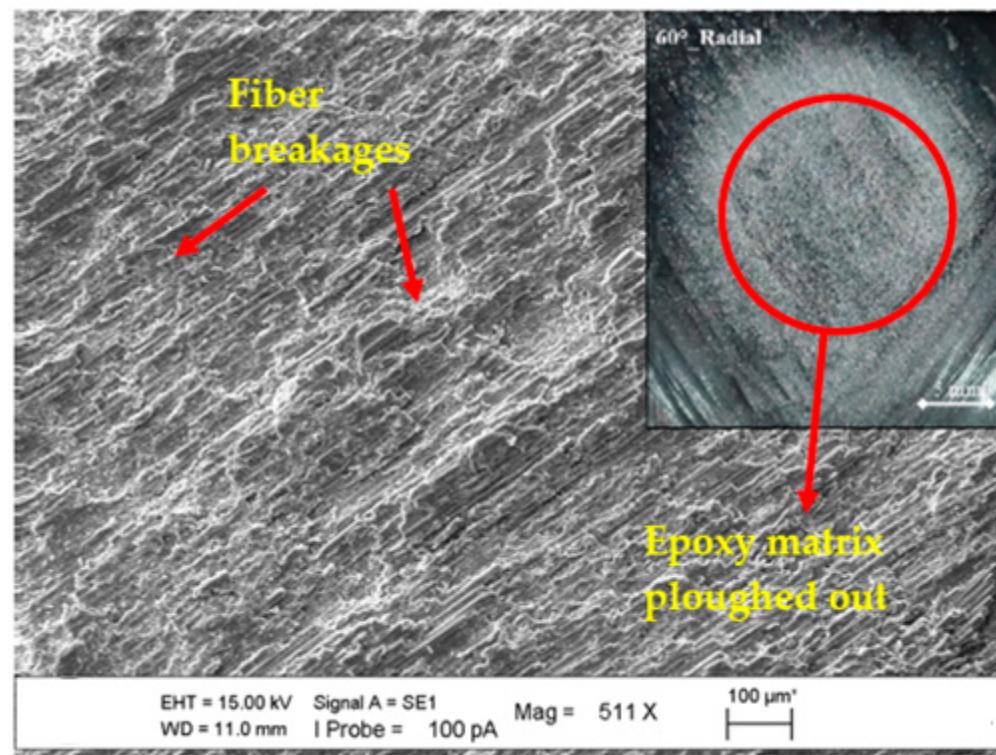
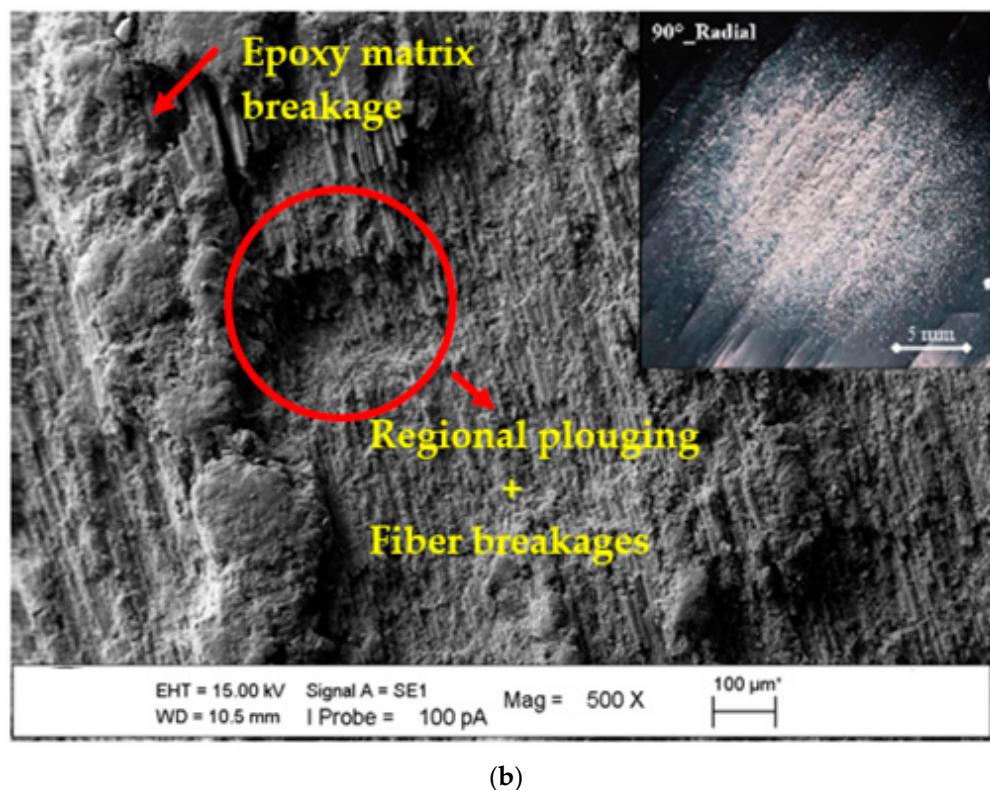
Figure 14. SEM images of matrix damages and fiber breakage on the surface at the radial orientation in the lamina region with the changing impingement angle: (a) 60° and (b) 90°.

In the SEM image comparisons in Figure 14a,b, the impingement angle difference of the radial orientation test position was examined. Although the axial orientation compatibility in these images was similar, the impingement angle at which maximum erosion wear occurred was 60° , resulting in a material tendency transition to semi-ductile. The rolling effect on the sample surface was prioritized by the particles in the right-angle application experiments.

It was observed that the matrix of the composite pipe was ploughed more strongly at the impingement angle of 60° and fiber damage occurred in a larger area. At the 90° impingement angle, the matrix was intense in the worn area and partial fiber damage was observed.

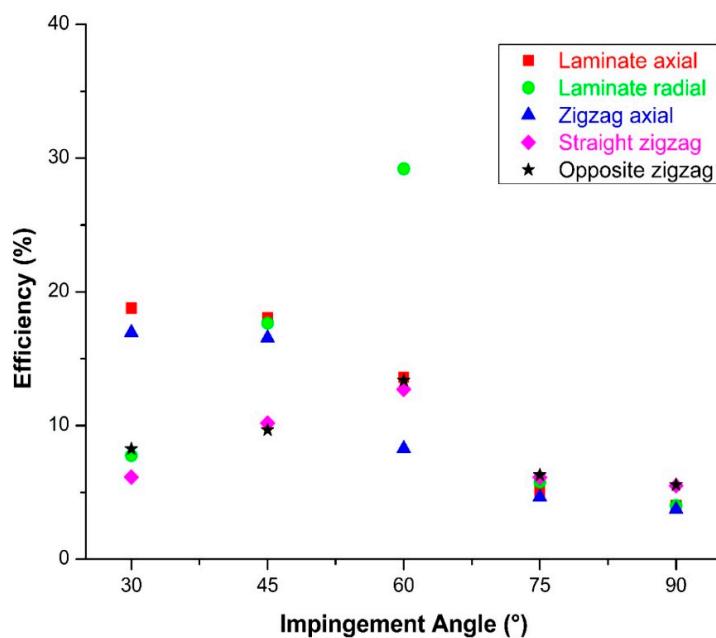
Figure 15. Effect of impingement angle on erosion efficiency in BFR/EP composite pipe outer surface radial and axial orientations.

The changes in the efficiency values of 30, 45, 60, 75, and 90° impingement angles, respectively, were calculated using Formula (3), and the graph in Figure 15 was created. While the angle-specific comparison effect determines priority dominance, radial and axial pipe outer surface orientations have a direct impact on erosion resistance. Furthermore, the findings revealed that the separation from the sample surface was interpreted as the abrasive particle activity gradually penetrating the surfaces. In addition, it was discovered that the outer surface orientations of filament winding composite pipes had a positive effect on erosion efficiency and an inverse effect on erosion resistance.
