Case Studies in Thermal Engineering

Two real room fire and the evaluation of its consequences in terms of fire safety

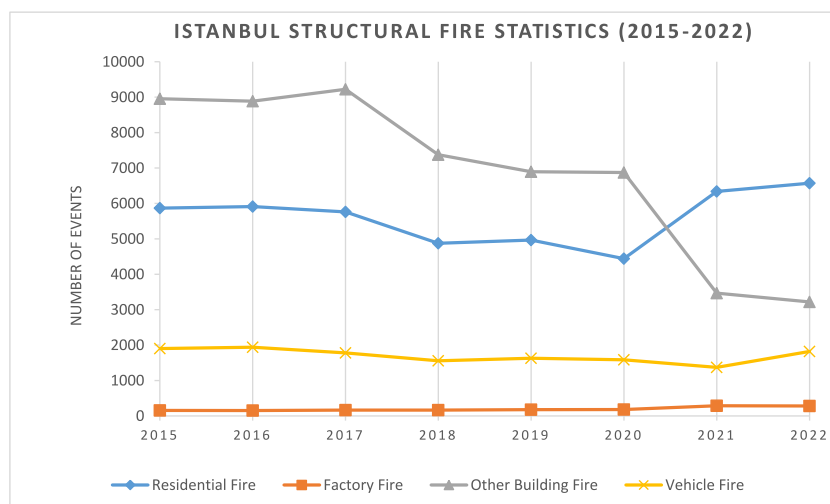
Fig. 1. Istanbul structural fire statistics (2015–2022) (URL-1) [23].

Istanbul Fire Department Istanbul Province fire statistical data for 2015–2022 is given in Fig. 1. When the statistics are analyzed, it is seen that housing and building fire totals have the largest structural rate, even if they vary by year [23]. In the light of these statistical data, the idea of experimental investigation of residential and building fires was formed.

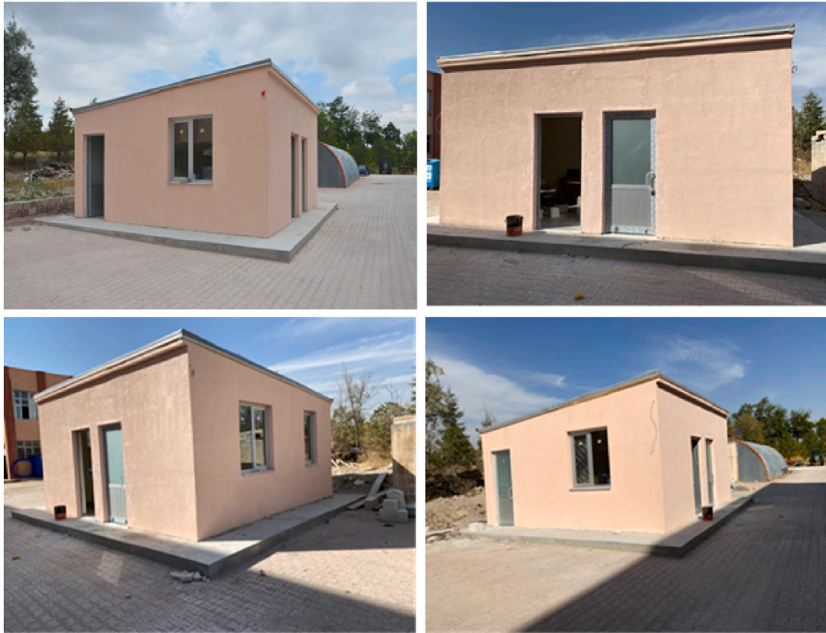
Fig. 2. Ground floor plan and finished images of the building.

For the experimental studies, a Fire Test Laboratory was designed within the Konya Technical University Vocational School of Technical Sciences, Department of Construction and a 1/1 scale building was prepared. The ground floor plan and the finished images of the building are given in Fig. 2. There are 2 rooms measuring 300 × 350 cm and 1 room measuring 190 × 620 cm in the fire test building. The building was constructed in masonry construction technique with 20 cm thick aerated concrete on the walls and 15 cm thick reinforced aerated concrete as a ceiling slab [24].

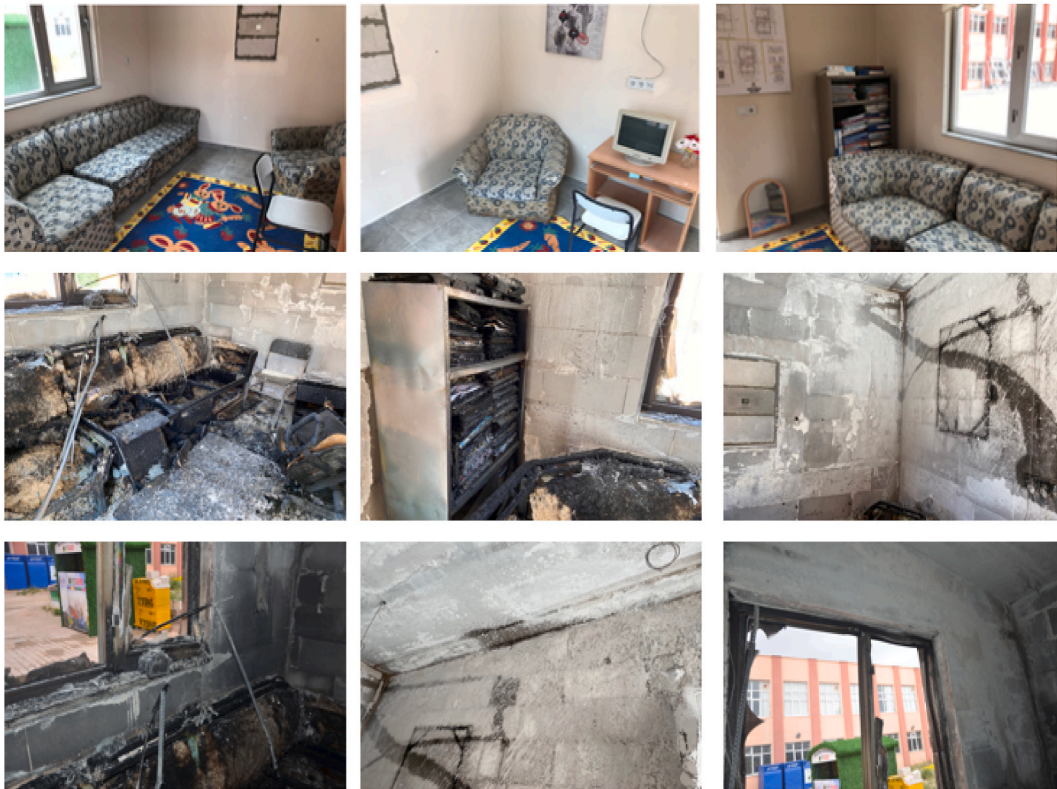
Fig. 4. Living interior images.

The outer walls of the fire test building are made of 20 cm thick aerated concrete. The experimental building was prepared as 2 experimental rooms and 1 observation and control room. A window was left in the observation and control room to observe both rooms. One of the rooms, whose interior visuals are given in Fig. 4, was designed and furnished as a Living room.

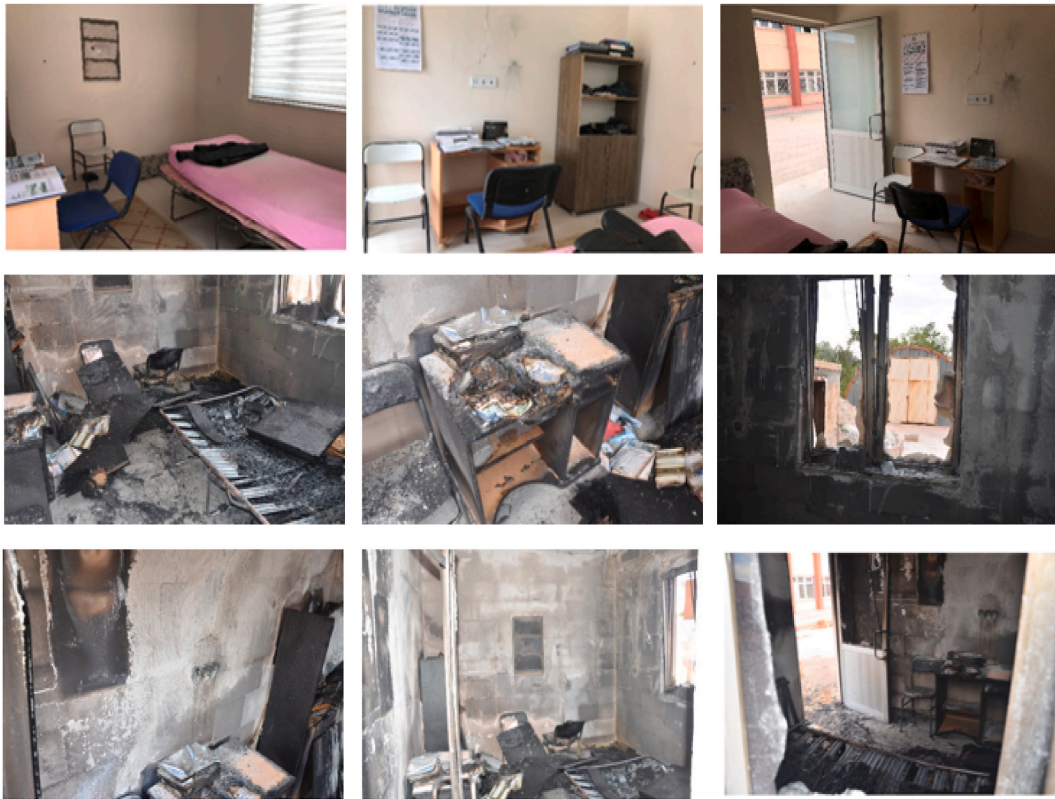
Fig. 5. Bedroom interior images.

One of the rooms, whose interior visuals are given in Fig. 5, was designed and furnished as a bedroom.

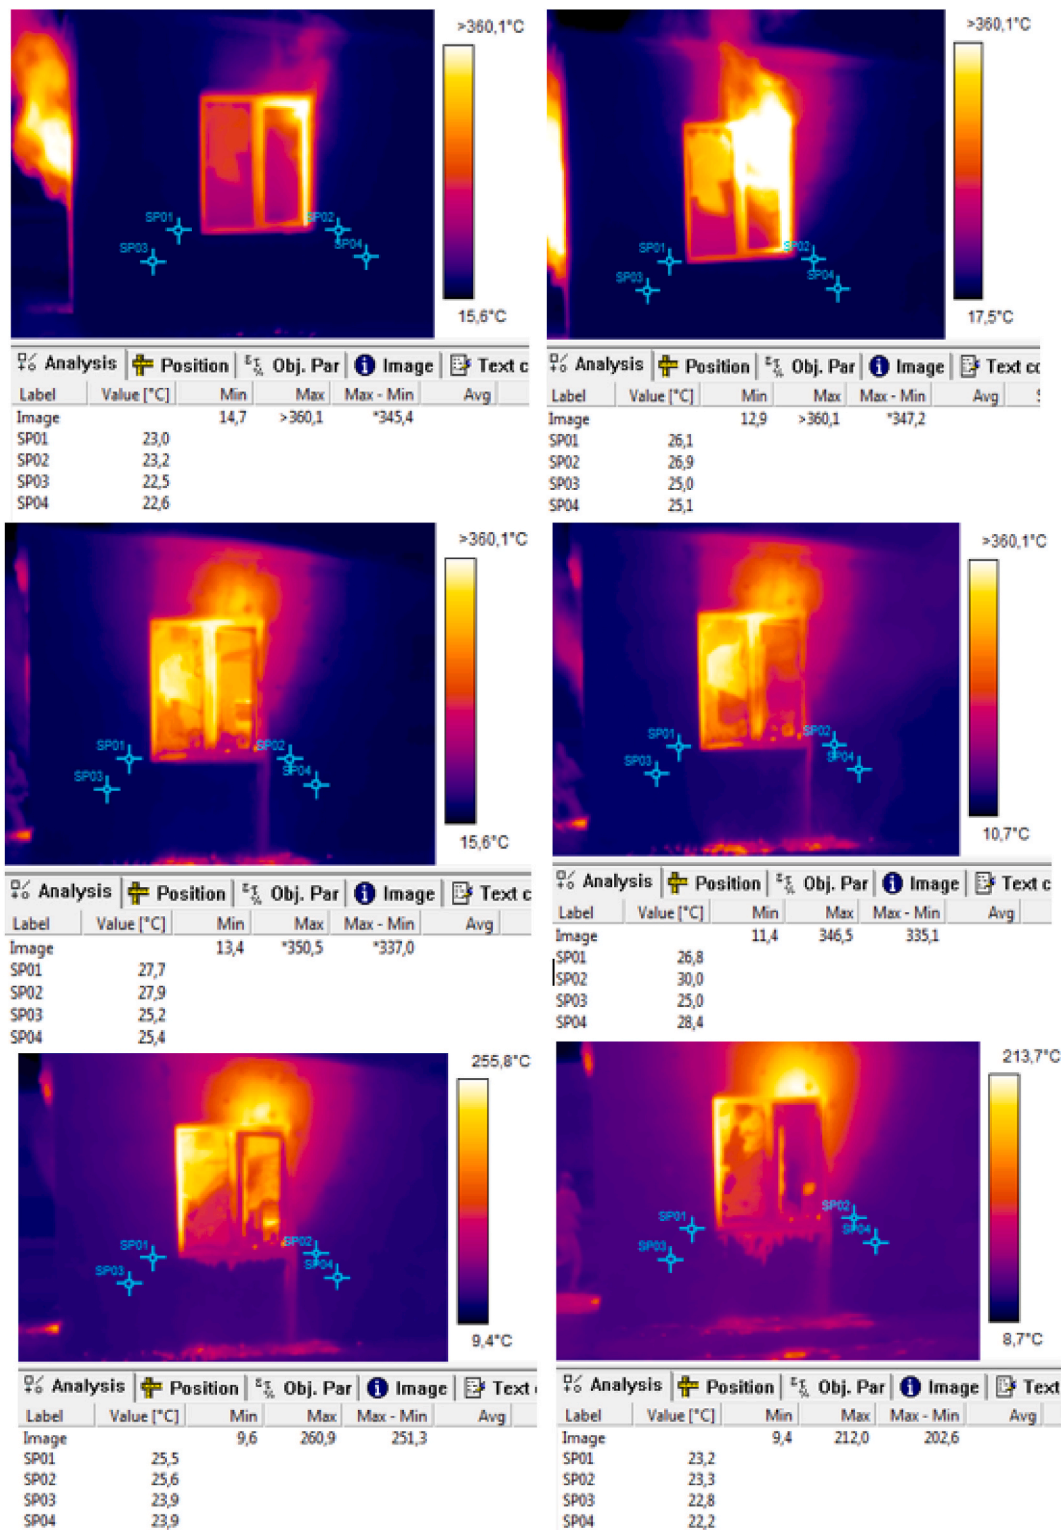
Fig. 9. Exterior wall surface temperature measurements during bedroom fire.

With a thermal camera, temperature measurements can be taken from walls, windows, and doors in different environments with very low error margins [32]. Surface temperature measurements on the outer wall of the bedroom are shown in Fig. 9 during the fire with the thermal camera. Measurements were taken from 4 points on the outside wall of the room at different times.

The top temperature inside the bedroom was max 1200 °C, the middle zone temperature was 800 °C and the lower zone temperature was around 400 °C, while the wall temperature outside the room was max 30.0 °C. Points SP01 and SP02 are closer to the window. SP03 and SP04 are lower in height than the other two points. It was observed at all points that the temperature increased from the floor to the ceiling in the wall temperatures outside the room as well as inside the room. It was also observed that heat concentration occurred in the window zone. Points SP01 and SP02 are closer to the window. Points SP03 and SP04 are farther from the window than the other two points. At the peak of the temperature, SP01 measured 26.8 °C while 25.0 °C was measured at SP03. While 30.0 °C was measured in SP02, 28.4 °C was measured in SP04. These data show that the temperature reached higher values in the region where the aluminum window was located. The peak temperature during the fire was after the glass had exploded.
