**İSTANBUL**  
**International**  
**Modern Scientific**  
**Research**  
**Congress -III**

**THE BOOK OF FULL TEXTS**

## TRADITIONAL HOUSING TYPOLOGY IN KONYA CITY CENTER

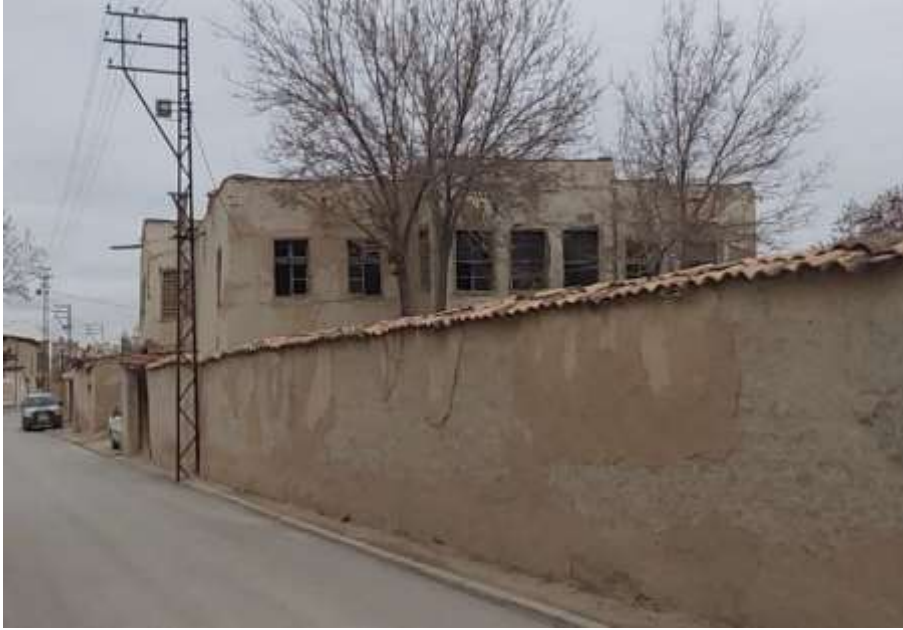
**Figure 2.** Nakipoğlu House Facade (Dönmez, 2021)

**Estimated Construction Period** : First Half of the 19th Century  
**Current Usage** : in ruins Condition

**Information About the Building:** The residence was built in a large garden surrounded by high walls with a design concept isolated from the street. The main façade of the house is the south façade facing the garden (Figure 3-4). In the garden of the house; There are traditional items such as kitchen, toilet, tandoor well and barn (Figure 3-4). In addition, although it is mentioned in some sources that guest room "Hariciye" is located in the garden of the house, it has not been found today (Aygör, 2015). The house is planned as two floors (ground and first floor) and an " iç sofa" interior hall (Figure 4). There are traditional equipment items such as closet, ghuslhane and triclinium in the rooms (Ulusoy, 2007). The façades of the building are mudbrick plastered and are quite plain. There are three bay windows in the house (Figure 4). The sofa bay window on the south and the room bay window's on the east and west have three sides (Figure 4). The bay window's of the rooms are carried with wooden brace, and the bay window of the sofa is carried by wooden columns. The bearing walls of the house and the outbuilding in its garden were built with rubble stone up to the basement level, the walls above the basement level were built with mud bricks, and wooden beams were used as binding elements (Ulusoy, 2007; Dönmez, 2017). The house is covered with a flat roof (Figure 2-3).

**Periodic Features of the Building:** Based on the features of the house in a design approach facing the isolated garden from the street, the house (originally) not having a door opening directly to the street, the façades designed in a plain appearance without ornaments, the presence of a guest room, kitchen, toilet, water well and similar traditional outbuildings in the garden, the house has 19 It is thought to have been built in the first half of the th century. At the same time, the fact that the mains water, which was put into use in 1901, was not found in the house, is another data that suggests that the building was built before this date. In addition, the fact that the house is covered with a flat roof is another feature that suggests that it was built before the use of Marseille tiles in the houses became widespread.

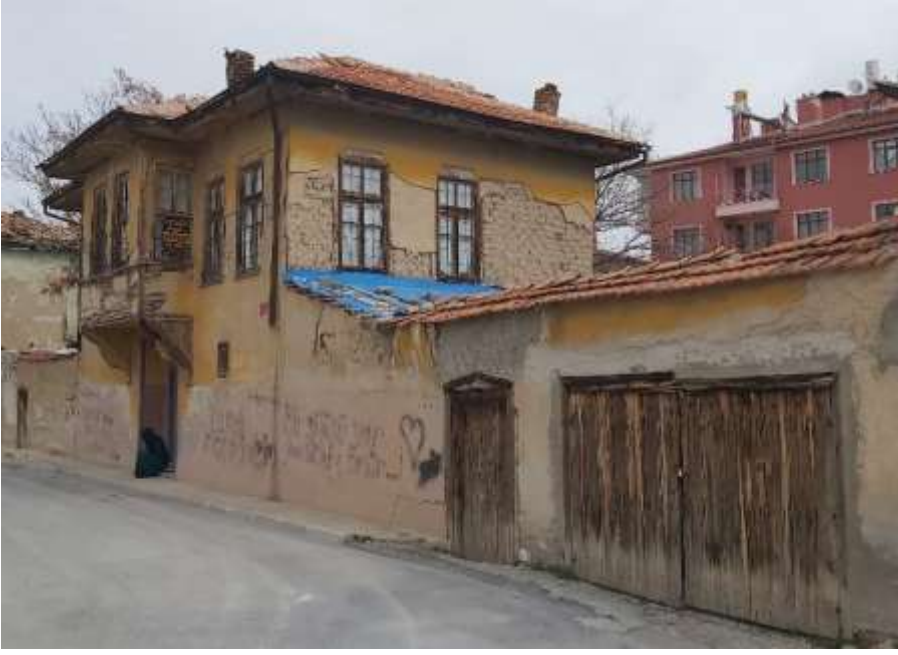
**Figure 5.** Kazım-Nesibe Büyükşalvarcı House Facade (Dönmez, 2021)

**Estimated Construction Period** : Second half of the 19th Century  
**Current Usage** : It is used as housing

**Information About the Building:** The garden walls of the house join with the main wall of the building on the western façade after the entire parcel is surrounded. In addition to the entrances to the garden, the house has an entrance that opens directly to the street (Figure 5). In the garden of the residence, outbuildings such as traditional kitchen, toilet, tandoor and pool are included. There is one room on each side of the ground and first floor interior hall (Figure 7). The rooms have traditional design elements such as ghuslhane, closet and so on. The façades of the house were arranged quite simply, and the aesthetic concern was tried to be created with a structural form rather than ornamentation (Figure 5). A three-sided interior hall “Sofa” bay window is encountered on the east and west facades of the house (Figure 7). The bay windows are supported by geometrically shaped buttresses on the façade, resulting in an aesthetic appearance. The appearance of imitation cut stone is provided with the joint up to the ground floor level on the street façade (Aygör, 2015). When all the facades of the house are examined, it is seen that the window openings are concentrated on the street façade of the first floor (Figure 7). The house is covered with a hipped roof using Marseille type tiles (Figure 6). The dwelling was built using rubble stone up to the subbasement level and adobe brick in the remaining part using the masonry technique (Dönmez, 2021).

**Periodic Features of the Building:** Although a limitation was brought by placing high garden walls between the public area and the house in the layout planning of the house, it is seen that the house is oriented towards the street more than the first half of the 19th century examples with its windows concentrated on the street front of the first floor. In addition, imitation cut stone appearance is provided with the joint up to the ground floor level on the street façade and decoration is included. In addition to this, it is seen that the house preserves its early period features with the simplicity of the façades, the lack of room windows on the ground floor street façade, and the presence of kitchen, toilet and similar wet areas in the

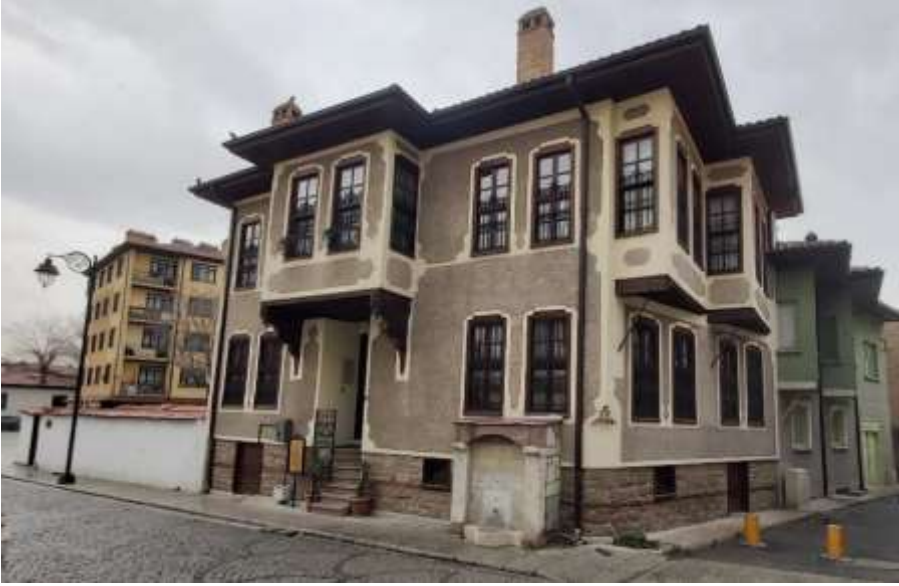
**Figure 8.** Fahriye Büyükmatür House Facade (Dönmez, 2021)

**Estimated Construction Period** : 20th century First Quarter Late Ottoman Period  
**Current Usage** : Foundation Building

**Periodic Features of the Building:** Although the house has a small traditional garden, it is seen that it was designed in a plan scheme that faces the street, not the house garden. Unlike the 19th century examples, the fact that the house has windows on the ground floor street front, that the house is directly accessible from the street, and that the bay windows are built

in close relation with the street, shows that the house was built with a street-oriented design approach. In addition, the fact that the street facades are decorated with spray plaster is another sign of the design for the street facade. The miter bay window, which was not encountered in previous examples, is seen in the house in order to increase the aesthetic perception towards the outside. Although there are toilet and kitchen spaces in the garden of the house, it is seen that a separate toilet and kitchen are designed inside the house. This situation shows that the house was built after 1901 in connection with the distribution of the mains water to the houses in 1901 in Konya. Although Berk (1951) stated that the kitchen was kept outside the houses in the houses produced in the late 19th and early 20th centuries, it is thought that the residential building was built just after 1901. In addition, another remarkable case is the inclusion of the basement floor plan in the house and the elevation of the ground floor level so that it can be reached with the help of a ladder in order to open a window to the basement floor. In this period's buildings, unlike the previous period's buildings, access to the residence is provided via a 6-7-step staircase. In this way, it was thought to meet the need for light and air by opening windows to the basement floors (Dönmez, 2021). This has resulted in the residences being half times higher than the previous period residences.

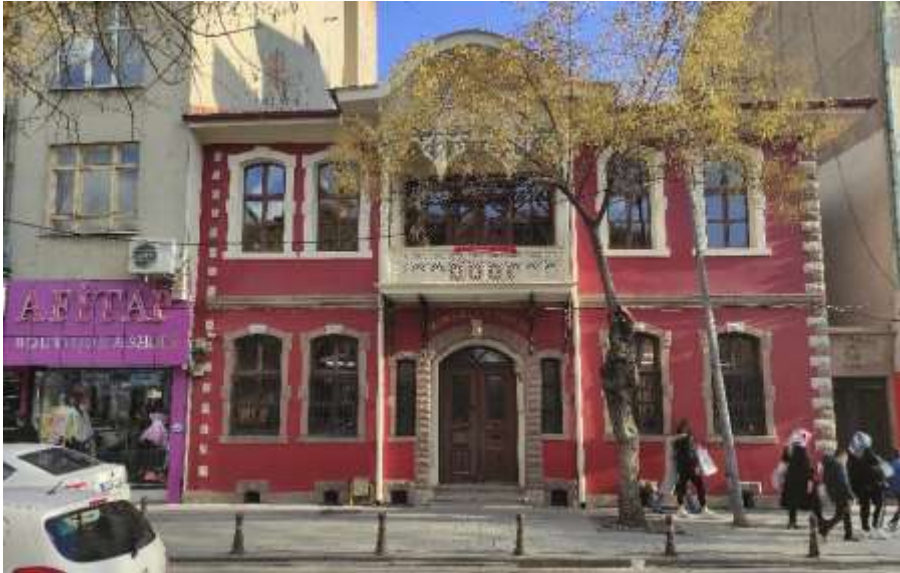
**Figure 11.** Mimarlar Odası / Dr. Nevzat Özkal House Facade (Dönmez, 2021)

**Estimated Construction Period** : 20th Century First Quarter 1st National Period  
**Current Usage** : Professional Chamber

**Information About the Building:** The building was built in 1912 (Odabaşı, 1998). The building, which is used as the Chamber of Architects today, was later restored by the same institution (Aygör, 2015). During the restoration, changes were made in the plan of the building, but the facade layout was not changed (Aygör, 2005). The residence has three floors with a basement. The basement floor main walls of the residence were built by masonry construction technique using rubble stone, the ground floor and first floor main walls were built by nogging technique using adobe or rubble stone between the wooden frame. It is seen that the bagdadi technique is used on some interior walls (Aygör, 2015). Concrete material is used in the hall added in the south direction on the ground floor and in the construction of the stairs that provide access to the upper floor (Aygör, 2015). The garden in the south of the house is quite small. There are no traditional outbuildings such as tandoor, barn and so on. Since the house has mains water use, the kitchen and toilets are located inside the house (Figure 13). The east and west facades of the house are deaf-fronted due to the adjacent layout (Figure 11). The building has two entrances on its northern façade (Figure 11-13). The first is the main entrance to the north, which opens directly to the street, and the other is the garden entrance, which is located to the west of the main entrance, which was added later. From the double-winged main entrance door located in a 30 cm niche with a low arch, first the closed room with a stone floor is passed, and then the interior hall (Figure 13). The ground floor plan and the first floor plan are similar (Figure 13). There are no ghuslhane, closet and similar elements that reflect the traditional texture in the rooms today (Dönmez, 2021). The flattened arched stone jambs surrounding the windows placed symmetrically at regular intervals in the direction of the vertical and horizontal axes on the street façade of the house were protruded from the façade (Figure 11). The only bay window of the building is designed as a balcony, right above the main entrance, as a continuation of the first floor interior hall (Figure 11). The ornaments of the wooden balcony and the arched form of its eaves are remarkable examples of ornamentation not seen in previous examples. The house is a hipped roof covered with

Marseille tiles, and the garret is used as a warehouse. The use of staggered corner stones on the facades of the house and the horizontal floor separation formed by profiled moldings at the first floor level are included (Figure 11). Corner stones and profiled moldings are designed to overflow from the main wall of the building.

**Periodic Features of the Building:** The residence was built in the first national architectural style. In addition to the small size of the residential garden, the traditional guest room "Hariciye", tandoor, barn, poultry house and similar traditional outbuildings are not seen. The kitchen and toilets in the house, which has mains water use, are located only inside the house. With the change, the bathroom design on the upper floor took the place of the ghuslhane, which were in the examples of the previous period. As another indicator of the change, a balcony design, which was not seen in the examples of the previous period, is encountered in the continuation of the first floor interior hall. The residence is designed to be accessed directly from the street. On the street facade, the window design that starts at a low level can be seen on the ground floor. In addition, the windows on the entire street facade are distinguished by their low-arched and keystone jamb applications. The wavy fringe seen in the housing design and not encountered in previous periods has a striking appearance. These features show that the house was built with an understanding of a facade oriented towards the street facade, with intense decorations.
