# ARCHITECTURAL SCIENCES AND CULTURAL HERITAGE

**Architectural Sciences and  
Cultural Heritage – Traces of the History**

**An Evaluation on New Function Suggestion in  
Worship Buildings: Akşehir Armenian Church**

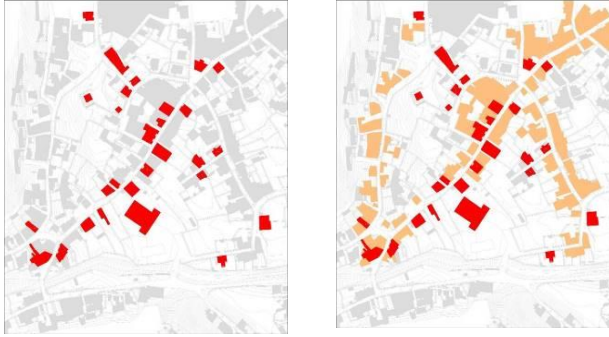
**Figure 3:** The condition of the church and the registered buildings around.

The buildings marked in red in the first figure show the church and the buildings around it, which are registered on a single building basis (Figure 3). Considering the density of registered buildings along Değirmen Street where the church is located and the church together with its surroundings, it is understood that the conservation process will proceed easily due to its location in a historical built environment. Because in such cases, the people living there should be able to look at the issue consciously and help. When the preservation status of the church and the surrounding buildings is examined, it is understood that as a result of the street sanitisation practices, all the buildings along the streets, whether registered or not, are tried to be preserved (Figure 4). Akşehir Armenian Church, which is located in the urban protected area, is within the important region where maintenance and repair works are carried out by the Ministry of Culture, local administration and various companies through tenders. It is located in an area where there are dwellings that have undergone simple repairs, street sanitisation, where

the façade and roof can be preserved, or where arrangements are made in order not to disrupt the silhouette of the façade, considering the buildings that have disappeared over time. In this case, it has an accelerating effect on the conservation process of the church.

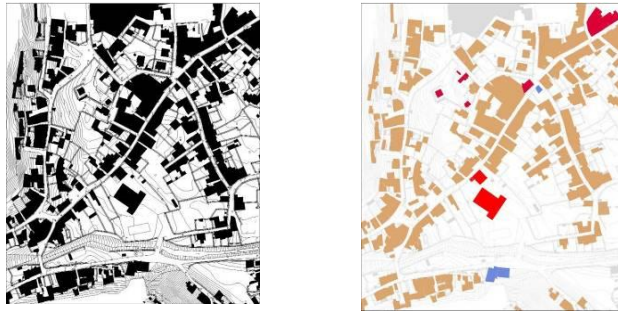
**Figure 5.** Full-empty analysis of the church and surrounding buildings

It is located in an environment with a significant occupancy rate due to the adjacent buildings on the entrance façade and other sides (Figure 5). Only the gardens of the adjacent buildings and the gaps on the side facing the Akşehir Stream behind the church stand out.

Functionally, the majority of the area is dominated by residential buildings. Apart from these, there are a few historical-religious buildings, a grocery store and a workshop. This workshop is a building where materials and equipment used for restoration works are stored and prepared. Apart from this, there is Gazi Mustafa Kemal Primary School, which is located in the same garden with the church and which suffers the fate of being idle together with it. Most of the houses are still in use in their current state. There are a few houses that have been transferred to the ownership of the municipality and are awaiting repair and are planned to serve various cultural projects.

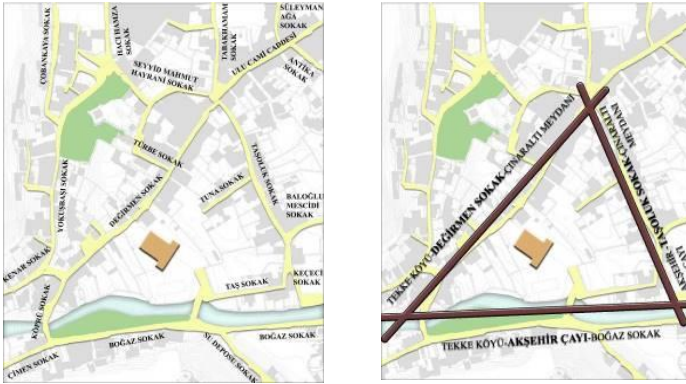
**Figure 7.** Conditions limiting the church and its surroundings  
**Figure 8.** Roads and streets in and around the church

When we look at the roads and their names seen in and around the church, all of them have taken their shape and name from the meaning they have been attributed over time. Değirmen Street, which is the most important and provides access to the church, is an important passage on the route from the city square to the urban forest. Apart from this, Boğaz Street, which is located on the back facade of the church, is in a situation where the church can be seen even though it is lower due to the elevation difference. The

Bogaz Street, which runs parallel to the road formed by the Akşehir Stream, reaches from the Nasreddin Hodja Tomb to the Tekke Village and the Urban Forest (Figure 7) There are three issues that limit this church in Akşehir. The first of these is the important historical streets mentioned above. Değirmen Street in the northwest and Taşoluk Street in the northeast. However, the existence of Tuna Street extending from Taşoluk Street to the church cannot be ignored. The second boundary element is the elevation difference on the rear façade. It will also be possible to take the Akşehir Stream as the third element here. These boundary tools, which play an active role in access to the church and at the same time in determining its borders, are situations that develop spontaneously over time through natural means. In this respect, they do not constitute any obstacle in terms of using the data of the area (Figure 8).
