## **Architectural and Social Adaptation of Traditional Housing from Past to Present; The Sample of Karahüyük in Konya**

**A. Deniz Oktaç Beycan, Sinem Tuğçe Şahin**

Konya Technical University

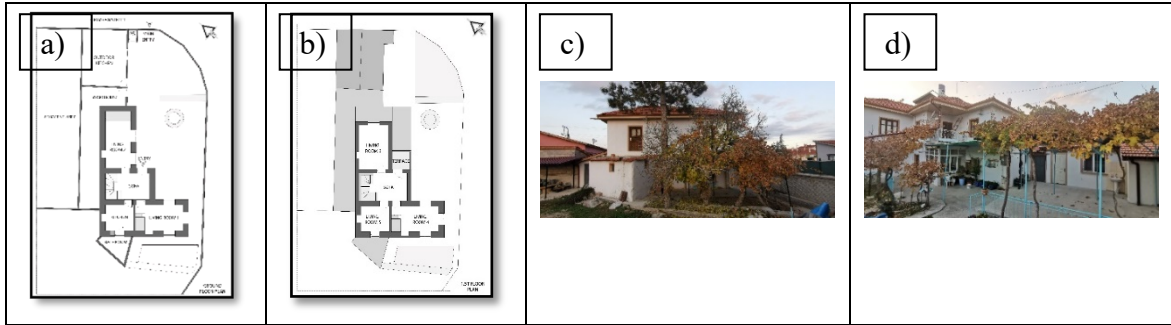
Şahin House was built using the traditional construction material of adobe and the technique of rammed earth. The building has two floors, with a central hall (sofa) and three rooms opening onto the hall on each floor. The lower floor walls were constructed with two layers of main adobe and one layer of small adobe, with a thickness of 60 cm. The upper floor walls were built with one layer of main adobe and one layer of small adobe, with a thickness of 30 cm.

The building has a sawtooth-shaped floor plan. The entrance to the rooms is through the central hall (sofa). The central hall serves as a space that connects the rooms and the staircase, and it is accessed from the courtyard on the ground floor (Fig. 7-a). Both floors consist of three rooms and one central hall (Fig. 7-a, 7-b). Due to the sawtooth-shaped floor plan, the external facade of the building has a dynamic appearance. The ground floor windows open to the northeast, southeast, and southwest directions (Fig. 7-c, 7-d).

**Figure 7.a)** Ground Floor Plan [31], **7.b)** First Floor Plan [31], **7.c)** Rear (Southeast) Elevation and Garden of the House [28], **7.d)** The House's Courtyard After Renovation and Its New Kitchen [28]

After the initial renovation, the lower and upper floors are used by two separate families. Access to the upper floor is provided through an external staircase. Today, this staircase has been removed, and both floors are used by the owner as originally intended (Fig. 7). The current user of the building has renovated the storage areas and the windows of the lower floor when they purchased the house (Fig. 8). Due to the maintenance difficulties of the grid wooden system, the ceilings have been covered with wooden paneling. Additionally, a wooden staircase has been added later on. In the central hall (sofa), there is a wooden staircase that connects to the upper floor (Fig. 8-b). The heating system of the building was provided by a stove until 2016. With the introduction of a natural gas pipeline to the neighborhood, heating is now done using a natural gas central heating system (Fig. 8-a).

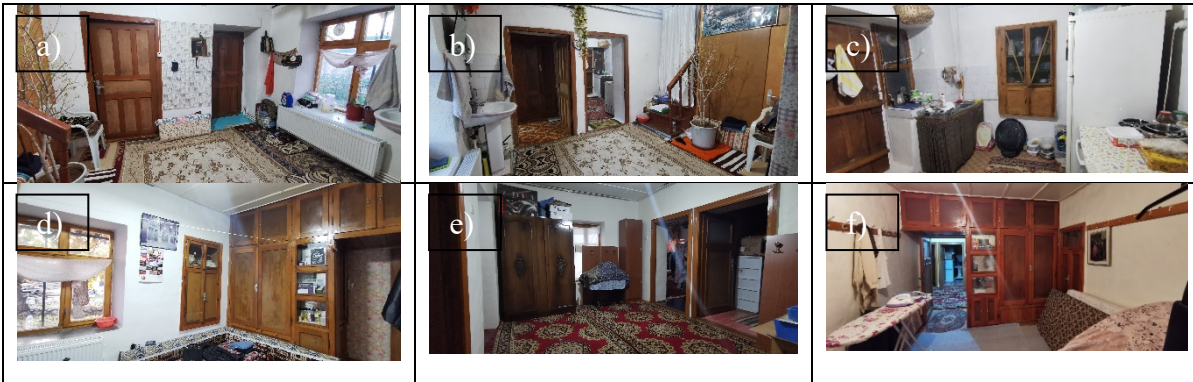
**Figure 8.a)** Ground Floor Reception Room and House Entrance [28], **8.b)** Ground Floor Reception Room [28], **8.c)** Kitchen [28], **8.d)** Niche and Cupboard in the Living Room [28], **8.e)** First Floor Reception Room [28], **8.f)** Niche and Cupboard in the Living Room on the Upper Floor [28].

On the ground floor of the building, there are two rooms, and the same rooms on the upper floor have niches and storage areas. The storage areas include wet areas to meet the bathroom needs (Fig. 8-d). The kitchen requirement of the building is designed in one of the rooms on the ground floor, specifically for kitchen use (Fig. 8-c).

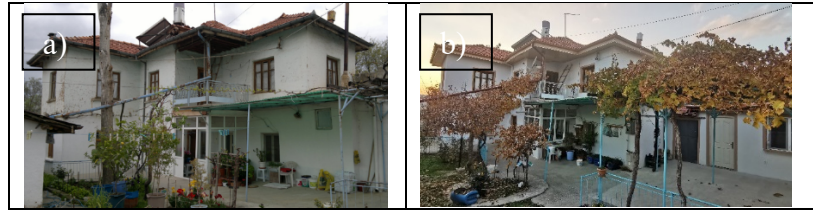
The exterior facade of the building was initially finished with a layer of clay over the adobe plaster, followed by a lime wash (Fig. 9-a). In the exterior facade renovation carried out in 2018, a cement-based plaster was applied to the entire facade. The roof covering was repaired, and the eaves were covered with wooden material (Fig. 9-b).

**Figure 9.a)** Building Photo Before Facade Renovation in 2011 [28], 9.b) Building Photo After Facade Renovation in 2022 [28]
