**9TH INTERNATIONAL CONGRESS  
ON LIFE, ENGINEERING, AND  
APPLIED SCIENCES IN A  
CHANGING WORLD  
PROCEEDINGS BOOK**

# INVESTIGATION OF THE DETERIORATION TYPES OBSERVED AT THE KANUNİ SULTAN SÜLEYMAN MOSQUE IN HATAY BELEN DISTRICT

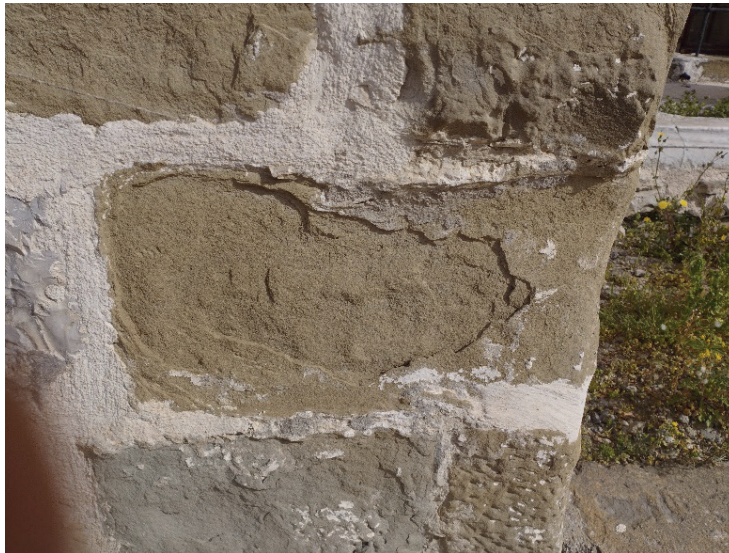
In the Belen district of Hatay, summers are warm and hot, and winters are cold and rainy. Temperatures throughout the year range from 3°C to 29°C (MGM, 2023). This situation causes wetting-drying and salt crystallization processes, which are deterioration processes, to be effective in the region. These processes were identified as the main cause of deterioration developments in the monument. These processes led to the development of contour scaling-type deterioration in building blocks, ranging from mm to cm (Figure 2).

Figure 2. Contour scaling type observed in the monument

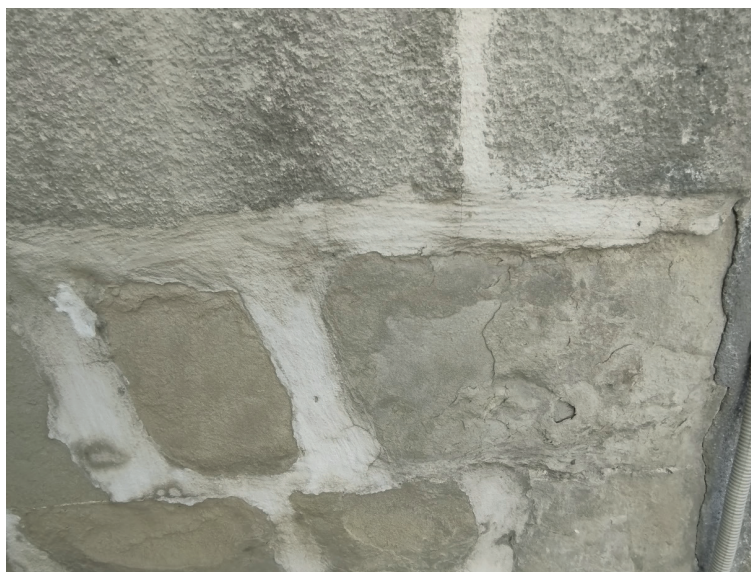
In addition, blistering and differential erosion type deterioration were determined in different parts of the monument. (Figures 3, and 4).

Figure 3. Blistering type anomaly

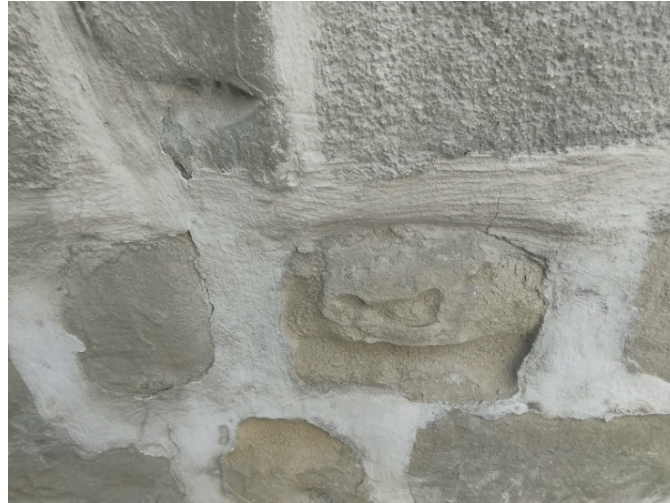
Figure 4 Differential erosion part anomaly
