International ICONTECH SYMPOSIUM-3 on Innovative Surveys in Positive Sciences

FULL TEXTS BOOK

WEATHERING TYPES OF STONES USED IN ABDÜLMÜMIN MASJID (KONYA, TURKEY)

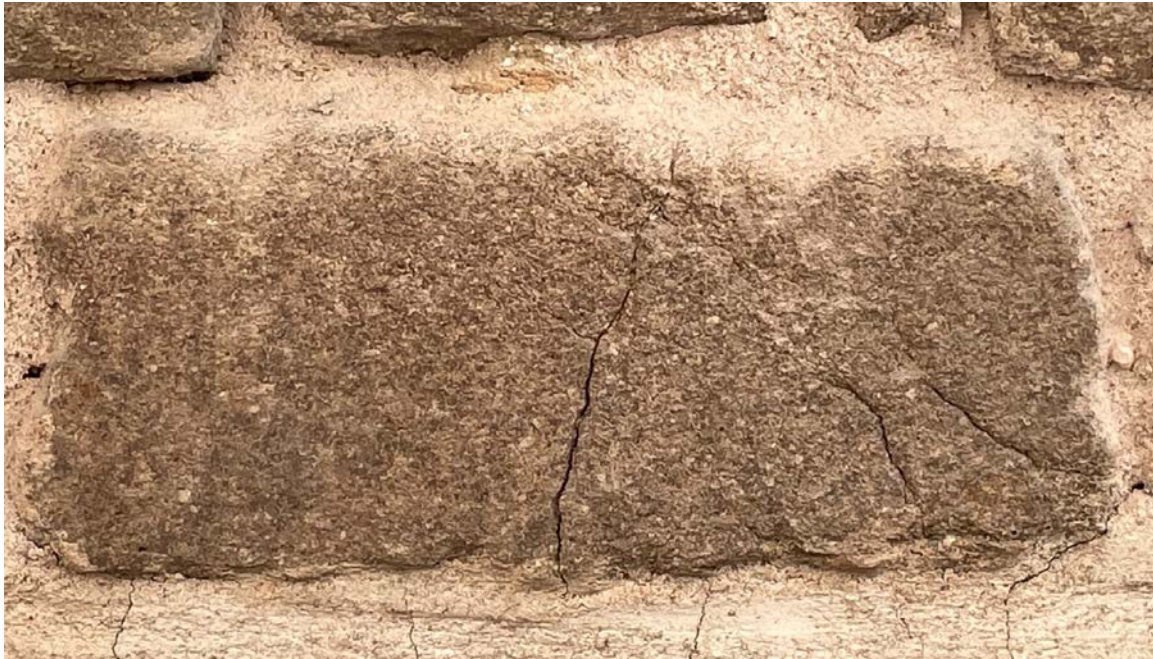
Cracking occurs as a result of atmospheric processes such as salt crystallization, wetting-drying, freezing-thawing and thermal shock and static changes due to load (Hatir et al. 2020; Hatir, 2020). When the building stones in Abdülmümin Masjid were examined, the crack anomaly was determined in pyroclastic and dacite rocks (Figure 2).

Figure 2. The view of crack anomaly.

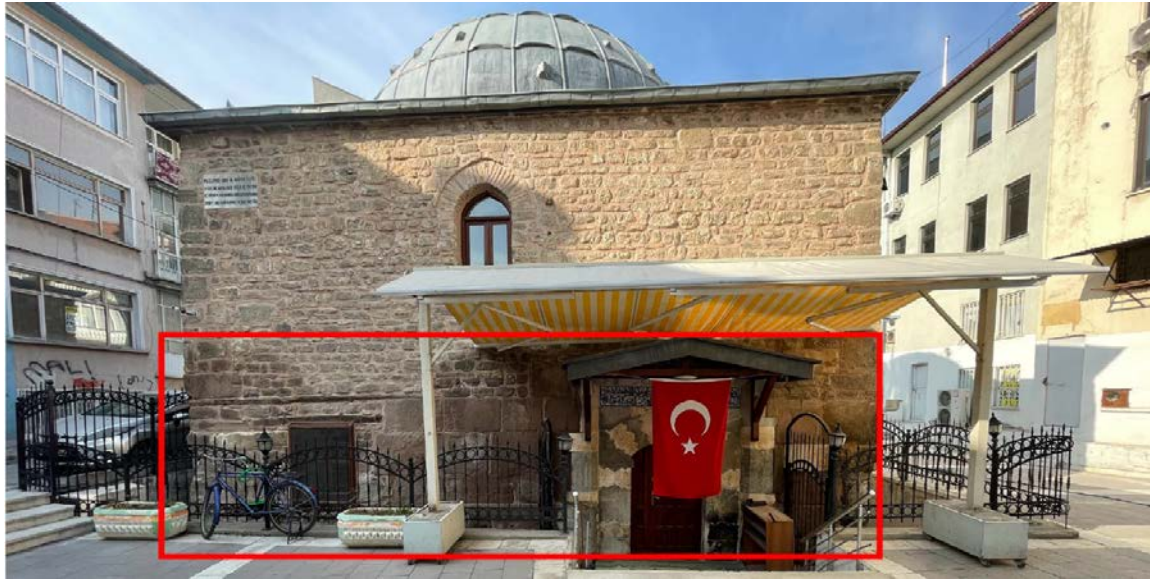
Moist area, one of the types of weathering under this group, is the darkening of the stone surface due to moisture. Depending on the water content in the capillary region of the structure examined in the study, a darker surface appearance was formed in the pyroclastic and dacite rocks (Figure 5). As a result of the reaction between CaCO_3 origin rocks, atmospheric pollutants and water, a black crust form occurs on the stone surface. Abdülmümin Masjid, located in the city center of Konya, is constantly exposed to pollutants such as PM, SO_x and NO_x due to the high use of solid fuels in the environment and the intensive vehicle traffic. In addition, with the presence of water at the capillary level, a black crust anomaly occurred in some types of travertine stones (Figure 6a) and marble entrance gate (Figure 6b).

Figure 5. The view of moist area.

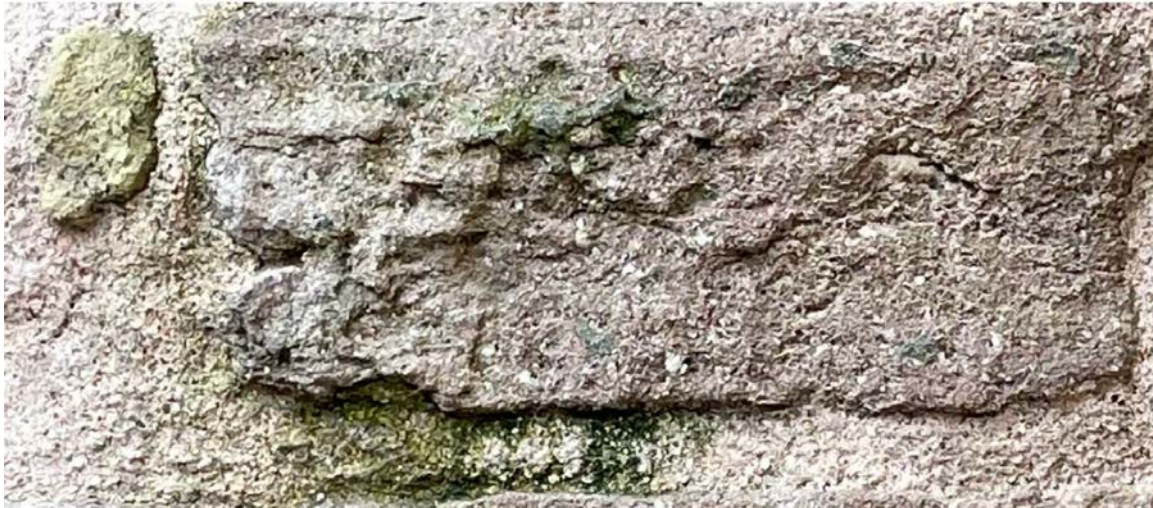
Biological colonizations such as algae, lichen and fungus in this group settle on stones with high surface roughness and develop under organic material accumulation, humidity and suitable temperature conditions (Korkanç & Savran, 2015). Within the scope of the study, lichen formation occurred only in a part of the eastern front (Figure 7).

Figure 7. The view of lichen effects in dacite.
