**VII. INTERNATIONAL "BAŞKENT"
CONGRESS ON PHYSICAL, SOCIAL
AND HEALTH SCIENCES
PROCEEDINGS BOOK**

INVESTIGATION OF THE DETERIORATION TYPES OBSERVED AT THE ASLANLI TOMB IN THE PHRYGIAN VALLEY

Immovable cultural heritages, which are historical documents, were generally built with stone materials in order to be passed on to future generations. The monuments, in which stone material is used, were made of building stone in a masonry work system or by carving into the rocks. Low-strength rock types were generally used in historical buildings, built for functions such as worship, defense, and tombs carved into the rocks. As these rocks are easily affected by atmospheric processes such as freeze-thaw, wetting-drying, and salt crystallization, the types of deterioration in historical buildings develop rapidly and this can cause many problems in monuments from textural features to integrity. In this study, Aslanlı tomb, which is located in the Phrygian valley and where atmospheric effects are widely observed, was examined. The material properties of this monument, which was carved into the pyroclastic rock, were investigated by laboratory tests, and the deterioration types were macroscopi

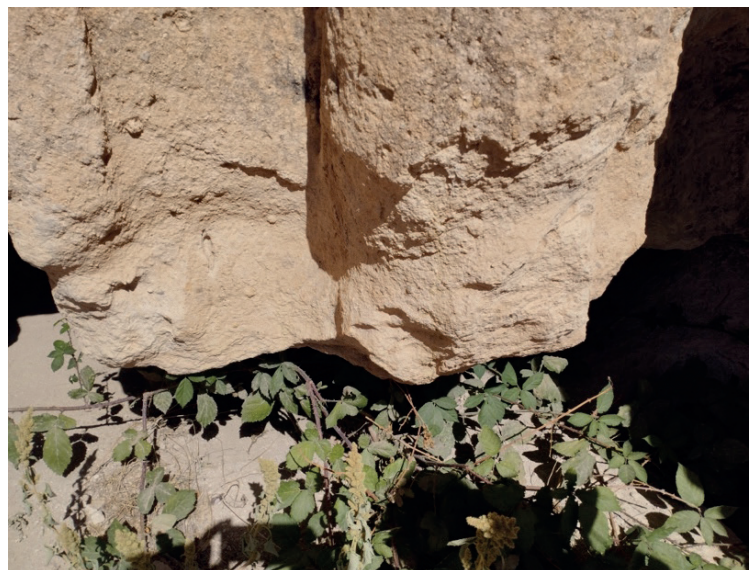
The this type of deterioration on the columns at the entrance door of the tomb structure has progressed up to a maximum of 13.2 cm (Figure 2). Furthermore, as a result of the progression of this process, a missing part anomaly can be observed on either side of the entrance door (Figure 3).

Figure 2. Contour Scaling With The Maximum Depth Observed On The Monument

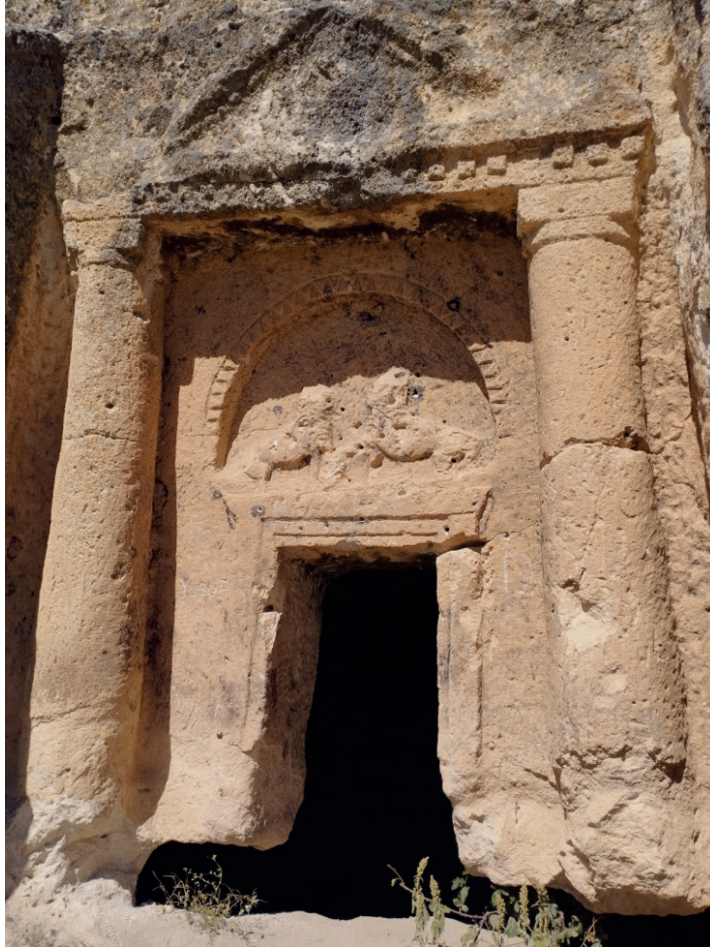
As a result of these missing parts, a crack has developed on the entrance door to the tomb as the tensile strength has been exceeded (Figure 3). There is also evidence of biodegradation on the monument resulting from the atmospheric effects to which it is subjected. While runoff has led to lichen growth on the triangular pediment of the monument, a higher plant developed in the ground area (Figure 3). In addition, mechanical damage resulting from vandalism can be observed on the structure (Figure 4).

Figure 3. Missing Part Anomaly

The study has found that the Aslanlı Tomb has been affected by different forms of deterioration in the Phrygian Valley, threatening this important item of heritage. In addition, the index and strength values of the pyroclastic unit from which the monument has been carved has been determined. The different types of deterioration observed on the tomb structure can generally be attributed to the lithology of the rock and local climatic conditions. Deterioration types on the monument range between mm scale (contour scaling) and m (crack) scale. It damages the aesthetic integrity of the monument because of atmospheric and biological effects as well as human effects on this unique heritage. In addition, the deterioration process was faster in sections also showing signs of damage caused by people. Since all these types of deterioration in the building have come to affect the structural properties of the monument, it is recommended to carry out urgent restoration works on it.

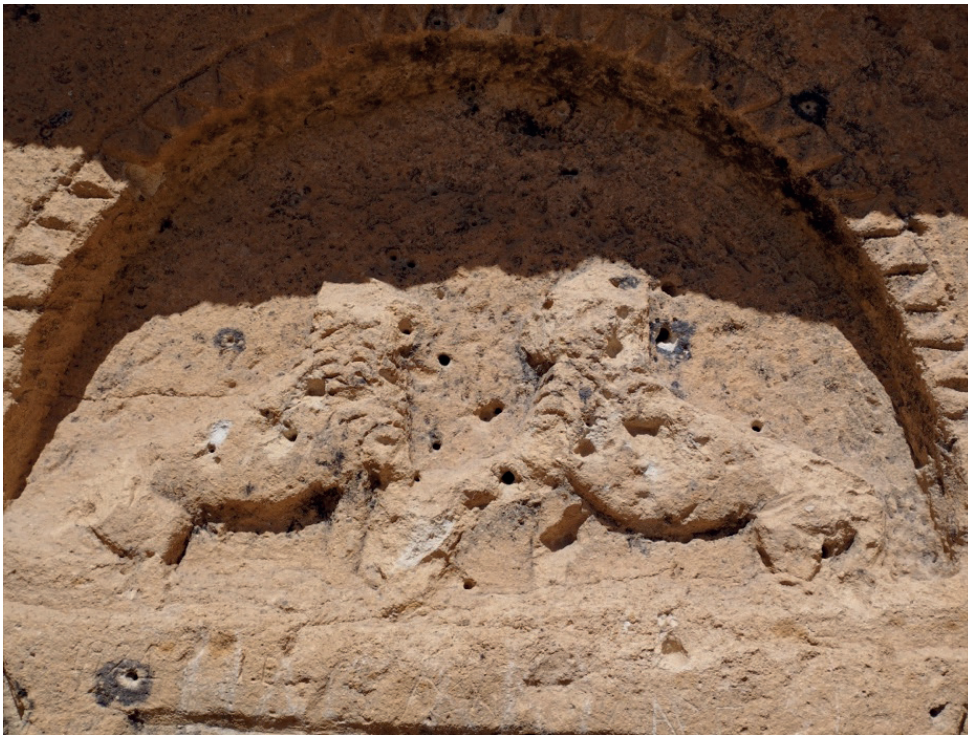
Figure 4. Anthropologic Effect Observed On Figures
