# A comprehensive experimental study of enhanced solid particle erosive resistance on the inner/outer surface of graphene nanoplatelets modified basalt/epoxy composite pipe

Basalt fiber reinforced polymer (BFRP) composite pipe is an excellent alternative to glass and carbon fiber reinforced composite pipes in industry and promising in high recycling for polymer composite used in aerospace, marine, and automotive. To enhance the solid particle erosion (SPE) properties of filament-wound BFRP composite pipe while preserving its mechanical properties, reinforced BFRP composite pipes were prepared to employ non-functionalized graphene nanoplatelets (GnPs) at a reinforcement concentration of 0.25 wt.% and ultrasonication mixing technique. The SPE behavior of GnPs reinforced and non-reinforced BFRP composite pipes were characterized by axial and radial positioning of the inner and outer surfaces of the pipes. In each case, the erosion rates of these composite pipes were evaluated at five impingement angles (30°, 45°, 60°, 75°, and 90°) and an impact velocity of 34 m/s. The erosion response of both BFRP composite pipes' outer surfaces showed a semi-ductile in the axial positioning, with a

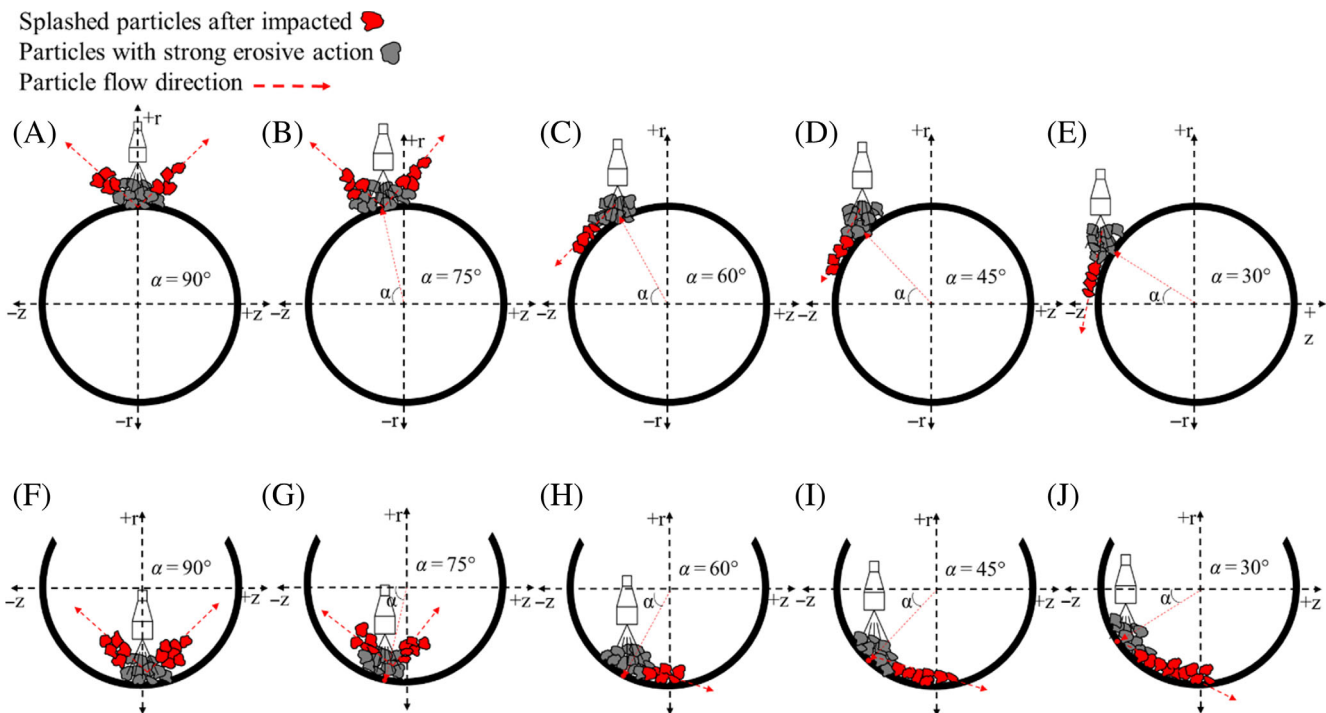
**FIGURE 5** Schematic views of the variation of the impingement angle in the BFR composite pipe outer (A–E) and inner (E–J) surfaces radial positioning. Illustrates the trajectory of splashed particles (in red) and particles that cause intense erosive action (in gray) as they flow in the direction of particle impact.

with a cylindrical geometry, as seen in Figures 4 and 5. For concave surfaces, the erosion rate is generally higher due to the focusing effect of the surface geometry. This

Figures 4A–E and 5A–E demonstrate that solid particles striking the outer surface have varying impact intensities, with some particles hitting the surface tangentially, resulting in less abrasive effects. This phenomenon is particularly prominent at impact angles of 45° and 30° when in radial positioning. In contrast to tests with axial positioning, a higher wear rate is observed at a 60° impact angle in radial positioning, resulting in semi-ductile erosive wear behavior on the outer surface due to the occurrence of cracks and material loss. In axial positioning on the outer surface, the impact angle has an active role in wear, as the force acting on the fiber and matrix increases with the cosine component of the impact angle. The erosion rate increases on the inner surface due to the concave geometric shape and cumulative impact of abrasive particles that accumulate on the surface, causing more wear. In axial positioning tests, the SPE rate in the internal surface reaches its maximum value at a 45° impact angle, resulting in semi-ductile erosion wear behavior. The maximum SPE rate is observed at a 60° impact angle on the outer surface in radial positioning, with abrasive particles causing cracks on the surface and resulting in significant material loss. The maximum material loss at a 45° impact angle on the inner surface is due to an increase in the particle/contact surface resulting from the solid particle focusing effect on the concave surface of the pipe, causing more material loss.

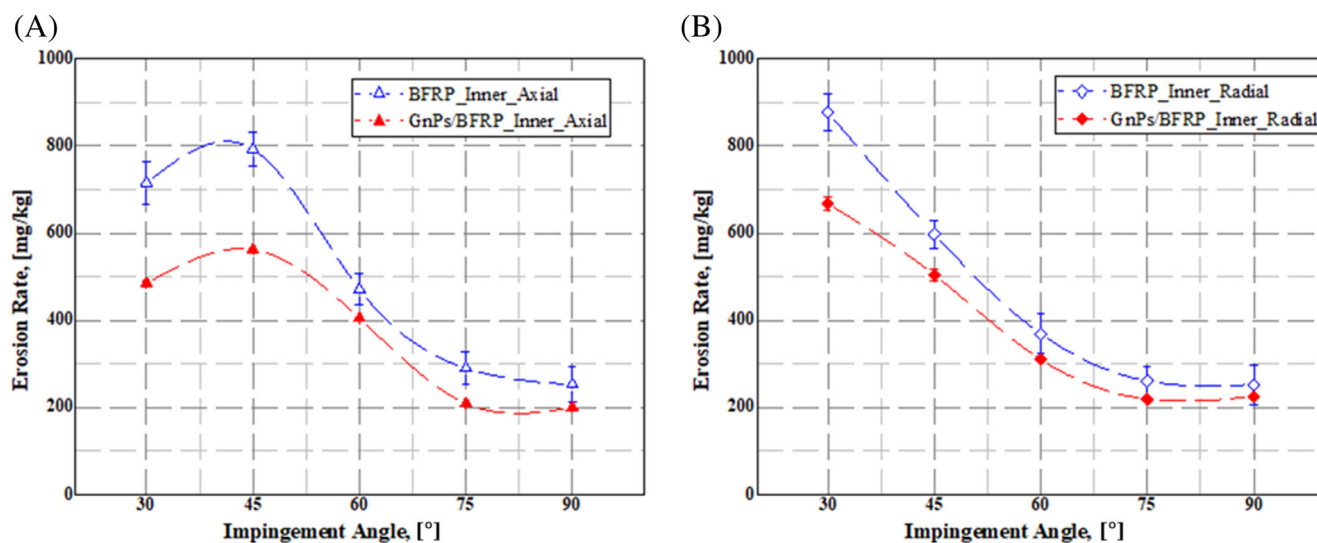
FIGURE 6 The erosion rates of BFRP and GnPs/BFRP composite pipe as a function of an impingement angle at different positioning; (A) inner surface in the positioning of axial and (B) inner surface in the positioning of radial.

The pipe's inner eroded surfaces' response is similar to the outer eroded surface behavior. Figure 4B shows that the erosion rate decreases with increasing impingement angle. In contrast, Figure 4A shows that the erosion rate increases with increasing impingement angle up to 45° and then decreases again. As mentioned above, it is seen that the inner surface of the pipe is ductile in radial positioning and semi-ductile in axial positioning. These results are consistent with studies<sup>40,41</sup> reporting that fiber-reinforced composites have ductile and semi-ductile erosion behavior.

The erosion behavior of the GnPs reinforced BFRP composite pipes under various influences of impingement angle ( $\alpha$ ) was investigated. As seen in Figures 3 and 6, the erosion rate of all GnPs/BFRP composite pipes, as compared BFRPs, showed the same decreasing trend, regardless of axial and radial specimen positioning. In each impingement angle case, adding GnPs significantly reduces the erosion rate of the BFRP composite pipe. The minimum erosion rate is detected for the GnPs reinforced BFRP composite pipes at 90° of impingement angle in the radial specimen positioning of the outer surface. The maximum erosion rate values are 877.12 and 667.25 mg/kg for the BFRP and GnPs reinforced BFRP composite pipes at 90° of impingement angle in the radial specimen positioning of the outer surface, respectively. With the addition of 0.25 wt.% GnPs to the epoxy, it is reached a significant improvement of 54.74% in the erosion rate at 60° in the axial specimen positioning of the outer surface. The decrease in the erosion rate can be

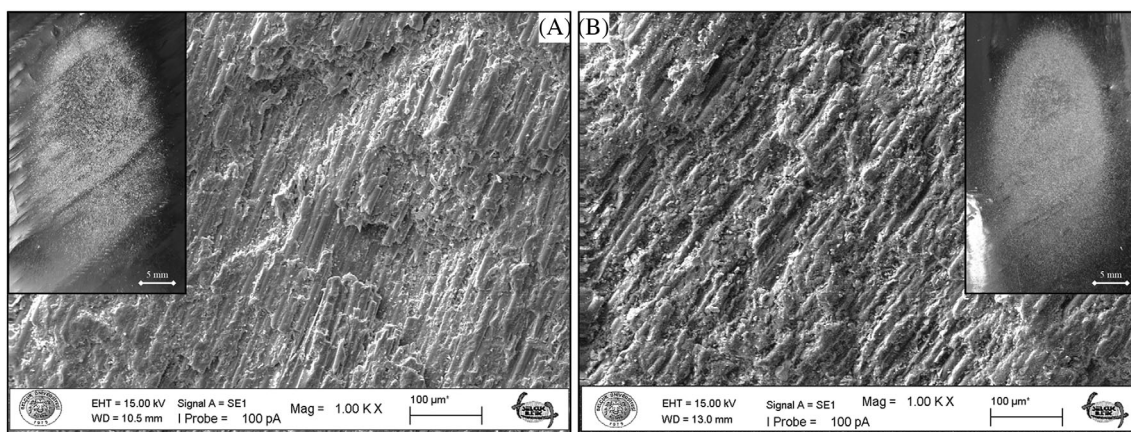
FIGURE 7 SEM images of matrix damages and fiber breakage on the outer surface at the 30° impingement angle in the positioning of axial: (A) BFRP and (B) GnPs/BFRP composite pipes.

The SPE-induced damage images of BFRP and GnPs/BFRP composites pipes formed in  $\pm 55$  angle-ply lamina region is given in Figures 7–10. These SEM and stereomicroscope images were selected based on the maximum SPE rates on the outer and inner surfaces of neat BFRP

The effects of GnPs on the damage of the outer and inner surfaces of BFRP composite pipes were investigated. The results are presented in Figures 7–10 for different impingement angles. For the outer surface, at a  $30^\circ$  impingement angle in axial positioning and a  $60^\circ$  impingement angle in radial positioning, adding GnPs reduced the depth of erosion damage but did not significantly affect the spread of regional damage on the pipe surface. Similarly, for the inner surface, at a  $45^\circ$  impingement angle in axial positioning and a  $30^\circ$  impingement angle in radial positioning, GnPs decreased the depth of

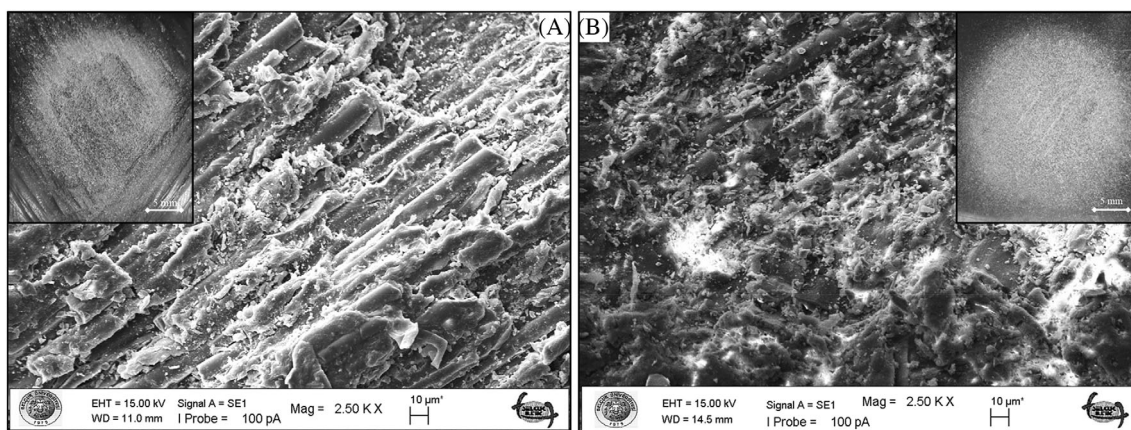
FIGURE 8 SEM images of matrix damages and fiber breakage on the outer surface at the 60° impingement angle in the positioning of radial: (A) BFRP and (B) GnPs/BFRP composite pipes.

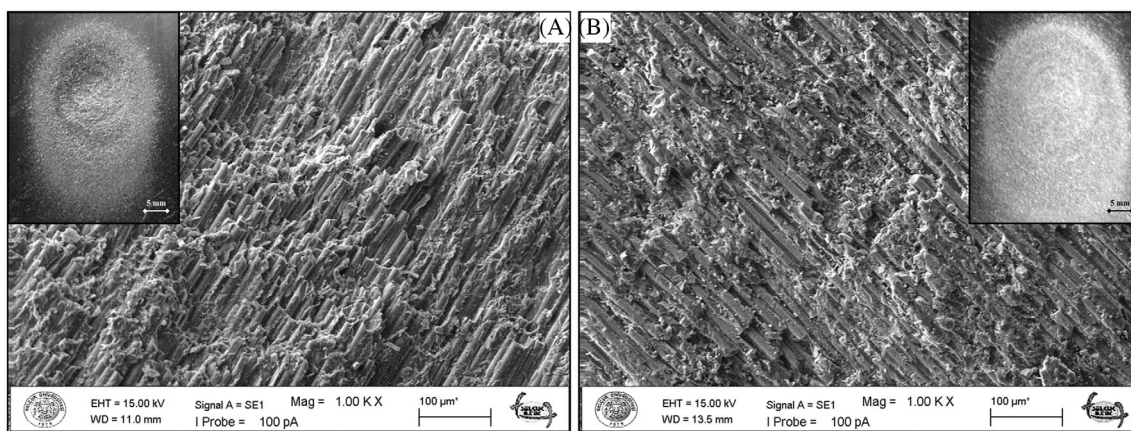
FIGURE 9 SEM images of matrix damages and fiber breakage on the inner surface at the 45° impingement angle in the positioning of axial: (A) BFRP and (B) GnPs/BFRP composite pipes.

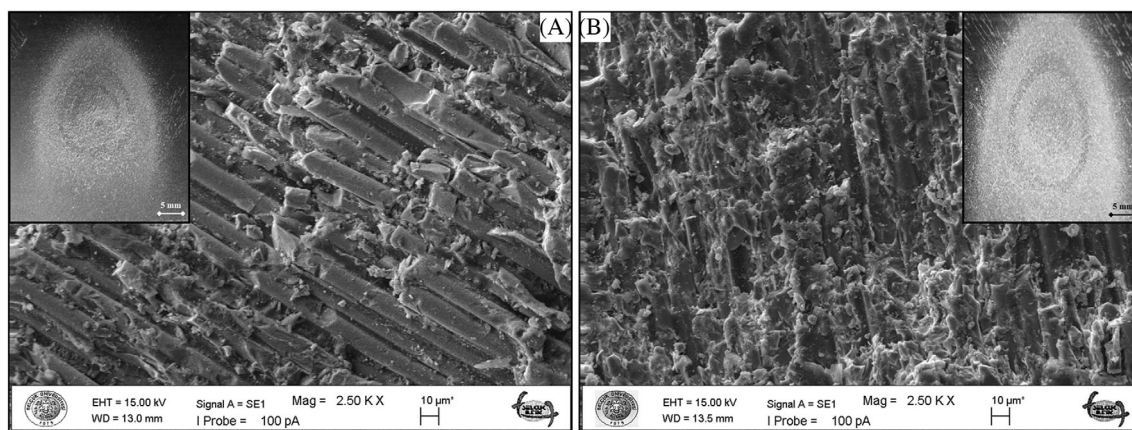
**FIGURE 10** SEM images of matrix damages and fiber breakage on the inner surface at the 30° impingement angle in the positioning of radial: (A) BFRP and (B) GnPs/BFRP composite pipes.

SEM images revealed the presence of epoxy residues on the fibers in the damaged region formed in the inner and outer surfaces of the pipes. These residues' formation was attributed to the interfacial strength enrichment between the fiber and epoxy. The addition of GnPs significantly improved the adhesion of the epoxy to the fibers. Furthermore, SEM images of pipes doped with GnPs showed a much lower erosion depth than those without additives, indicating improved wear resistance. This improvement in erosion resistance is also contributed by the solid lubricating effect of GnPs, which reduces friction and erosion between the abrasive particle and the GnPs reinforced epoxy. In addition to improved erosion resistance, the addition of GnPs also led to an increase in the impact toughness of the epoxy. The increased impact toughness significantly supported the reduction of the SPE ratio with less fragmentation on the eroded surface. Increased interfacial strength resulted in an increase in the hardness value of the pipe. Overall, these results obtained from damaged surfaces suggest that the addition of GnPs can significantly enhance the mechanical properties of BFRP composite pipes, making them more durable and resistant to erosion.
