To Cite: Horasan B.Y, Ozturk A, 2021. Features of Andesites Used in Buildings Around İncesu (Seydişehir) Region, Journal of the Institute of Science and Technology, 11(3): 2079-2090.

Features of Andesites Used in Buildings Around İncesu (Seydişehir) Region

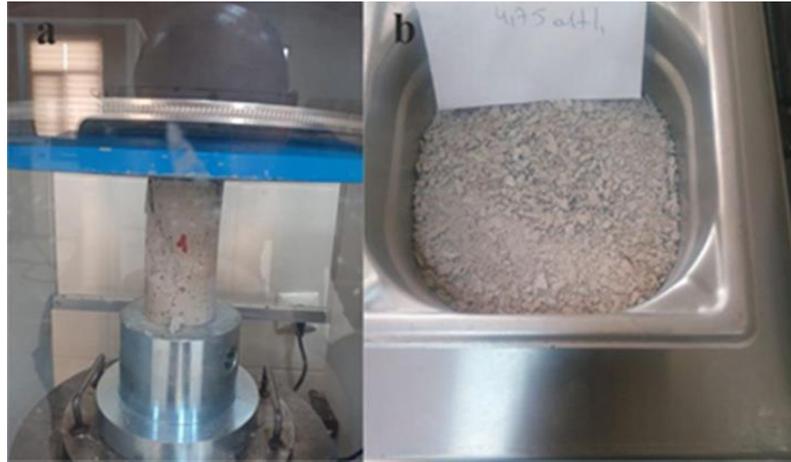
Figure 2. Experimental studies (Sample prepared for uniaxial pressure experiment and Na_2SO_4 experiment)

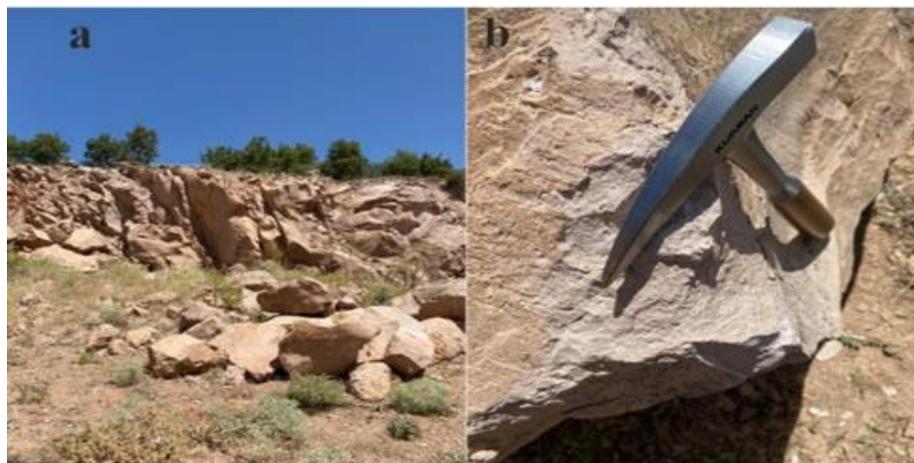
Sulutas volcanic observed in the area where the study was carried out generally consist of oyster white, gray, pink-colored andesite, and dacites and a small proportion of rhyodacite, rhyolite, and basaltic neck, dyke, and lava flows. It was named as "Sulutas andesite member" within "Dilekçi formation" by (Göğler and Kırıl, 1973). In regional scale studies (Jung and Keller, 1972; Keller et al., 1977; Besang et al., 1977), these rocks were defined as andesite, dacite, rhyodacite, and rhyolite; these have been defined as andesite and dacite by (Ota and Dinçel, 1977) and these were defined as "Büyükgevelletepe andesite/dacite member" and "Doğuşalayayla basalt member" by Ozkan (2017) and Eren (1993) defined these lavas, which crop out mostly by cutting the other units, as Sulutas volcanic, and this denotation was adopted in this study. These rocks are seen on fresh surfaces as lava flows in pink, light gray, gray, color tones in some locations, and volcanic nails, neck, and dykes in some regions (Figure 3 a and b). Andesites are pink, gray, dark gray, locally red, and contain large quartz grains, amphibole, and feldspar crystals that can be seen by the eye (Figure 3 a and b).

Figure 3. a and b Appearance of andesites in the study area
